# Application of Walkability Index for Older Adults' Health in the Brazilian Context: The Case of Vitória-ES, Brazil

**Abstract:** This study follows up on the article ‘Walkability Index for Elderly Health: A Proposal’, published in 2020, as well its validation in the Historic Center of Porto, published in 2021. The 2020 article presented the theoretical and methodological bases relating qualities of public spaces, the walkability of older adults, and the direct benefits on health. The 2021 article validated the applicability of the index in the Historic Center of Porto, Portugal. Both articles incorporated the factor ‘slope’, solving a criticism evidenced in related literature about the slope being ignored in older adults’ walking conditions studies. The present study, however, aims to validate the conceptual design of the Walkability Index for Elderly Health (WIEH) in the Brazilian context at the historic center of Vitória. The methodology included the analysis and evaluation of public spaces regarding the pedestrian network—urban fabric, urban scene, and safety—and the presence of slopes and/or stairways. Subsequently, these spaces were classified according to the WIEH, ascerta

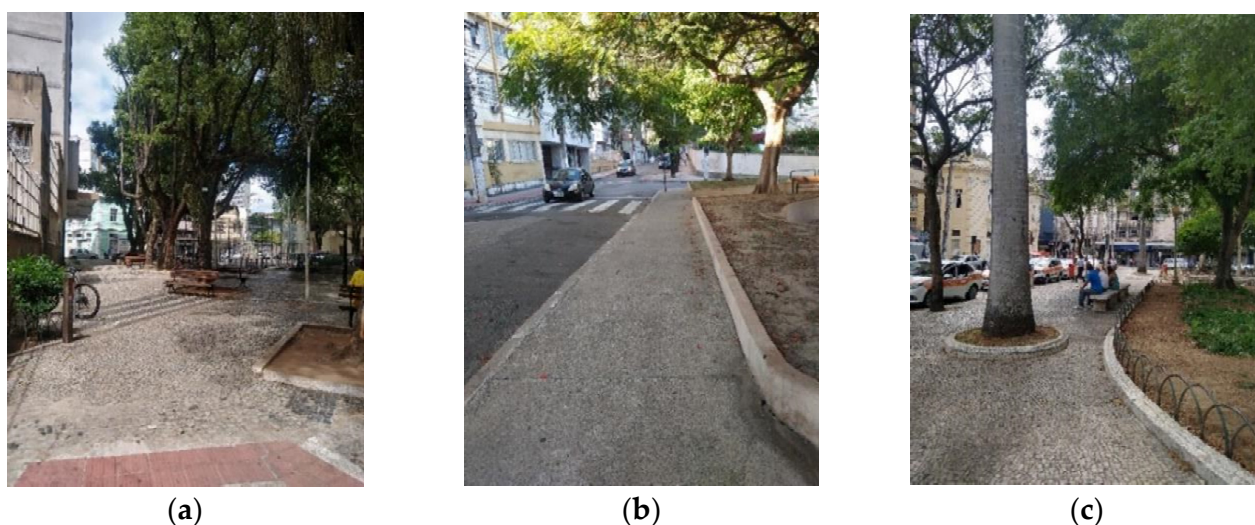
**Figure 10.** Examples of stretches with the best WIEH ratings, thus considered age-friendly routes. (a) Pedestrian walkway, next to the Ubaldo Ramalhete square; (b) Rua Coronel Monjardim, next to Praça Irmã Josefa Hosana and near the Senior Citizen Center; (c) sidewalk at Costa Pereira Square, a major city landmark, surrounded by the Carlos Gomes Theater and Glória Theater—it provides access to Cidade Alta and to tourist attractions such as the São Diogo Staircase and the Metropolitan Cathedral.

Figure 10a–c shows three of the stretches with the best WIEH evaluation, considered the friendliest to older adults’ walkability given their good physical conditions.

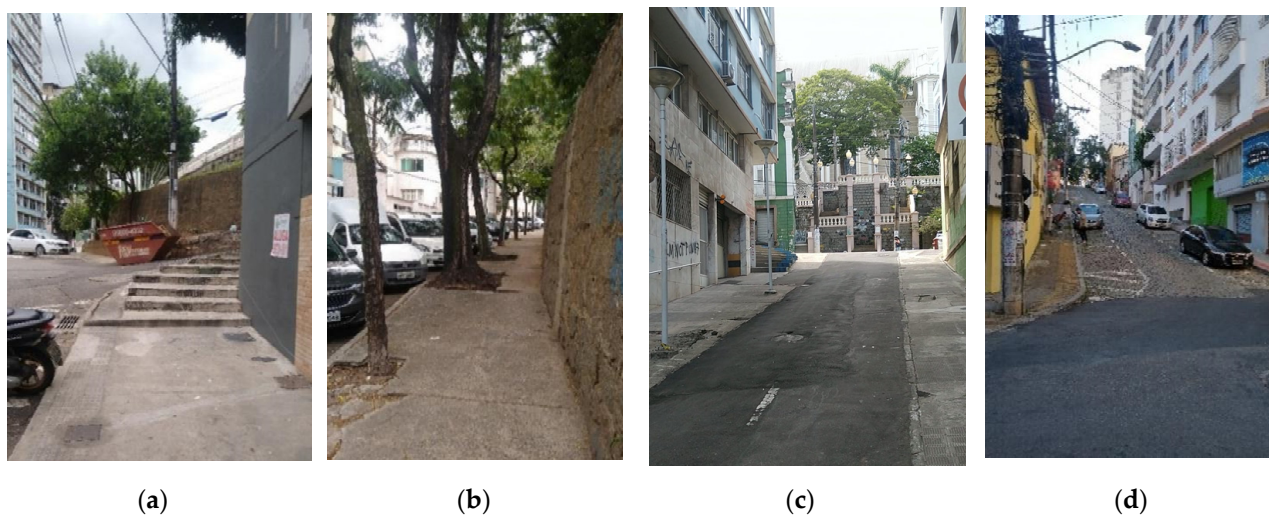
**Figure 11.** Examples of stretches with the worst classifications, and thus spaces unfriendly to older adults according to the application of the WIEH (a) Rua Dionísio Rosendo, with stairway at the inflection angle; (b) Rua Dionísio Rosendo, with narrowing of the passage and uneven floor, heightening the risk of falls; (c) Rua Cerqueira Lima, the only shared street in the study area, presents a steep slope and several potholes; in the background, the access stairway to the Cathedral, through Dionísio Rosendo Street; (d) Rua Prof. Baltazar, with an incline greater than 10%, and which also provides access to the Cathedral.

Figure 11 shows examples of sections with the worst WIEH scores and thus not considered age-friendly.

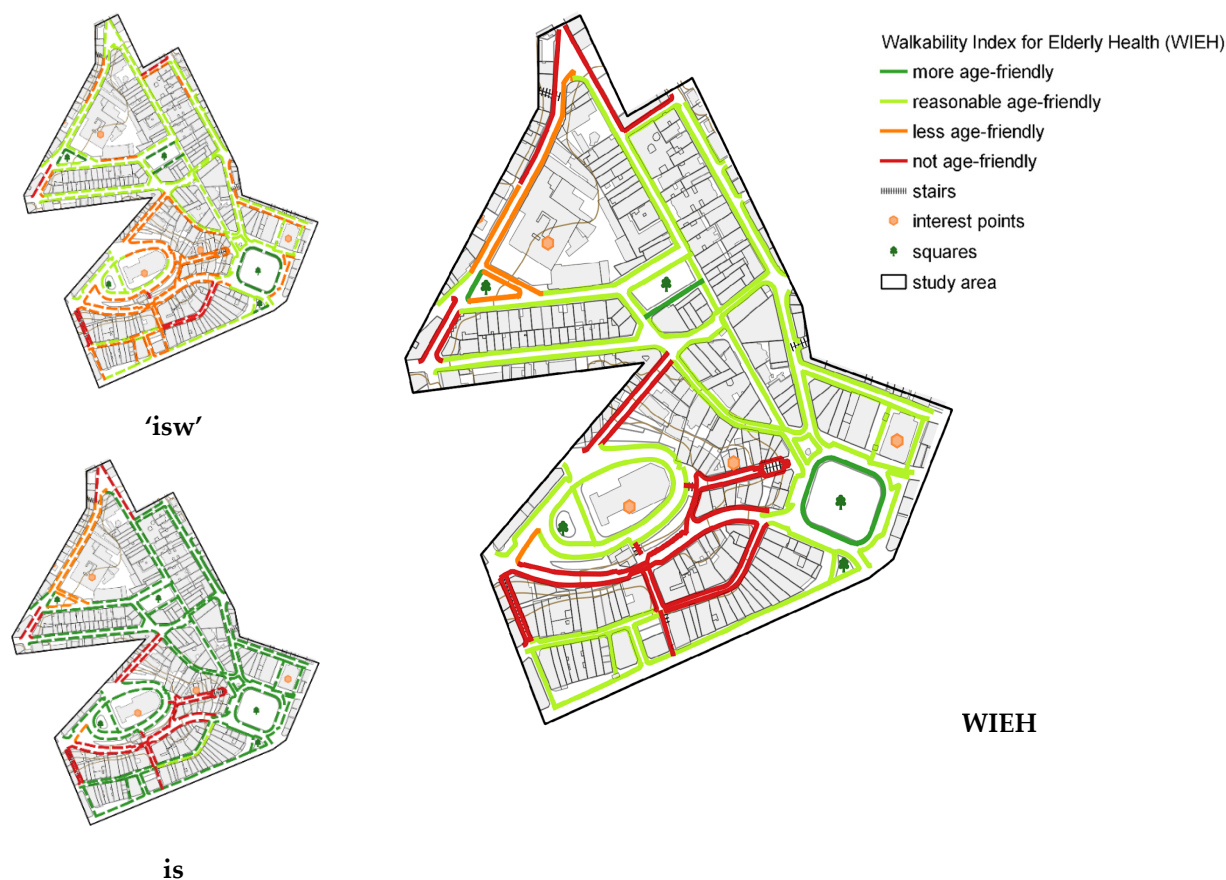
**Figure 12.** Comparison of 'isw', 'is', and WIEH ratings.

Figure 12 presents the comparison map of ‘isw’, ‘is’, and WIEH. The least age-friendly spaces, according to the WIEH, are mainly located in the area around the Metropolitan Cathedral (oval terrain), which was built on high ground. The stretches providing access to the Cathedral were classified as not age-friendly, given the steep slope, the presence of stairs, and/or the poor quality of the pedestrian network. The stretches south of the Cathedral present predominantly commercial use and several unoccupied buildings, in addition to abandoned sidewalks.

It should be noted that this comparison between ‘isw’ and ‘is’ maps with the WIEH (Figure 12) drew attention to a marked difference in the evaluation of some stretches—changing from ‘less adequate’ in the ‘isw’ (in orange) to ‘reasonably friendly’ to the older adults in the WIEH (in light green), which seems contradictory. This change in rating was induced by the WIEH parameters (Table 15), which were quite different from the ‘isw’ parameters (Table 12); more specifically, the broadening of the parameter for classification as ‘reasonably friendly’ in the WIEH, which covered values between  $>1.0$  and  $\leq 2.5$ . Ob-

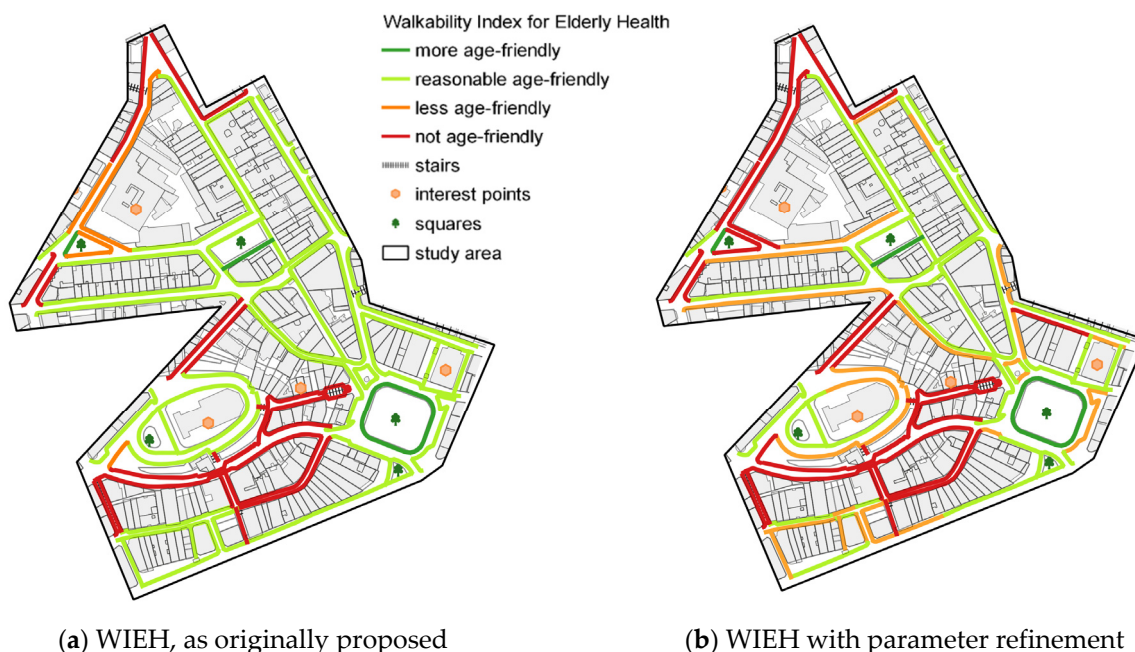
**Figure 13.** Comparison of WIEH ratings as per initial parameters in the previous study and the WIEH reclassifications in this study, through parameter refinement (a) WIEH as per Table 15 and Figure 9; (b) final WIEH, with the adjusted parameters, as per Table 17 (values of the ‘isw’ rating bands).

Figure 13 demonstrates that the refinement of WIEH parameters proved adequate regarding its coherence. That said, unfortunately, the real walkability conditions for the older adults are not very adequate, as shown below.
