An empirical investigation on the correlation between solar cell cracks and hotspots

Mahmoud Dhimish¹✉ & Pavlos I. Lazaridis²

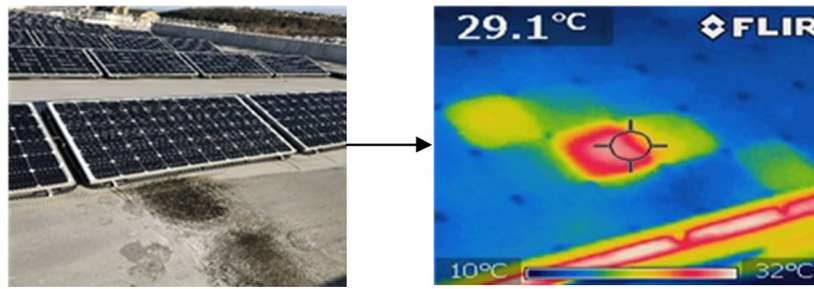
Figure 1. The physical and thermal image of a PV module is affected by hotspots; the thermal image is captured using a FLIR i5 thermal imaging camera, which has a thermal sensitivity of $\pm 1^\circ\text{C}$.

To aid the transition to green energy, there has been a considerable demand to combine more photovoltaic (PV) systems into the electric grid to support the growth of renewable energy sources. As such, PV reliability and durability receives great interest from the industry as there are currently various mismatching conditions affecting these installations^{1–3}. One of the challenges in today's PV modules is the well-known phenomenon called hotspots⁴. A hotspot is a localized heat source that can be present in part(s) of the PV module, leading to locally increased temperature in the solar cells. An example of a PV module affected by hotspots is shown in Fig. 1.

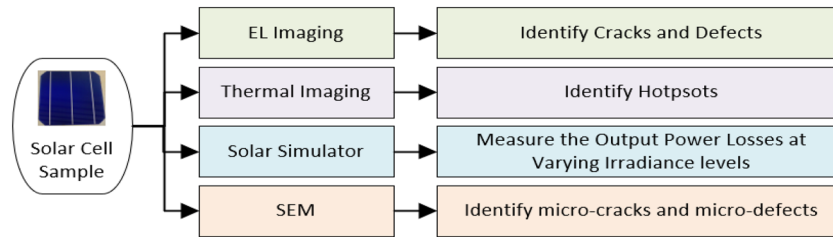
Figure 2. Detection methods used in this study.

Scientific methods and techniques. The scientific methods/techniques to study the solar cell samples are summarised in Fig. 2. EL imaging is used to identify the cracks and defects in the cells^{23,24}, whereas thermal imaging is applied to determine whether the cell sample has a hotspot. The solar cell samples have been tested under the sun simulator at STC conditions, where the cell was illuminated at 1000 W/m^2 light intensity. The temperature of the cell was measured from the rear (non-illuminated) side using a thermal camera. For every sample, the temperature was left to develop for 10 min before measurement. This allowed sufficient time for the hotspots, if any, to reach a steady state with minimal fluctuations observed. And finally, to observe any micro-level fractures and defects in the cells, we have used scanning electron microscopy (SEM).

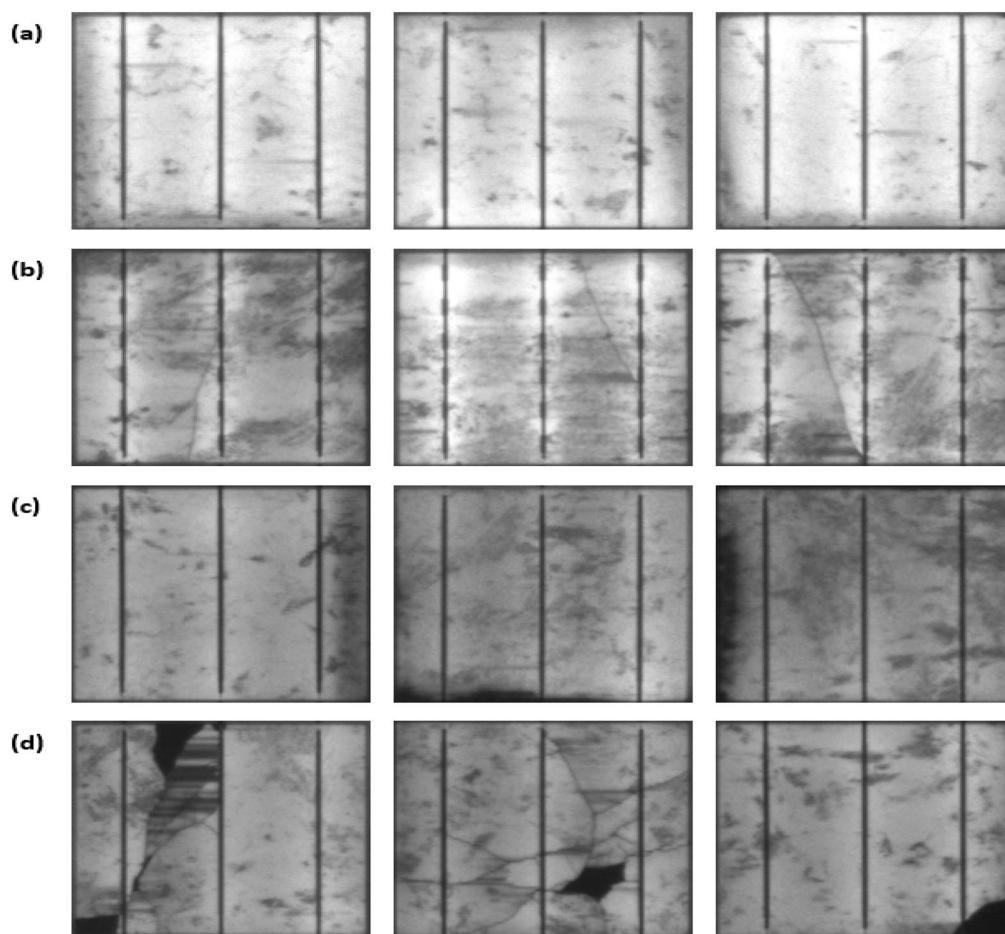
Figure 4. EL image of the examined solar cell samples (a) mode 1, (b) mode 2, (c) mode 3, and (d) mode 4.

EL imaging. Every solar cell was subjected to EL imaging to inspect the fracture and the crack mode. In this study, we have investigated four different modes: (i) crack free (mode 1), (ii) micro-crack (mode 2), (iii) shade area (mode 3), and (iv) breakdown (mode 4). For every mode, three different solar cell samples were selected, all presented in Fig. 4. Here the cracks were classified into four different modes. In contrast, in previous research^{25,26}, solar cell cracks were distinguished by either a singular crack mode, named micro-crack or μ crack. We find our classification is significant because not every crack mode can lead to hotspots or a substantial drop in the output power.

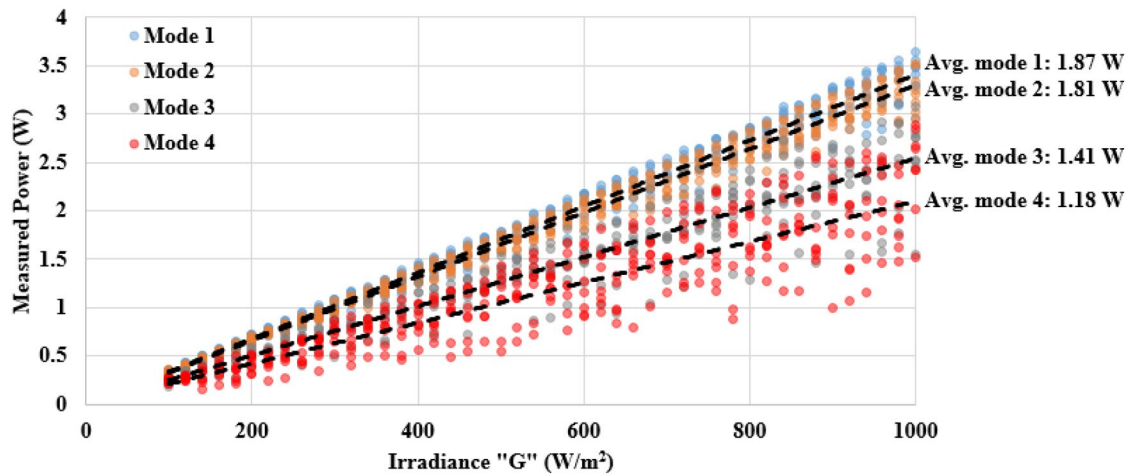
Figure 6. Measured power vs irradiance of the examined solar cells.

Output power measurements. Using the solar simulator, the examined samples were subjected to illumination over the spectrum range from 100 to 1000 W/m^2 . The results of each mode are given in Fig. 6, including the linear regression. Modes 1 and 2 have a similar output power pattern, and their average measured power is 1.87 W and 1.81 W, respectively. On the other hand, a significant drop in the measured power for modes 3 and 4 is observed, averaged at 1.41 W and 1.18 W, respectively.

We show here that for modes 1 and 2, there is an insignificant change for the maximum-to-minimum output power across the range of the solar spectrum. However, for modes 3 and 4, a considerable difference in the measured power, particularly at high solar irradiance ($> 500\text{ W/m}^2$).

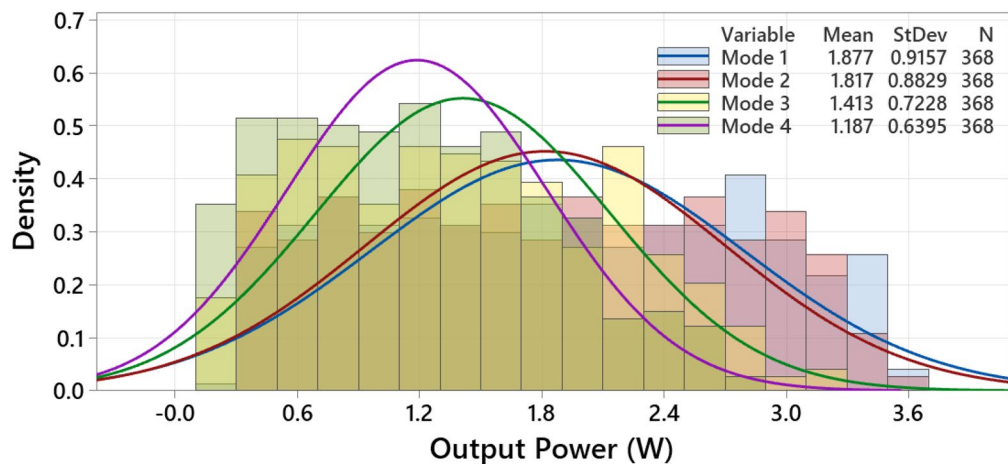
Figure 7. Normal distribution function applied for all measured data points.

Additionally, we summarise that the measured output power of the solar cell samples follows a normal distribution as presented in Fig. 7. However, a lower standard deviation (StDev) for modes 3 and 4 indicates that the output measure power tends to be close to the mean value. This result suggests that a significant drop in the

solar cells' output power is likely to be noticed if the EL image exhibits a shaded area or breakdown regions. Finally, please note that for Fig. 7, the y-axis (density) represents the percentage of the observations in the dataset.

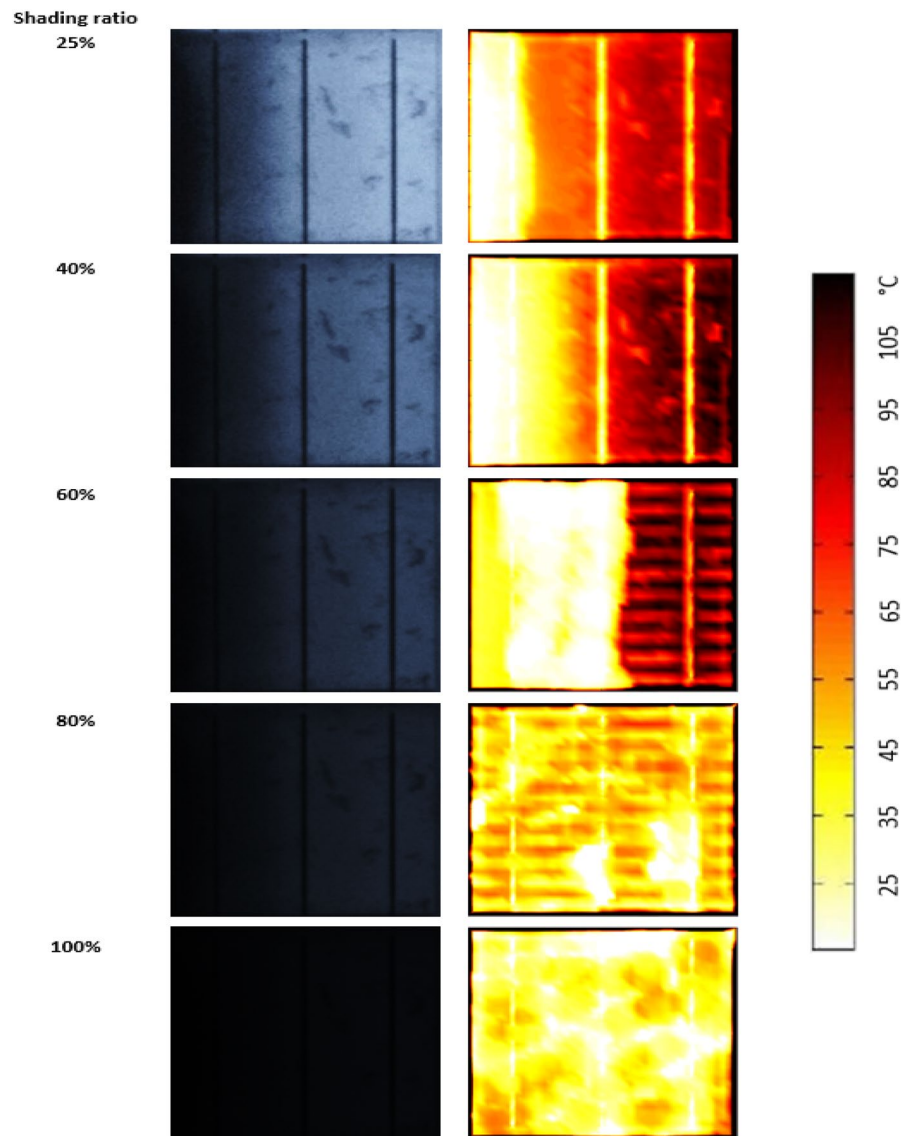
Figure 9. Progressive shading of a solar cell affected by mode 3 crack; the samples were subjected to illumination under STC conditions.

Shading ratio vs hotspots development. So far, we have evidence that solar cells affected by modes 3 and 4 are expected to have hotspots. Therefore, we have further investigated the correlation between the shade ratio in mode 3 and the presence of hotspots. The outcome of this experiment is presented in Fig. 9.

The progressive range of shade, including 25%, 40%, 60%, 80%, and 100%, is examined. If the solar cell is affected by 25% shading ratio, a maximum increase in the cell's temperature of approximately 75°C is detected. Progressively, if the solar cell is affected by a greater shading ratio, 40% or 60%, the hotspot area has a significant

increase in temperature, equivalent to 105°C. Therefore, a hotspot is likely to develop for these three shading ratios.

For the last two shading ratios, when the solar cell is affected by 80% or 100%, no hotspot in the cell area is witnessed. The hotspot disappears due to the absence of the photo-generated current. The remaining dark current flows within the cell for insignificant cell heating and an average temperature approximately at the experimental condition, 25°C. Thus, the worst-case scenario for the hotspot to develop occurs at the shading ratios of 40% to 60%, with an expected increase in the cell temperature from 25°C to 105°C.

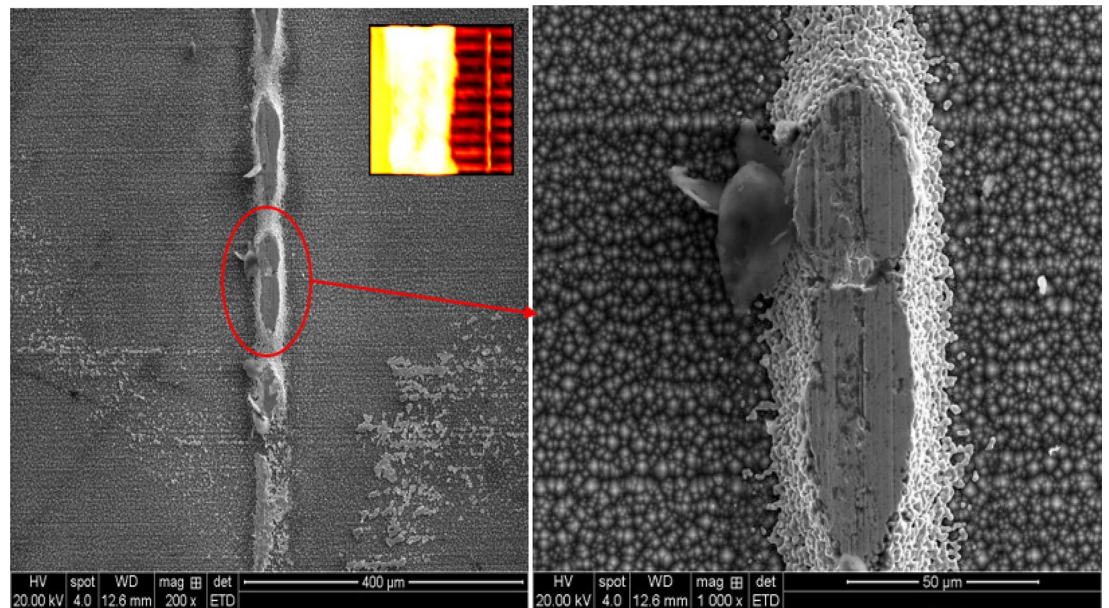
Figure 10. Capturing the busbar under SEM of the solar cell affected by 60% shading ratio.

Therefore, we have scanned the solar cell affected by a 60% shading ratio under SEM. This experiment was performed after the cell has been under illumination (1000 W/m²) for three continuous hours. The SEM image of the hotspot busbar is presented in Fig. 10 under 200 and 1000 magnification. Here we can observe that the hotspot develops stress in the busbar and the surrounding area in the form of cracks. In theory, busbars are made of copper-plated silver, and silver plating is necessary to improve current conductivity.

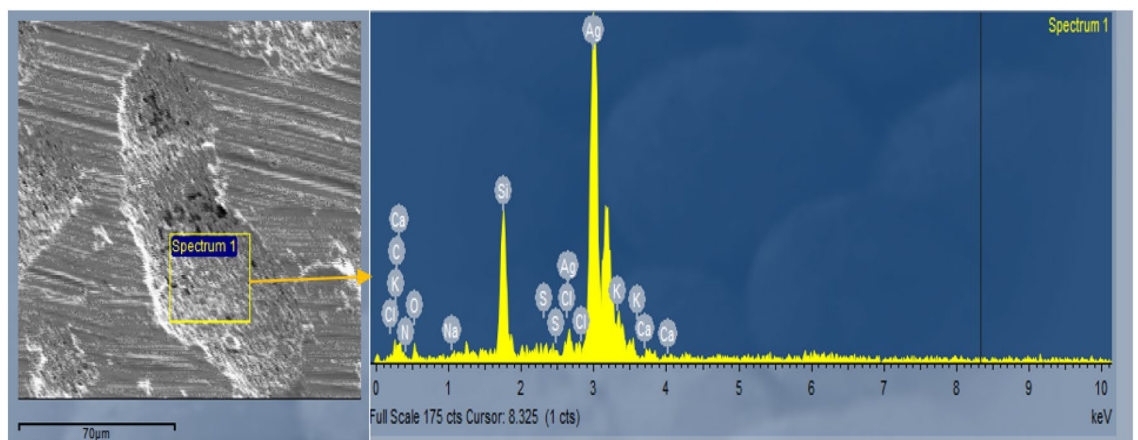
Figure 11. The busbar has 60% silver, 37% silicon, and 2% other material.

In this experiment, the material of the affected region of the busbar was obtained using the SEM image. According to the results shown in Fig. 11, it is recognised that the material (silicon) of the defective area of the cell is merged with silver, significantly reducing the busbar silver-plate composition, 60% silver, 37% silicon, and 2% other material. This arrangement in the solar cell is merely evidence of why the current is dropping in the non-shaded area of the cell, making this part of the cell affected by a significant increase in the temperature (hotspot).
