Mechanical irritation by protruding bone: A possible cause of breast implant rupture

Matthias Michael Aitzetmüller¹, David Johannes Haslhofer², Raphael Wenny², Manfred Schmidt², Dominik Duscher^{1,2}, Georg Michael Huemer²

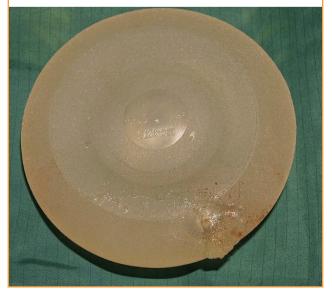
Intraoperative picture of the explanted implant in case 1. Leakage in the lower right border of the implant is clearly visible.

The decision to perform a capsulectomy with implant exchange was made based on the clinical symptoms, with the patient's consent. During the operation, the leakage of the implant became obvious (Fig. 1). Interestingly the area of the leakage was in direct contact with a protruding bony spur of the 6th rib. The implant was examined closely, and we noted that a small amount of silicone gel had leaked out through a small hole in the surface that had been in direct contact with the exostosis (Fig. 2). The diameter of the leakage was about 2 mm. After the bony spur was ablated using a bone rongeur, a capsulectomy was performed and a new implant was inserted. Over 5 years of follow-up, no new complications occurred.

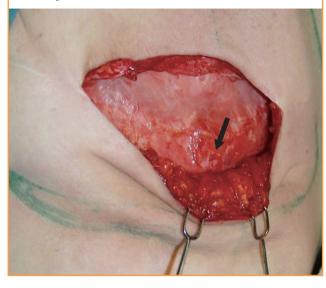
The black arrow shows a protruding bony spur of the 6th rib, which had been in direct contact with the implant and may have caused the leakage.

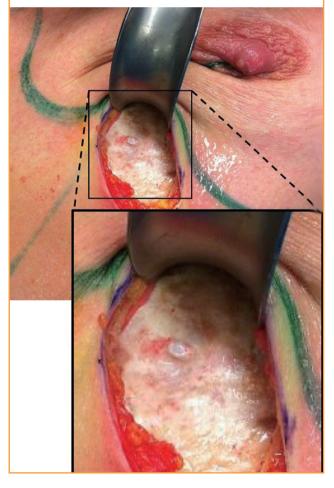
Fig. 3. Intraoperative picture of case 2

Again, the exostosis was located on the 6th rib, and had been in direct contact with the implant, predisposing the implant to rupture.

A 37-year-old female patient had undergone cosmetic augmentation. Five years after breast augmentation via a transaxillary approach, performed at another clinic, she presented at our department with pain in her left breast. She recalled minimal trauma. MRI was performed, and we verified implant rupture in the left breast. When explanting the ruptured implant (Mentor, Siltex, 300 mL, round, high profile) we found a bony spur of the 6th rib (Fig. 3). The bony spur was smoothened using a bone rongeur and the implant was replaced. During 3 years of follow-up, no further complications were noted.
