Spontaneous fracture of indwelling pleural catheter

Respirology Case Reports, 6 (8), 2018, e00365

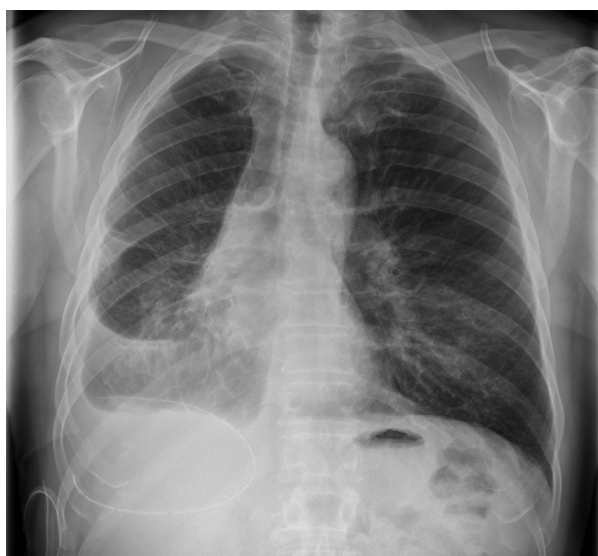
Blocked IPC was suspected, and a 50-mL saline flush was unsuccessful at unblocking the tube. The patient proceeded to have a repeat chest X-ray, which revealed a spontaneous fracture of the IPC (Fig. 1). There was no identifiable precipitant such as trauma, tugging, or tampering of the device. Enquiry from the patient revealed normal daily activities with no undue stress to the insertion site or drain.

Figure 1. PA chest X-ray showing fractured IPC.

Bedside thoracic ultrasound performed in the clinic showed an enlarging right pleural effusion, with visualization of fractured IPC in pleural space.

The free-floating fractured IPC fragment was removed with rigid pleuroscopy under deep sedation with anaesthetic support using the optical rigid forceps. The distal subcutaneous IPC fragment was removed in the usual fashion following blunt dissection around the cuff.

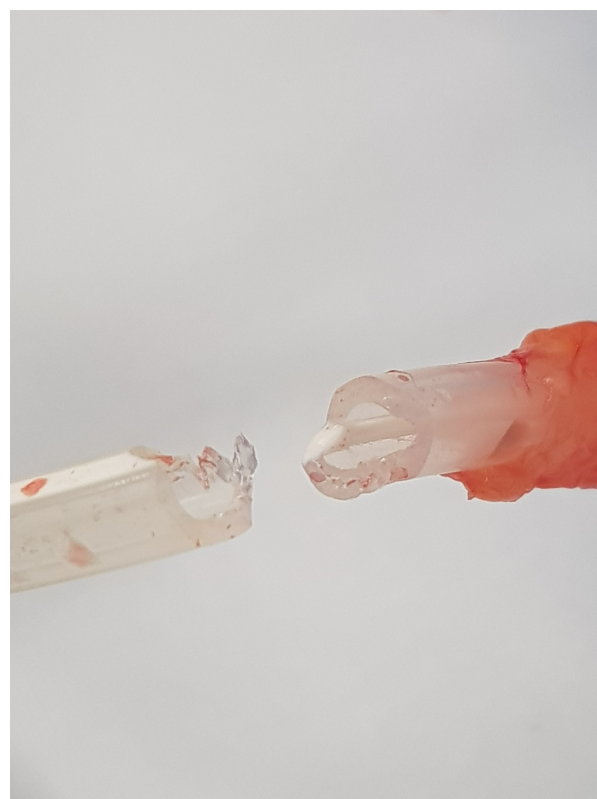
The IPC fragments were noted to have severed at the section immediately proximal to the cuff. The fracture site had a ragged edge with both ends fitting well, indicating there was no missing segment (Fig. 2). As discussed with patient, immediate insertion of new IPC was not undertaken to allow time for assessment of symptoms. Furthermore, on direct visualization of the pleural space, the patient had achieved auto-pleurodesis with only basal trapped lung.

Figure 2. Severed IPC fragments.

In our case, there was no evidence of excessive adhesions on the cuff during dissection, and there was no evidence of tumour infiltration on either fragment to postulate these as the culprit of spontaneous fracture. The location of the break, which was proximal to the cuff, is unique. Various postulations can be hypothesized regarding the mechanism of spontaneous IPC fracture. Proximity of IPC to the rib and constant friction during respiration may have led to the disintegration of the IPC, leading to spontaneous fracture. The IPC exit site remains inferiorly situated, thus applying traction to the IPC and accelerating the deterioration of its integrity.

Other mechanisms that can be hypothesized include damage to IPC during the insertion process or structural or manufacturing defect in the segment of the IPC immediately proximal to the cuff, leading to spontaneous fracture, although there was no clear evidence of either situation in our patient. Likewise, based on our clinical assessment and assessment of community nurses involved in draining IPCs in the community, there were no evidence of tampering of IPC by the patient.
