# Comparison of porcelain veneer fracture in implant-supported fixed full-arch prostheses with a framework of either titanium, cobalt–chromium, or zirconia: An in vitro study

**Objectives:** The aim of this study was to compare porcelain veneer strength on screw-retained implant-supported fixed full-arch prostheses with a framework of either milled titanium (Ti), cobalt–chromium (CoCr), and yttria-stabilized zirconia (Y-TZP) in an in vitro loading model.

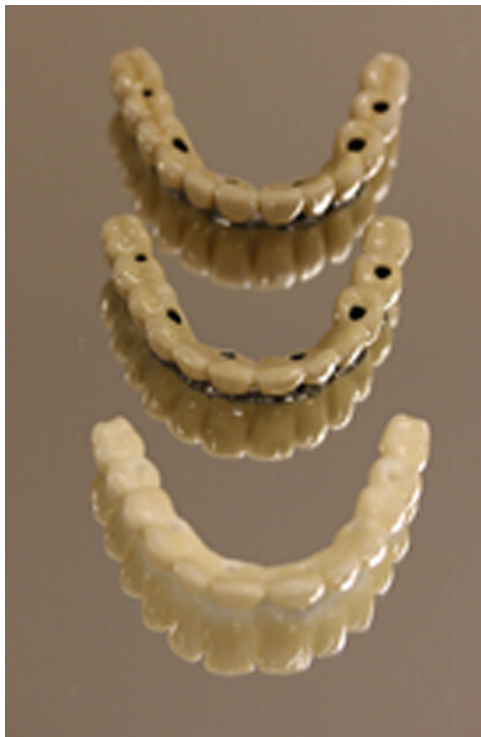
**FIGURE 1** The three different types of frameworks. From top to bottom, CoCr, Ti, Y-TZP. CoCr, cobalt–chromium; Ti, titanium; Y-TZP, yttria-stabilized zirconia

In total, 15 screw-retained maxillary implant-supported full-arch prostheses were included. There were five Ti, five CoCr, and five Y-TZP frameworks with porcelain veneers (Figure 1). The CoCr and Ti FDPs were made from the same master model. The Y-TZP FDPs were made from a similar situation using another master model but using the same tooth setup. All the master models had six implants placed at roughly the same position, regio 15,12, 23,25 and between 21/22. However, in the Ti and CoCr models, a fixture was placed in regio 14 while the Y-TZP had a fixture placed in regio 13. The FDPs were produced on abutment level. The frameworks were used in earlier publications regarding fit (Svanborg et al., 2015, 2019), explaining the difference in implant positioning.

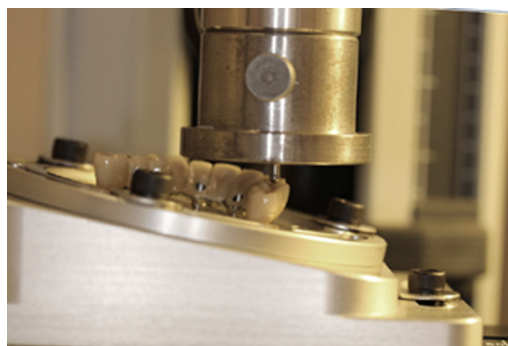
**FIGURE 2** Photograph of the mechanical strength test. Application of the force with a round steel ball in the distal fossa of the occlusal area of the pontic, replacing tooth 24

The FDPs were fixated, one at a time, on the epoxy model with bridge screws tightened at 15 Ncm and then mounted in a mechanical testing machine (Lloyd LRX, Lloyd Instruments Ltd., Bognor Regis, Great Britain) in a customized jig for angulation. The load was applied with a round steel ball, 3 mm in diameter, with a crosshead speed of 0.5 mm/min. The load was applied with a 10° angle to the longitudinal axis of the specimen, as shown in Figure 2. It was applied in the distal fossa of the occlusal area of the pontic, replacing tooth 24 (Figure 3), until fracture of the veneer was detected either visibly, by acoustic event or drop of load, detected by the Lloyd, which ever came first (Larsson et al., 2012; Nordahl et al., 2015).

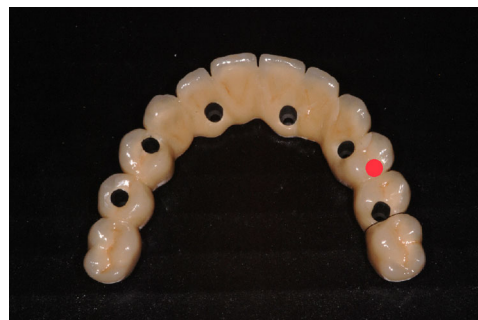
**FIGURE 3** Area of the loading procedure. Test performed in the distal fossa on the pontic replacing tooth 24

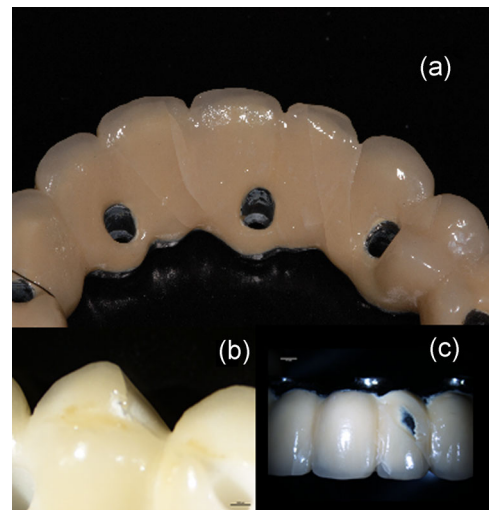
**FIGURE 4** Photographs of veneer fracture appearances (a–c). (a) Ti FDP nr 5 after load showing common appearance with cracks in the 21,22 area rather than chip off in the 24 area. (b) Y-TZP nr 5 after load. Common/typical appearance of fracture in Y-TZP FDPs. (c) Buccal view of Ti FDP nr 5 after load showing common appearance with chip off at 22 buccally rather than fracture in the 24 area

Three different fracture patterns were observed: local fracture, cracks in the anterior region without loss of the veneer, or cracks in the anterior region with loss of veneer. Local fractures were generally placed buccally on 24, while crack formations in the anterior region were running lingually or buccally as depicted in Figure 4. The Y-TZP FDPs showed only local fractures in the loaded area while CoCr and Ti more often exhibited cracks in the anterior region. For Ti FDPs, loss of veneer was observed in two cases (Figure 5).

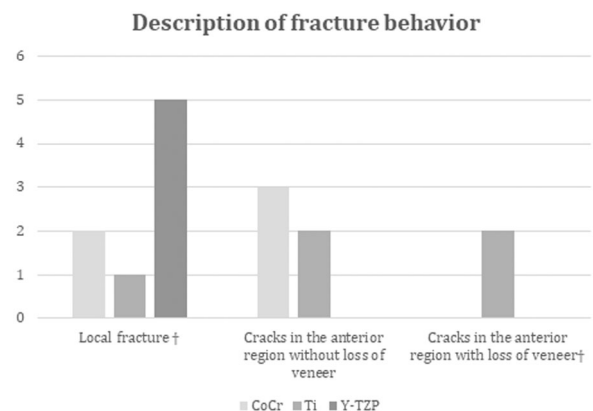
**FIGURE 5** Bar chart, fracture quality assessment. <sup>†</sup>Depicted in Figure 4b,c

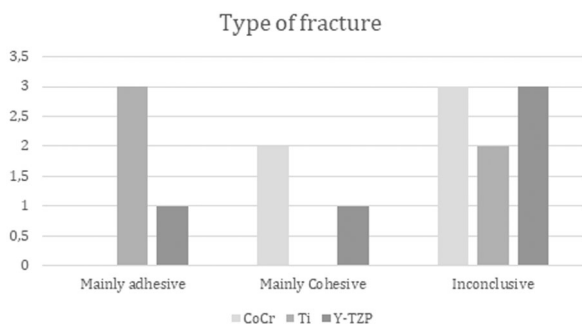
**FIGURE 6** Bar chart results based on fracture type

considered clear adhesive or cohesive fracture while three of the Ti FDPs were considered adhesive (Figure 6).
