Case report

## Unique relationship between osteophyte and femoral-tibia component size mismatch in determining polyethylene wear in primary total knee arthroplasty: a case report

*Journal of Medical Case Reports* 2009, **3**:59 doi:10.1186/1752-1947-3-59

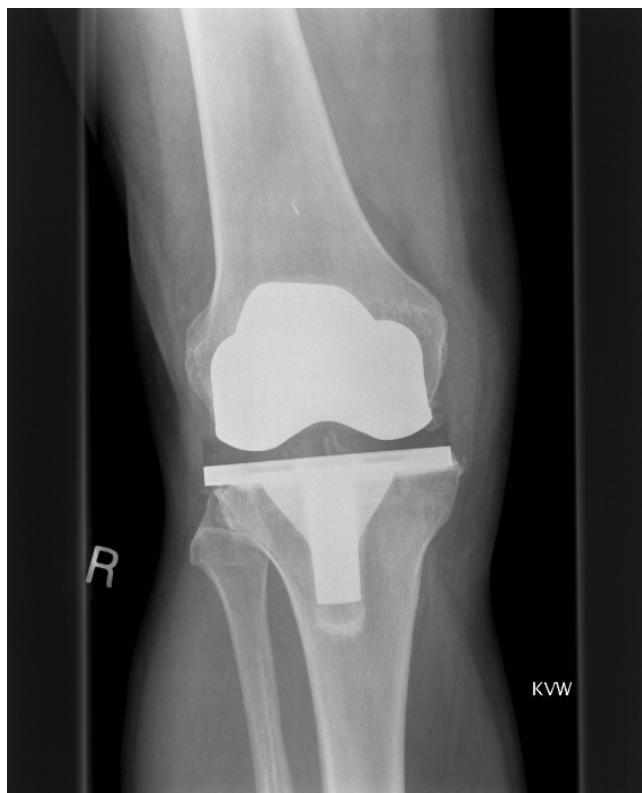
**Figure 2**  
Radiograph at 5 years post-total knee arthroplasty, with medial femoral osteophyte (arrow) and tibial component overhang compared to femoral component.

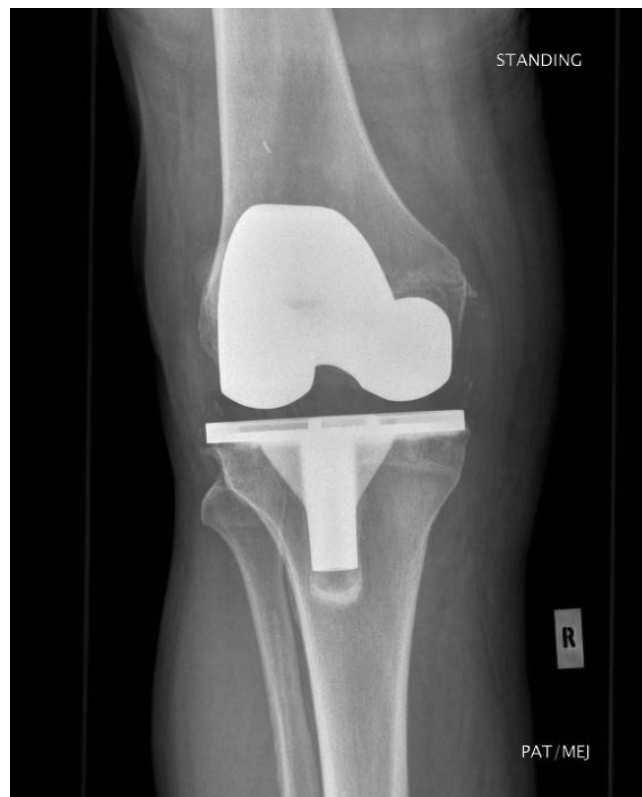
**Figure 3**  
Radiograph post-medial femoral osteophyte excision (arrow). Tibial and femoral components are unchanged.

a localised polyethylene rim wear (non-articulating part) and localised medial synovial reaction. The osteophyte was excised. Tibial and femoral components were stable and hence not revised. At 2 years post-osteophyte excision (Figure 3), the patient was pain-free and asymptomatic. Throughout this period, the patient had good knee alignment with 0 to 100 degrees of flexion.
