Percutaneous extraction of a leadless Micra pacemaker after dislocation: a case report

An 83-year-old patient with cardiac amyloidosis, chronic atrial fibrillation, and complete heart block was implanted with a leadless pacemaker (Micra, Medtronic). On the day after implantation, the device showed an exit block and on cardiac echocardiography and cardiac computer tomography, a device dislocation could be detected. During the day, the device moved at least three times between the tricuspid valve and the right ventricular apex. Each time causing non-sustained ventricular tachycardia. At the next day device extraction was scheduled. After 189 minutes of procedure time, it was possible to retrieve the device with the help of two steerable introducers (Agilis) and two snare catheters.

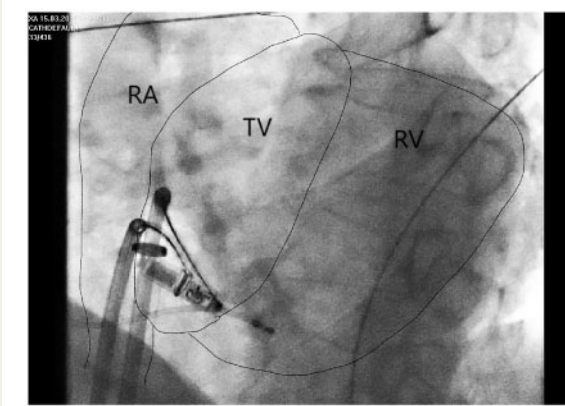
Figure 3 (left anterior oblique) view: extraction of the Micra. One snare is holding a fixation tine (right side) and the other snare is holding the Micra body. In addition, temporary pacing lead. RA, right atrium; RV, right ventricle; TV, tricuspid valve.

For device extraction, external pacing patches were applied and the leadless pacemaker sheath (Micra introducer, Medtronic, Minneapolis, USA) was inserted via the right femoral vein (for the position of the dislocated leadless pacemaker, see *Figure 2*). Into this sheath, the following additional items were inserted: first, a 14 french short sheath for hemostasis; second, a large curve steerable introducer (Agilis, Abbott, Abbott Park, Illinois, USA); third, a 6 F Amplatz (AL 2, Cordis, Milpitas, USA) diagnostic catheter with a snare (Amplatz Goose Neck 20 mm). After multiple repositionings, it was possible to snare one of the 'FlexFix' tines. However, it was not possible to retrieve the device out of the tricuspid valve. Therefore, a second large curve steerable introducer (Agilis, Abbott, Abbott Park, Illinois, USA) was inserted into the left femoral vein. Via the 2nd introducer, another Amplatz diagnostic catheter (AL 2, Cordis, Milpitas, USA) and another snare (Amplatz Goose Neck 20 mm) were introduced. Again, after multiple repositionings, it was possible to snare the body of the leadless pacemaker capsule. With both the snared tine and the body of the capsule, the device was finally retrieved successfully into the leadless pacemaker delivery sheath (Micra introducer, Medtronic, Minneapolis, USA) and extracted (see *Figures 3* and *4*). The entire procedure lasted 189 minutes. No pericardial effusion or aggravation of the tricuspid regurgitation occurred. Afterwards, the patient was implanted with a conventional VVI pacemaker and was successfully discharged. Unfortunately the patient did not come for a follow-up visit.

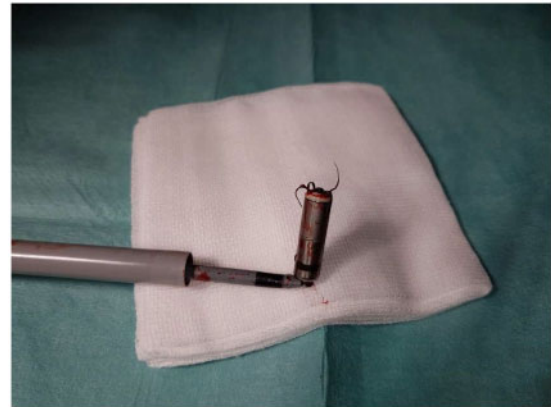
Figure 4 Explanted Micra, snared through an Agilis steerable introducer which is located in the Micra sheath.
