Refracture After Removal of the PFNA in a Healed Intertrochanteric Femoral Fracture: Case Report

Geriatric Orthopaedic Surgery
& Rehabilitation
Volume 13: 1–6
© The Author(s) 2022
Article reuse guidelines:
sagepub.com/journals-permissions
DOI: 10.1177/21514593221074179
journals.sagepub.com/home/gos

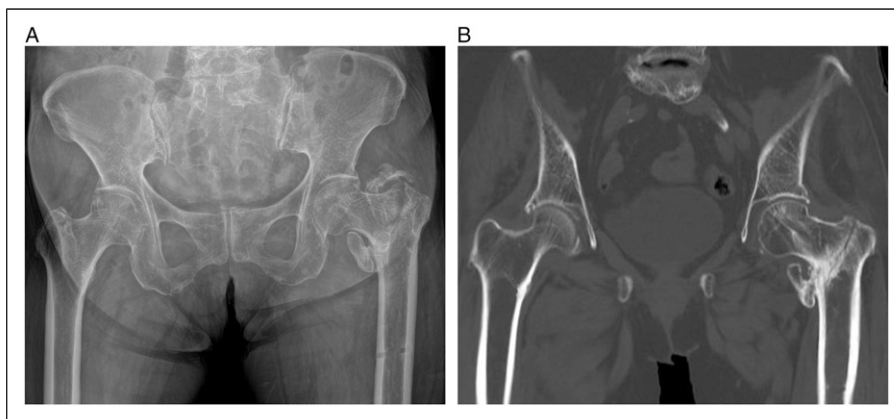
Figure 4. (A) 2 months after removal, follow-up X-ray showed decreased neck shaft angle and linear fracture line at trochanteric area. (B) Coronal CT image showed cavitory bone defect at the trochanteric area and extended refracture line from greater trochanter to lesser trochanter.

6 weeks after removal, the patient complained of pain during walking with no history of trauma. The X-ray showed decreased neck shaft angle measured 100° and fracture line extended from the greater trochanter to the lesser trochanter (Figure 4A). The CT scan showed cavitory bone defect at the greater trochanter area and pertrochanteric fracture line (Figure 4B). There was no evidence of femoral head necrosis or cartilage damage. We decided to correct the varus angulation and revision fixation, considering the patient's activity demand as a farm worker.

We assumed that the bending moment on the healed fracture site was gradually increased due to decreased neck shaft angle and the opening created by the nail removal on the tip of the greater trochanter may act as the starting point of a crack that extended along the intertrochanteric line to cause the refracture.

Although more detailed investigation in the trabecular structure was not performed, there was persistent lack of cancellous bone in the trochanteric area and the altered cancellous bone remodelling due to the change of the static in the presence of implant which is prone to increase fragility. In our case, we could presume that the causes of refracture. Relatively high loss ratio in the greater trochanteric area, cortical breakage on the greater trochanter after nail removal and lowered neck shaft angle: all of them attributed to refracture.

Intertrochanteric valgus osteotomy was done to correct the varus angulation, followed by fixation with angled blade plate without additional bone graft. Postoperative X-ray showed recovered neck shaft angle to 130° and stable apposition of the fracture site (Figure 5). After 4 months, the patient presented no pain and no limitation of daily living activity. The Harris hip score was 91 points. On the final follow-up X-ray and CT scan performed 2 years after revision surgery showed consolidation

We performed valgus intertrochanteric osteotomy to recover the neck shaft angle followed by revision fixation with 95° angled blade plate. After removal of the PFNA, there was broad cavitory bone defect at trochanteric area, which makes it difficult to control the fracture site for reduction as well as the maintenance of alignment. While technically demanding, the angled blade plate is a useful alternative device for revision in failed cephalomedullary fixation. It can be made to achieve correction and fixation simultaneously, anatomic restoration and bone healing are nearly assured.^{17,18}

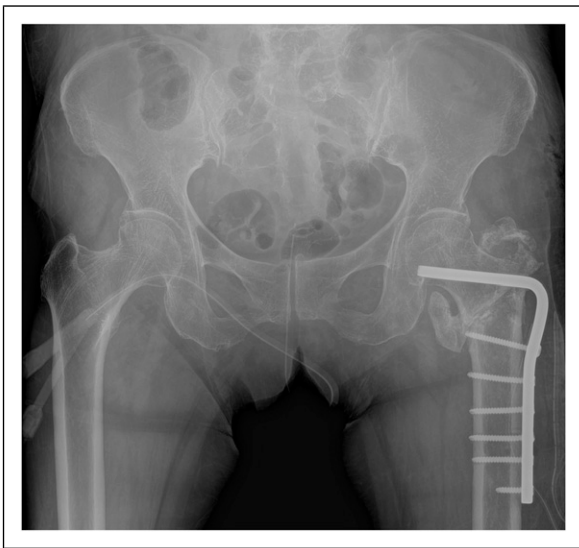
Figure 5. X-ray after revision fixation showed recovered neck shaft angle and stable apposition of the medial cortex.
