Commentary

Drains and the periphery of the water system – what do you do when the guidance is outdated?

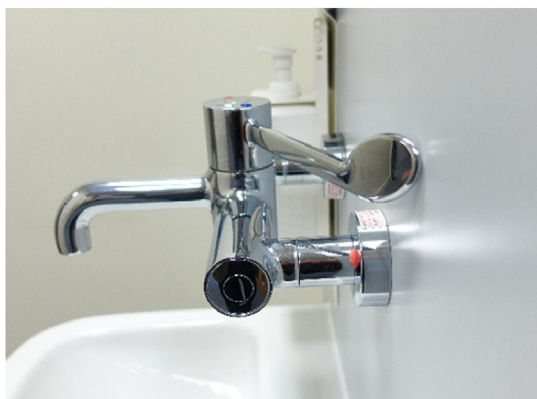
Figure 1. (a) Incorrect set-up of elbow-operated lever which is flush with the inspection panel behind making it difficult/impossible to operate with an elbow. (b) Correct set-up requires an angle of 15° in front of the main body of the outlet linking the hot and cold supply.

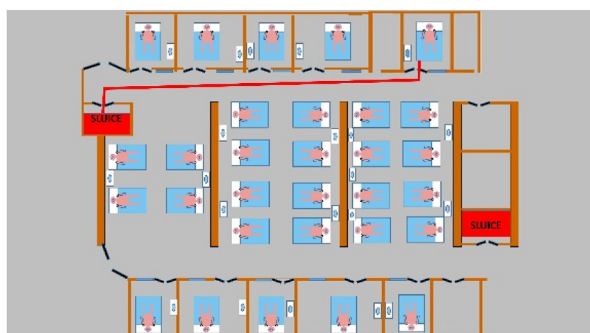
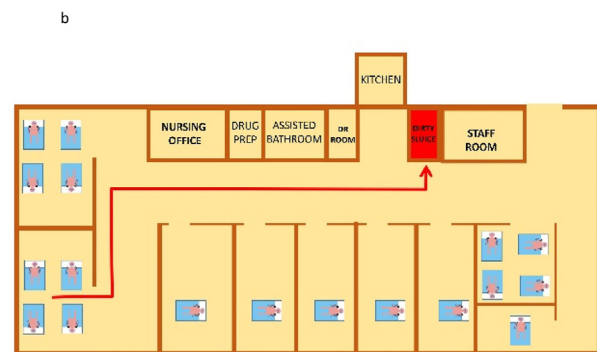
Figure 2. Layout of (a) an actual intensive therapy unit and (b) a medical ward detailing the distances staff have to travel carrying contaminated body fluids.

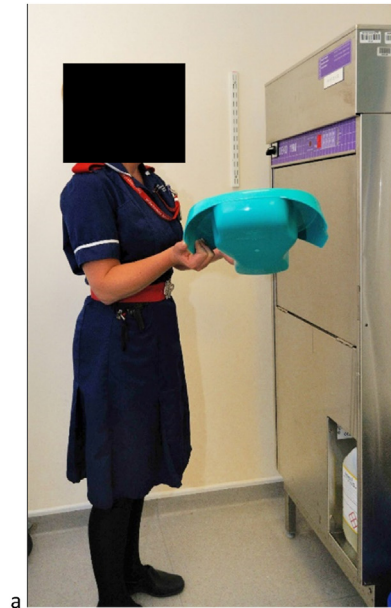
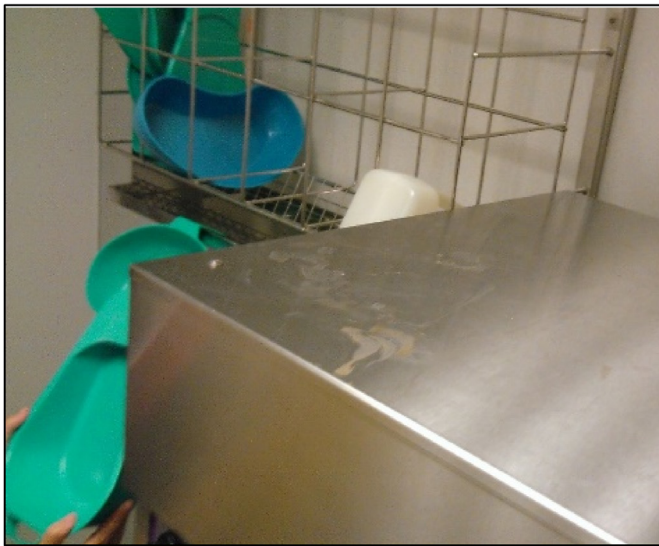
Figure 3. (a) A nurse standing in front of a bedpan washer disinfectator. These items are quite tall making it difficult to see any contamination on the top surface. (b) Faecal contamination of the top surface of the washer disinfectator.

The lack of flow from dirty to clean means that clean equipment may become contaminated. In Figure 3(a), a nurse can be seen standing in front of a bedpan washer disinfectant. These items are quite tall making it difficult to see any contamination on the top surface. Figure 3(b) shows faecal contamination of the top surface of the washer disinfectant. A lack of flow means that clean and dirty bed pans may be placed on the surface. Better design could improve compliance; e.g., if the top of the bedpan washer disinfectant was angled to prevent placement of items or redesigning the washer disinfectant such that it had two doors (one at either end: one for placement of dirty items and the other for removal of clean items). The washer disinfectant could be installed so that it straddled between two rooms – one side being the dirty entrance the other the clean side (as in a Central Sterile Services Department (CSSD)).

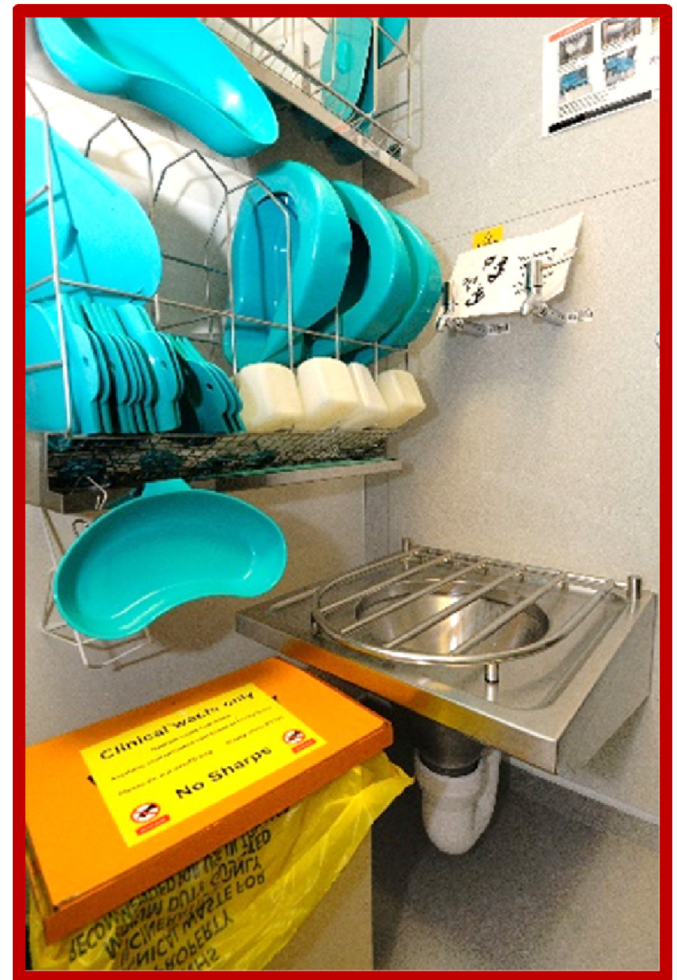
Figure 4. Clean items stored in close vicinity to sluice hopper placing them at risk from splashes/aerosols. Taps above the hopper will cause significant splashing when used.

- (2) Sluice hoppers. Poor design or careless use run the risk of dispersal of organisms through splashing or aerosol formation. The risk is compounded by frequent storage of clean equipment in close vicinity (see Figure 4). What is the purpose of a sluice hopper in a clinical dirty utility room? If disposable products are used, everything should go straight to the macerator; if reusable products are used, they should go straight into the bedpan washer. The design of sluice hoppers, location and placement of splash screens are considerations to enable these items of equipment to be used if still required in the future.
