Case report

Fracture of the insert cone of a polyethylene liner in a failed posterior-stabilized, rotating-platform total knee arthroplasty

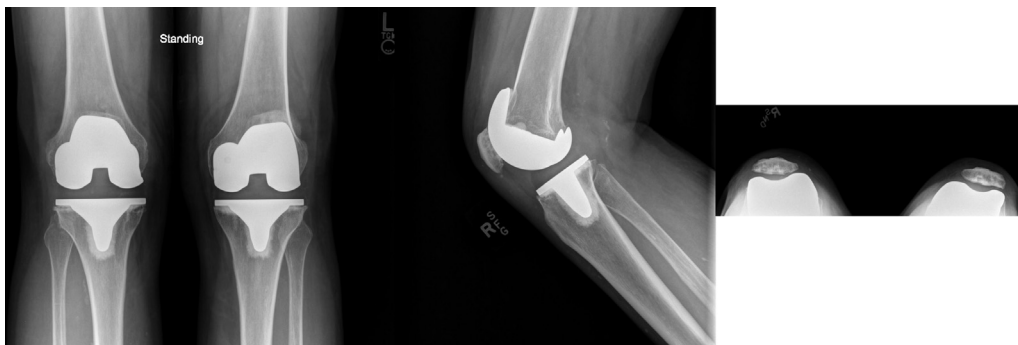
Figure 2. Anteroposterior, lateral, and Merchant radiographs of the right total knee arthroplasty at the 9-year follow-up interval.

media of the episode surrounding his right TKA. A 56-year-old male underwent an uncomplicated TKA with a PS rotating-platform (RP) design prosthesis (PFC Sigma Rotating Platform; DePuy Inc, Warsaw, IN) using a gap-balancing technique for advanced post-traumatic osteoarthritis of the right knee. His postoperative course was unremarkable and he returned to his previous recreational activities including athletic coaching as well as activities of daily living without limitation. His Knee Society Score at 1 year following the index procedure was 200 and remained unchanged over the next 9 years. He maintained routine follow-up every 2 to 3 years for radiographic and clinical examination. For the first 9 years following the index procedure, he was clinically asymptomatic and radiographs demonstrated no signs of wear or impending failure (Fig. 2).

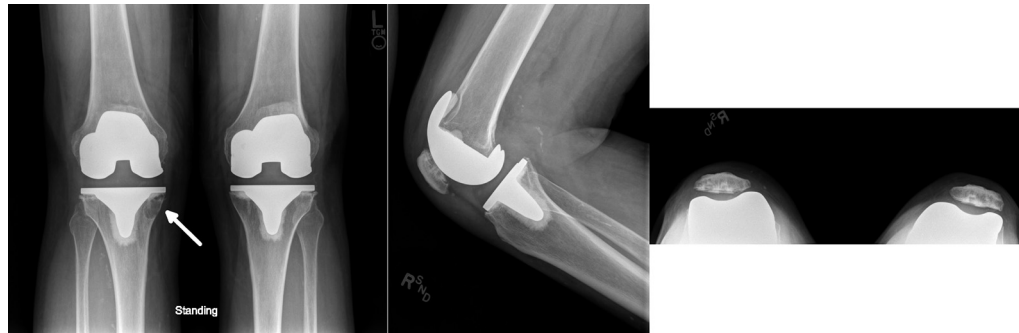
Figure 3. Anteroposterior, lateral, and Merchant views of the right total knee arthroplasty 11 years following operation. White arrow denotes osteolytic defect of the medial tibial plateau.

medial joint line was reproducible and consistent with his description. There was no coronal or sagittal plane deformity/instability, patellar crepitus, or maltracking. Radiographically, amid prosthetic components that remained well-positioned and well-fixed, the patient was found to have developed an osteolytic defect of approximately 2 cm^2 in the medial tibial plateau (Fig. 3). To rule out infection, his knee was aspirated and serum laboratory infectious markers were obtained, all of which were negative (synovial white blood cell count, 525 cells; neutrophils, 14%; crystals, gram stain, and culture-negative; erythrocyte sedimentation rate, 5 [normal, 1-15 mm/h]; C-reactive protein <2.90 [normal, $<3.00 \text{ mg/L}$]). Given the radiographic evidence of osteolysis and progressively worsening symptoms of pain and swelling, the patient underwent right revision surgery 11 years and 4 months following his index procedure. Upon arthrotomy, a copious amount of clear straw-colored fluid was evacuated. An $8 \times 18 \text{ mm}$ piece of delaminated polyethylene was encountered. It was found to have originated from the patellar bearing which was subsequently revised. A synovectomy of the joint was performed. There was a moderate amount of symmetric, delaminated wear of both sides of the polyethylene tibial insert. Upon removal of the insert, the polyethylene insert cone was found to be fractured 10 mm below the surface of the mobile-bearing tibial tray (Fig. 4). The remaining

insert cone was removed. The osteolytic defect of the medial tibial plateau was curetted and packed with bone cement. A new RP polyethylene tibial insert (15 mm, previously 12.5 mm) was placed. His remaining hospital course was uncomplicated and he was discharged on postoperative day 1. No postoperative restrictions were placed on the patient.

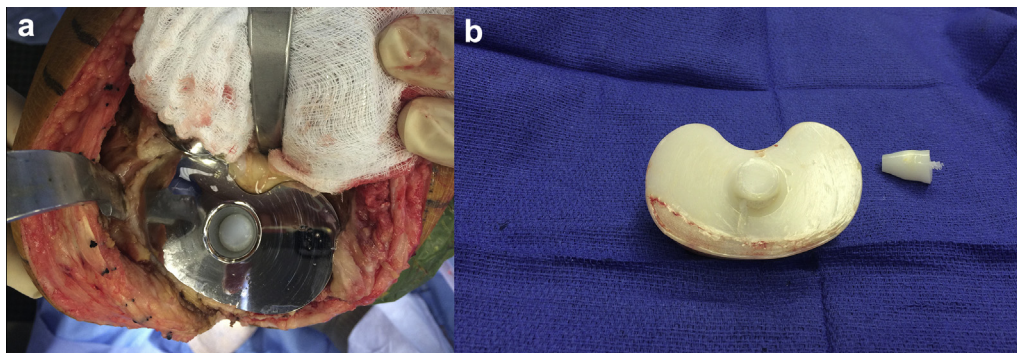
Figure 4. (a) Bird's eye view of broken polyethylene insert cone within a rotating-platform tibial tray. (b) Backside of the retrieved rotating-platform polyethylene tibial insert with delamination and a broken polyethylene insert cone.

authors surmised, based on an *in vivo* kinematic study by Kurita et al [45], that increased longitudinal stresses acting on the polyethylene insert cone in a highly congruent, PS, RP polyethylene liner resulted in the described failure. The patient also exhibited a 15° flexion contracture, and this limited ROM and abnormal shear forces generated across the joint may have been a contributing factor to failure. In contrast, our report details a case of late polyethylene insert cone fracture 11 years following the index procedure without polyethylene dislocation and associated with some delaminating wear of both the tibial insert and patellar component. Furthermore, our report describes a patient who had subtle pain along the medial joint line without signs of instability on examination but with radiographic evidence of focal osteolysis. This underscores the point that surgeons must remain vigilant for such a rare problem as polyethylene insert cone fractures do not always present with sudden onset of pain and instability. The authors suspect the cone fracture occurred at some time following the patient's 9-year postoperative evaluation because no effusion, pain, or radiographic osteolysis was evident at that time. We opine that the fracture allowed increased multidirectional wear patterns on the inferior aspect of the bearing, resulting in increased polyethylene wear generation and subsequent osteolysis.

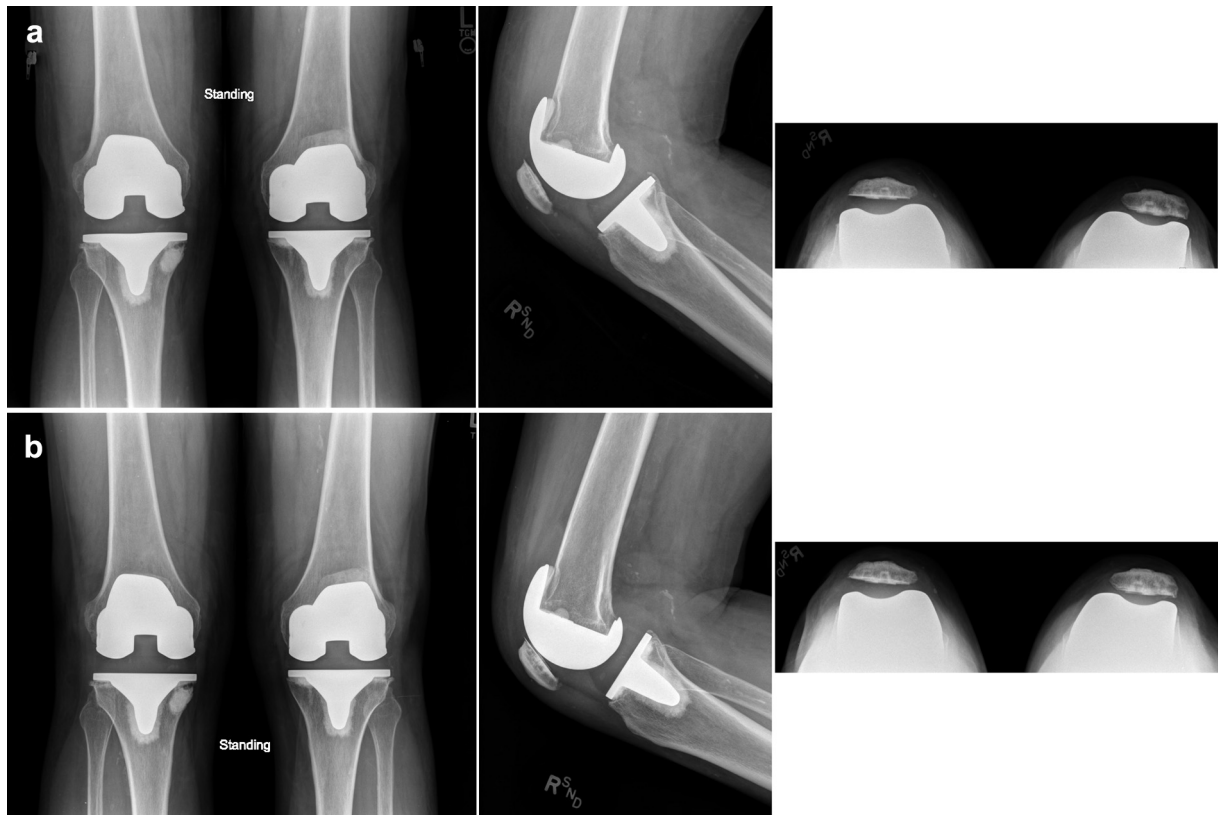
Figure 5. (a) Anteroposterior, lateral, and Merchant views of the right revision total knee arthroplasty at the 5-week postoperative visit. (b) Anteroposterior, lateral, and Merchant views of the right revision total knee arthroplasty at the 1-year postoperative visit.

Follow-up for the patient was performed at 2 and 6 weeks and at 1 year following his revision surgery. His preoperative effusion was not detectable at his 5-week nor 1-year follow-up evaluation. The remainder of his examination at his most recent follow-up revealed ROM of 0°–130°, without instability, patellofemoral crepitus, or maltracking. Knee Society Scores at 1 year following the index procedure were as follows: function, 90; knee, 100; ROM, 25; total, 190. The patient returned to his pre-morbid recreational and activity of daily living without limitation. Lastly, his most recent radiographs were unremarkable with no evidence of recurrent osteolysis and well-aligned, well-fixed prosthetic components (Fig. 5).
