Case Report

Removal of Separated Endodontic K-File with the Aid of Hypodermic Needle and Cyanoacrylate

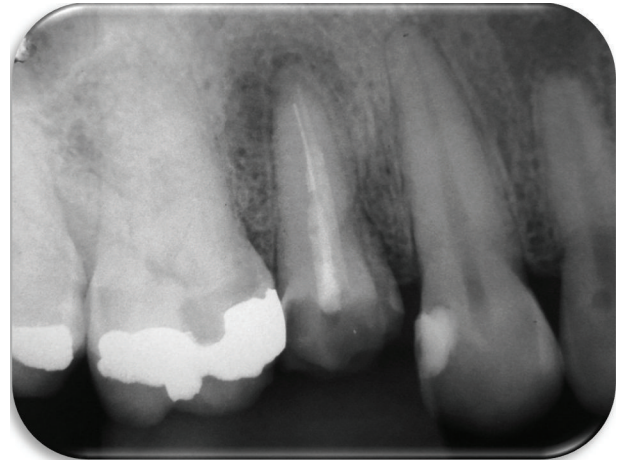
A 31-year-old healthy woman patient sought the clinic to have her maxillary left first premolar rehabilitated. During the clinic examination, it was noticed that the mentioned tooth had undergone an endodontic treatment, which was exposed to the oral environment at the moment of the examination. The patient reported that the treatment had been in contact with the oral cavity for more than 6 months. It was decided to retreat the tooth, and to do so a periapical radiograph was performed in which the presence of a fragment was seen compatible with a hand-file of a size around 6 mm, localized at the apical third of the palatine root of the mentioned tooth (Figure 1).

FIGURE 1: Initial periapical radiograph showing the fragment at the apical canal third.

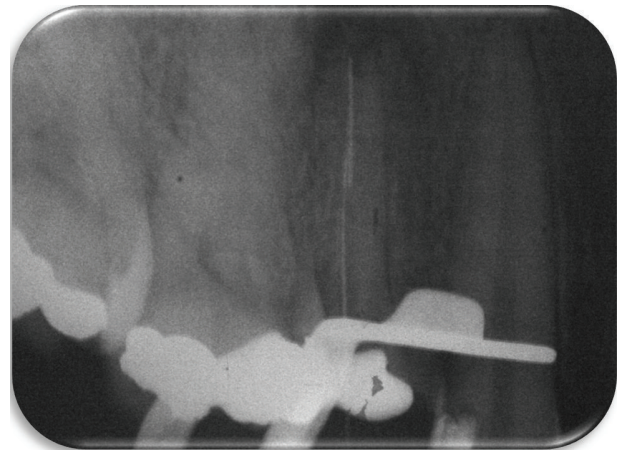
The endodontic treatment was initiated by the removal of the gutta-percha and of the endodontic sealer using the Gates-Glidden drills (#4, #3, and #2; Dentsply-Maillefer, Ballaigues, Switzerland) associated with repetitive irrigation of sodium hypochlorite 2.5%. Hand K-file instruments (Dentsply-Maillefer) were used for removing the filling material from apical thirds of canals. When the foraminal patency of the buccal canal was achieved, an attempt to bypass the fragment located in the palatine canal was achieved. An attempt of inserting manual instruments C-Pilot (#08, #10, and #15; VDW GbmH, Munich, German) in an apical direction tangentially to the fragment was performed. The instruments advanced 2 mm laterally to the fragment, but due to the difficulties related to the size of the fractured instrument and to the risk of causing a deviation in the original trajectory of the root canal, it was decided to stop this procedure (Figure 2).

FIGURE 2: Periapical radiograph of the moment when trying to bypass the fractured instrument using manual files.

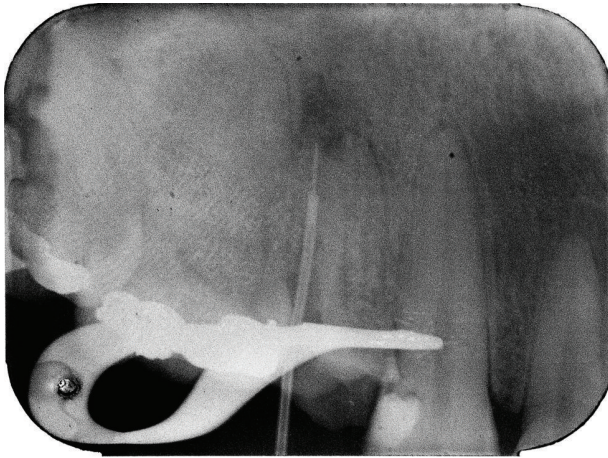
Thus, it was decided to proceed with the attempt of removing the fragment using manual Hedstroem instruments (Dentsply-Maillefer) that were rotated to capture the fragment. When the capture was achieved, the Hedstroem instrument underwent repetitive coronal traction. This attempt was unsuccessful such as the first one, so it was decided to stop trying to perform it due to the risk of fracturing the instruments used. The lack of resoluteness of the techniques applied boosted the decision of using an alternative mechanic method to remove the fragment from the inside of the canal. To perform this method, a hypodermic needle (20 mm × 0.55 mm; Becton and Dickson, Curitiba, Brazil) and a cyanoacrylate adhesive (SuperBonder; Loctite, Itapevi, Brazil) were used. The active part of the needle was removed to make the attachment of the needle to the fragment easier. The needle was introduced into the canal, and when a tactile sensation of attachment was perceived, a periapical radiograph was taken to confirm that the two parts were perfectly attached to each other. After the confirmation (Figure 3), the cyanoacrylate adhesive was inserted in the

FIGURE 3: Periapical radiograph confirming the attachment of the fragment to the hypodermic needle.

aperture of the needle that was turned to the crown of the tooth using K-files and slight air jets.

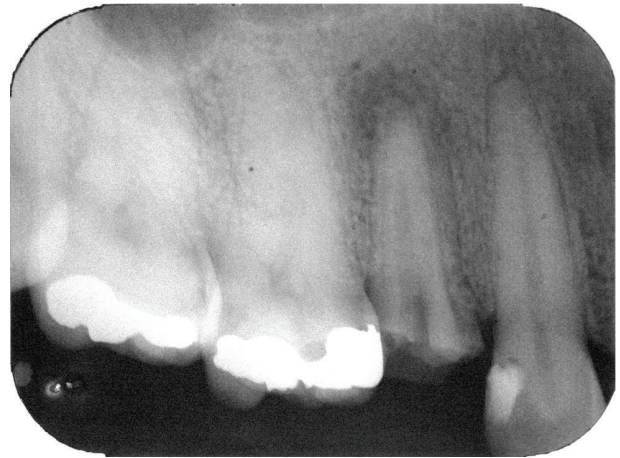
FIGURE 5: Periapical radiograph confirming the complete removal of the fragment.

A further radiographic examination revealed the successful removal of the fragment (Figure 5), which enabled the endodontic retreatment to be concluded satisfactorily (Figure 6).

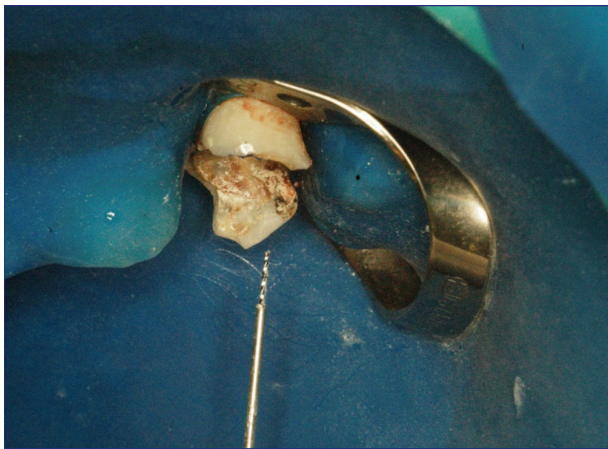
FIGURE 4: Photograph of the set hypodermic needle-fragment removed from the root canal.

After the polymerization time of 5 minutes, the hypodermic needle was rotated anticlockwise, allowing the unscrewing of the fragment (Figure 4) and its complete removal from the root canal.

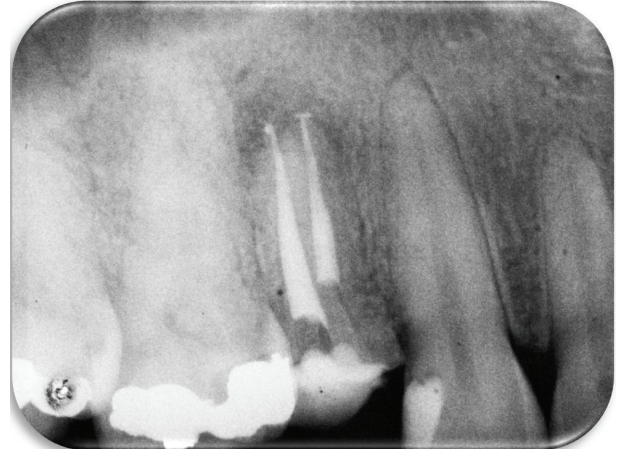
FIGURE 6: Periapical radiograph of the endodontic treatment completed.
