Case Report

Silastic Electrode Positioner Extrusion as a Late Complication of Cochlear Implantation Surgery

Cite this article as: Zarandy MM, Rezaeian S, Motasaddizarandy M. Silastic electrode positioner extrusion as a late complication of cochlear implantation surgery. *J Int Adv Otol.* 2022;18(4):371-373.

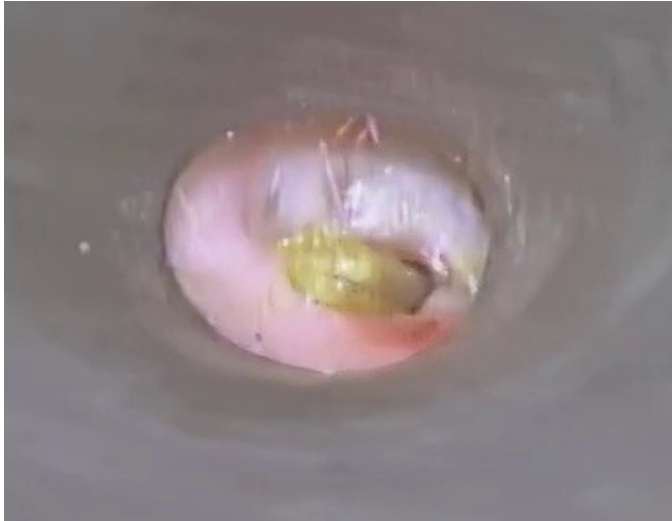
Figure 1. Electrode positioner extrusion through the tympanic membrane.

In December 2019, she came to our center complaining of ear pain and some episodes of otorrhea in her right ear. During examination upon removing cerumen from the canal, we noticed a solid object extruded from the posterior part of the tympanic membrane. After a thorough microscopic examination, we found that it could be the Silastic electrode positioner. The results of functional tests were normal (Figure 1).

For the safety of the patient, we did not manipulate the positioner in the clinic. The patient underwent surgery under general anesthesia. The ear canal was cleansed. About 2 mm of Silastic positioner was extruded from a posterior perforation in tympanic membrane. Other parts of the membrane were normal without any evidence of retraction, effusion, and sclerosis. An incision was made in the canal skin about 8 mm away from the annulus ring. Tympanomeatal flap was elevated and after tympanotomy, the middle ear was opened. To make sure to avoid traumatizing the tympanic membrane, tympanomeatal flap was split. The middle ear showed no evidence of infection. The main electrode was in its right position in the cochleostomy site but the positioner was displaced from the cochleostomy site through the tympanic membrane (Figure 2).

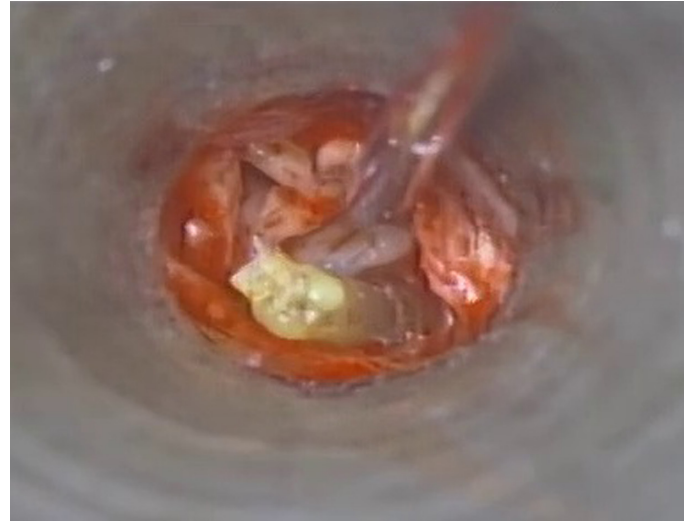
Figure 2. Electrode positioner extruded from the cochleostomy site.

With the cradle of the main electrode, the positioner was removed and the cochleostomy opening was sealed with perichondrium. Then cartilage tympanoplasty with temporalis muscle fascia was performed for repairing the perforated tympanic membrane. Intravenous antibiotics were used only during the perioperative

In our case, to prevent movement or extrusion of the main electrode, we did not remove the positioner through the tympanic membrane. Instead, we took the patient to the operating room, and under the direct inspection of the cochleostomy site and catching on the main electrode to ensure it is not moving out, the positioner was removed gently and cochleostomy site was sealed immediately to minimize the risk of infection.

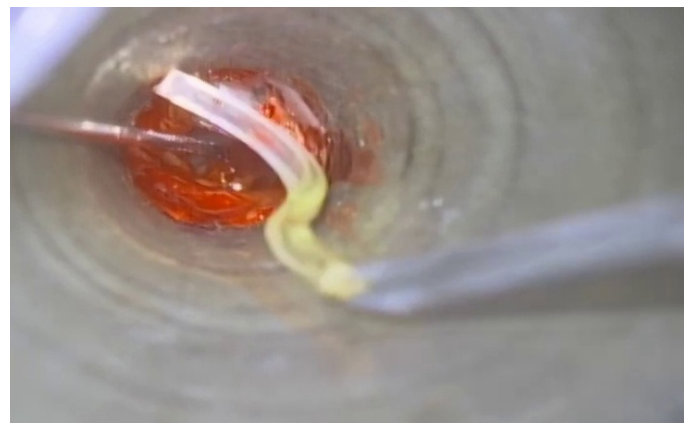
Figure 3. Removing the electrode positioner.

period. Antibiotics were prescribed for the duration of 1 week post-surgery (Figure 3).
