On the potential for saturated buffers in northwest Ohio to remediate nutrients from agricultural runoff

Stephen J. Jacquemin¹, Greg McGlinch², Theresa Dirksen³ and Angela Clayton¹

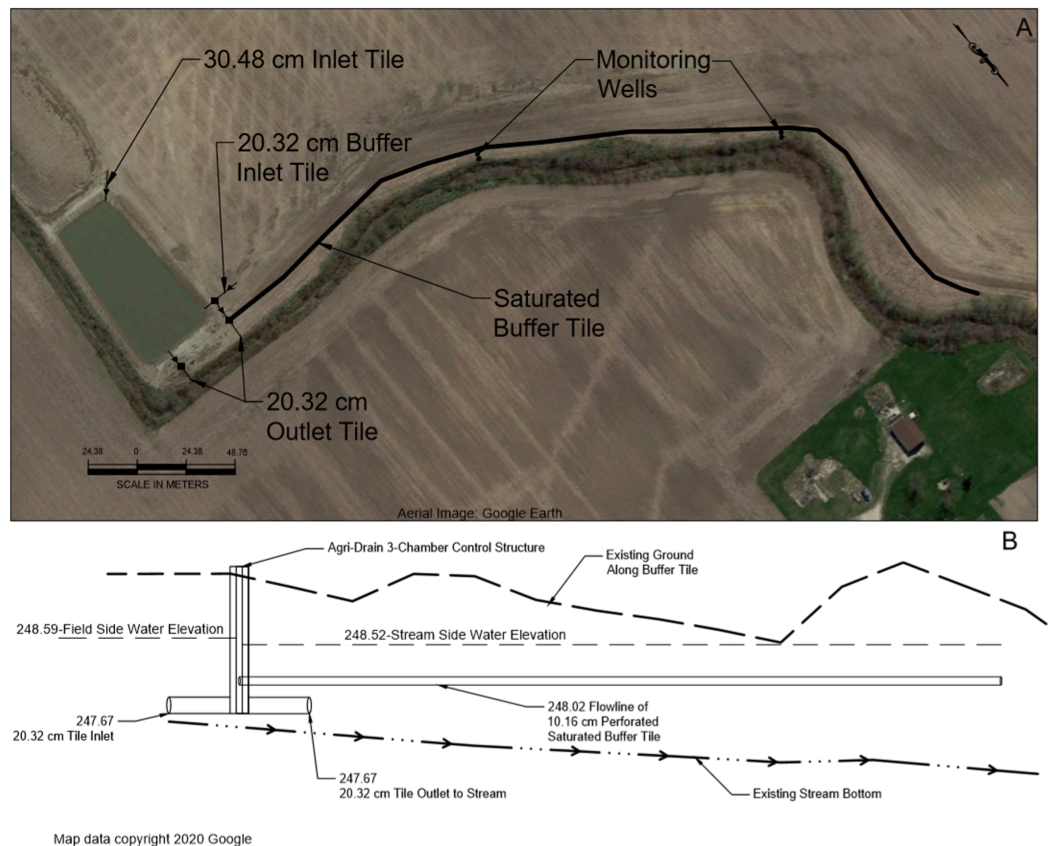
Figure 1 Site map (A) and overview of saturated buffer layout (B). Aerial image from Google Earth © 2020 Google. [Full-size !\[\]\(b345a1c4255362eec3746050dd71ccac_img.jpg\) DOI: 10.7717/peerj.9007/fig-1](https://doi.org/10.7717/peerj.9007/fig-1)

VanTilburg Farms, Mercer County, Ohio) to access the site and monitor water quality associated with conservation practices for the duration of the project. Soils at the site (and larger region) are primarily comprised of poorly draining clays—specifically, Pewamo Silty Clay Loam (~60%) and Blount Silt Loam (~35%) with lesser percentages of Elliott Silt Loam and Glynwood Silt Loam (Priest, 1979). Soil composition, texture, and organic matter was verified at two points using a coring auger to collect samples in 150 mm intervals from the surface down to ~2.5 m. Soil organic matter was estimated based on gravimetric mass change following the loss-on-ignition methodology of Nelson & Sommers (1996). Given the predominance of poorly draining clay in the field soils, the site has been tiled with 100 mm perforated pipe spaced ~13 m on center to facilitate drainage. Ultimately, both surface and tile flow from the site drain into Dennison Ditch (Four Mile Creek) as part of the larger St. Marys River watershed before draining into the western basin of Lake Erie via the Maumee River. In 2015, Great Lakes Restoration Initiative funding was used to install several drainage water control practices, including a saturated buffer, on the site. The saturated buffer design included a 100 mm perforated pipe set at level grade bedded in coarse gravel approximately 1 m below ground level extending 500 m along the riparian zone. The buffer tile was connected to a 3-chambered drainage control structure and fed by a 150 mm tile inflow draining a 7.3 hectare subwatershed area within the field. The riparian zone was planted with an NRCS-CP-21 mix of warm-season grasses and forbs with an average vegetated width between field and stream of approximately 15 m. Elevation difference between the field and the riparian zone varied between 0.5 and 4 m. The field exhibited an average slope, based on LIDAR data, of approximately 1.4%. Groundwater monitoring wells consisted of 2.5 m sections of 5 cm diameter pipe and were positioned in pairs along two transects spaced at 1/3 and 2/3 distance between the buffer and stream following the expected path of groundwater flow spanning the bottom of the buffer tile to the flow line of the adjacent stream (Fig. 1). Monitoring well holes were excavated using a 30 cm augur to a depth of between 1.7 and 2.3 m consistent with the expected flow path of water following the hydrologic gradient from tile to adjacent stream bed. Once wells were situated they were backfilled with sand which surrounded the ~60 cm long section of well slots to allow water to percolate freely into the well with a thick layer of bentonite clay packed above this sand layer to prevent surface water from infiltrating well areas followed by a top soil layer sloped away from the wells to further reduce potential for surface infiltration down the well pipes. Following installation of the wells, the subsurface distribution pipe was flooded using an adjacent irrigation pond to verify water level change in wells, ensuring that they were in line with the expected infiltration path of water.

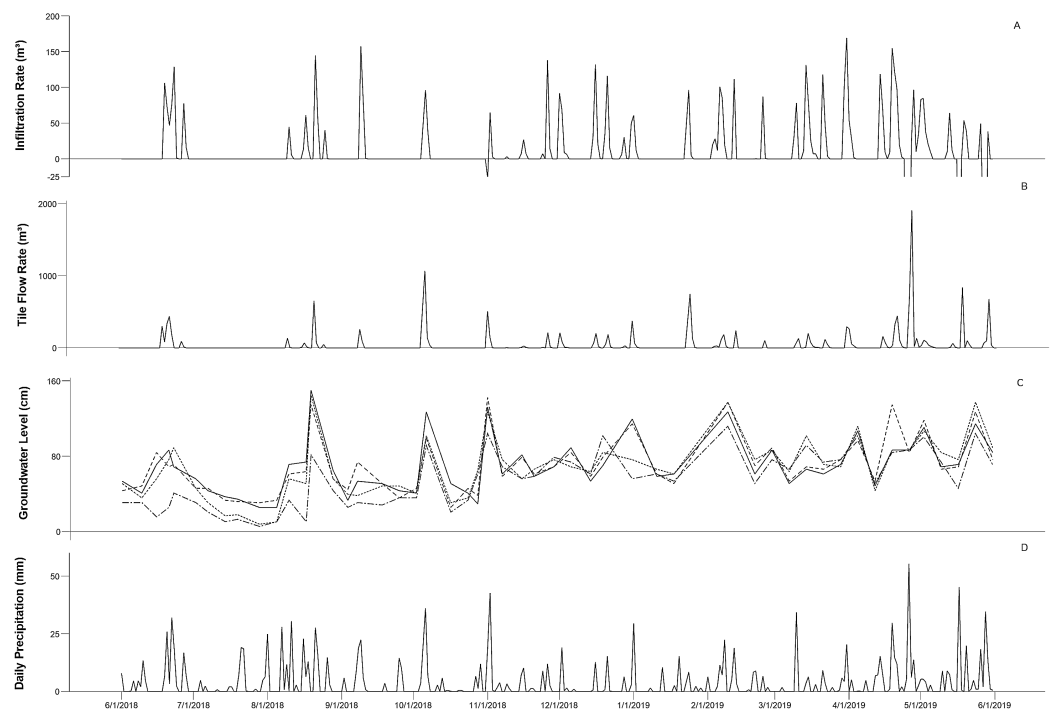
Figure 2 Overview of saturated buffer infiltration rate (A), tile flow (B), groundwater level (C), and daily precipitation (D). [Full-size](#) DOI: 10.7717/peerj.9007/fig-2

Annual precipitation (June 2018 to May 2019) at the site was 1,430 mm resulting in a combined rainfall volume of 104,099 m^3 (based on a watershed area of 7.3 hectares). This compares to annual averages from the site of approximately 1,049 mm, indicating a roughly 25% wetter than average year. Not surprisingly, spring rains represented the largest contributor to precipitation totals as both May and June exhibited among the highest monthly averages as well as the two highest single day precipitation totals ranging from 45 to 50+ mm. During this study period, tile inflow totaled 15,520 cubic meters, indicating that approximately 15% of the total precipitation volume drained through the tile. Tile flow was observed over 119 days of the year, and while surface flow was not measured, anecdotal observation of surface flow through one obvious lower swale did occur during the highest spring rains, indicating that the remaining 85% of precipitation was not all stored in soils. During this period, approximately 3,785 total cubic meters of flow was diverted into the buffer, indicating an infiltration annual average of ~25% of the total tile flow. This number varied substantially with precipitation totals and monitoring well water levels, reflecting a key relationship at this site between infiltration potential and ground saturation. Periods of highest groundwater levels saw the water table rise to 125+ cm in depth, occurring primarily during spring months which corresponded to an average infiltration rate of 20% and increased to between 35% and

44% during other times in the year. These lower spring infiltration rates included April and May of 2019, which exhibited mean infiltration rates of 4% and 0%, respectively. These periods of groundwater saturation created a small number of backflow events where the buffer actually discharged, reducing the overall efficacy of the system. Overall, the buffer actively charged 113 days, discharged 6 days, and did not receive any flow over 244 days of the year. During the 12-month study, greater than 50% of the total tile flow occurred over 10 days with flows ranging from 379 to 1,893 cubic meters per day. Not coincidentally, these periods corresponded to the highest precipitation and groundwater water levels and the time surrounding each of the backflow events (Fig. 2).

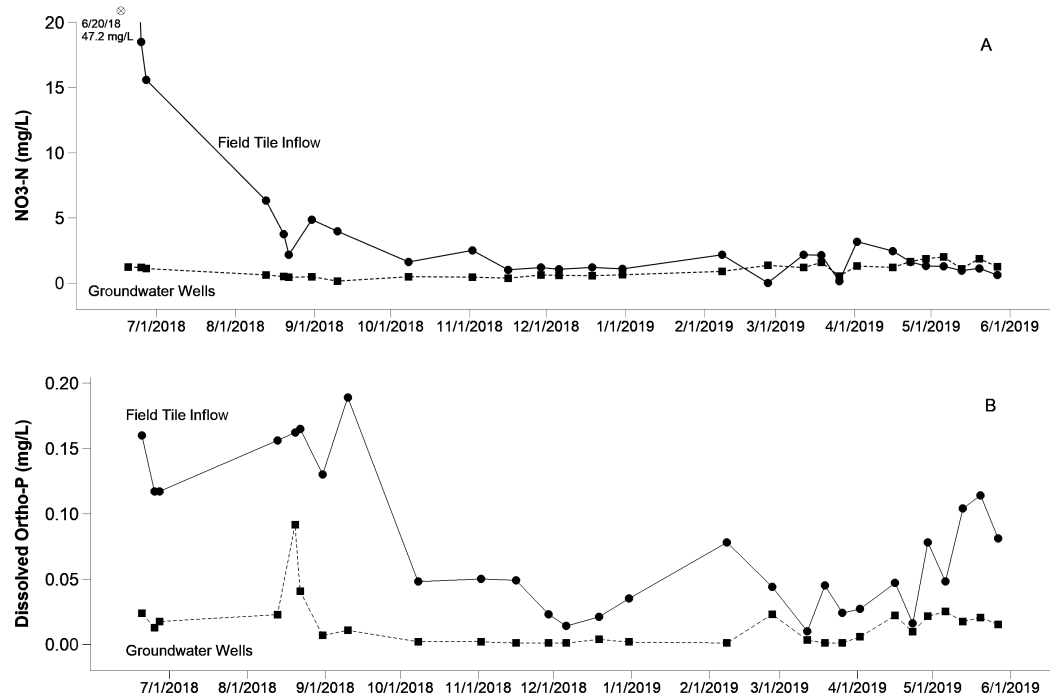
Figure 3 Nutrient variation of nitrate (A) and dissolved phosphorus (B) over time. The solid line indicates tile inflow sample, while the heavy dotted line signifies mean well concentrations across the four groundwater monitoring stations. Note that the asterisk in the nitrate-N plot signifies an outlier point that exceeds the scale bar, which has been truncated for clarity. Raw data for individual wells can be found in [Appendix 1](#). [Full-size](#) DOI: [10.7717/peerj.9007/fig-3](https://doi.org/10.7717/peerj.9007/fig-3)

Nutrient and sediment sampling included 28 separate events where the highest nutrient values on a per sample basis were seen in the tile and first set of 2 wells leading away from the buffer, respectively (Fig. 3). Interestingly, the second well transect set further down the buffer routinely registered lower nutrient values when compared with the initial well transect closer to the control box. Given the positive pressure in the buffer tile maintained during charging events coupled with the high covariation of nutrients between field tile and wells, however, we do not interpret this as evidence of extensive surface water dilution. Furthermore, the presence of a thick blue and gray clay layers situated beneath the glacial till that comprise the parent material of area surface soils suggests that variations in monitoring well concentrations or levels are unlikely to have been influenced from subsurface upwellings from deep aquifers, etc. (Priest, 1979). Overall, both nutrients and

sediment followed a similar pattern across the year long monitoring period where initial measurements taken during the spring and early summer seasons where highest and tapered off considerably throughout the year long study climbing slightly approaching the beginning of spring at the end of the study period (Fig. 3). This is undoubtedly a function of nutrient application from the producer where application records indicated nutrient addition schedules during the first part of year 1 but not yet occurring as the study concluded its monitoring period moving into the next agronomic year.

During the study period, $\text{NO}_3\text{-N}$ levels in drainage tile varied from <0.2 to 47.2 mg/L (average 4.7 mg/L; Fig. 3). Consistent and rapid declines in $\text{NO}_3\text{-N}$ concentrations were seen in well samples, which ranged from <0.2 to 1.98 mg/L (average 0.97 mg/L). Focusing just on those higher tile samples which registered above 2 mg/L of $\text{NO}_3\text{-N}$, reduction efficiencies associated with the buffer averaged 75%. The only exception to this pattern was a single observation where nitrate was slightly higher in wells compared with field tile. We attribute this to variation in point estimates as a time lag between tile runoff and infiltration into the ground surrounding the wells. It is relevant to note that this exception only happened once and it occurred at a very low nitrate concentration. Similarly, comparatively high DRP levels in drainage tile, varying from <0.05 to 0.19 mg/L (average 0.08 mg/L), exhibited steep declines once infiltrated within the riparian buffer area, ranging from <0.05 to 0.09 mg/L (Fig. 3). Focusing just on those higher tile samples which registered above 0.05 mg/L of DRP, reduction efficiencies associated with the buffer
