# Disassociation of a Cold-Welded Bimodular Titanium Femoral Stem by Intraoperative Ice Cooling

Modularity in total hip arthroplasty allows a surgeon to have intraoperative versatility, allowing for fine adjustments of the femoral offset, leg length, and version. However, modularity can be a source of multiple complications. This case report describes a novel intraoperative solution for the problem of cold welding of a neck-stem junction using sterile ice to cryogenically disengage the modular components.

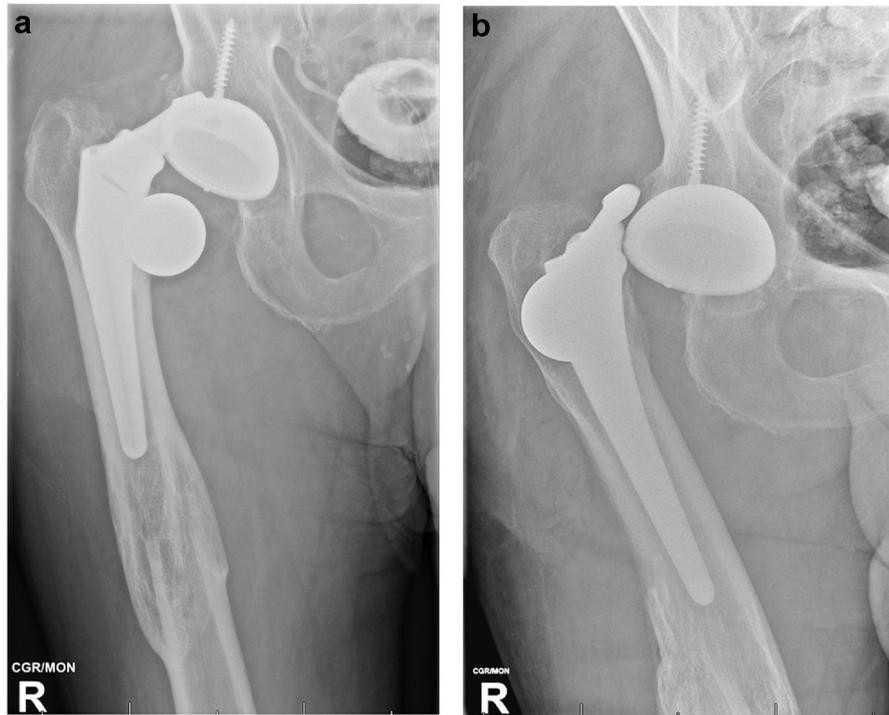
**Figure 1.** Preoperative anteroposterior radiograph (a) and attempted lateral radiograph (b) of the right hip showing right periprosthetic hip dislocation and disassociation of the femoral head from the modular neck.

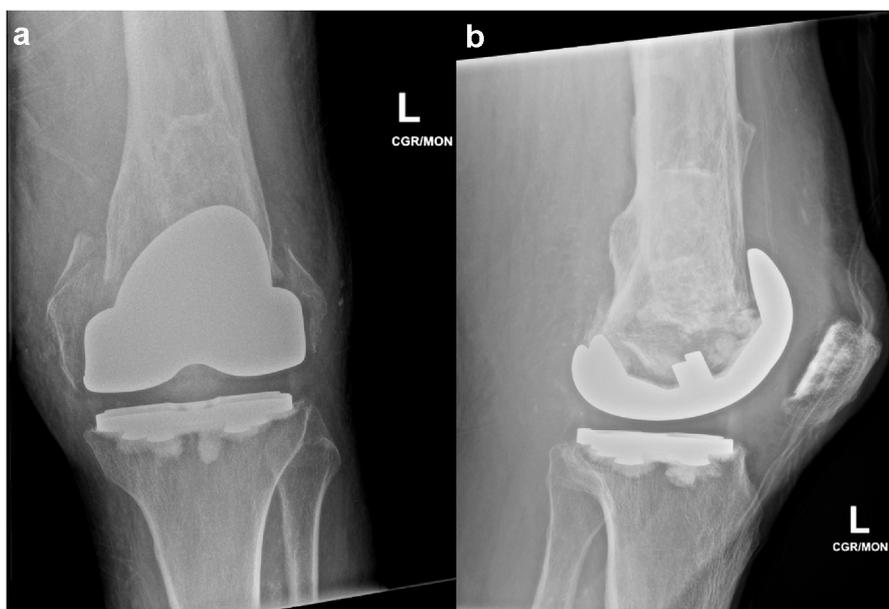
**Figure 2.** Preoperative anteroposterior radiograph (a) and lateral radiograph (b) of the left knee demonstrating a comminuted left distal femoral periprosthetic supracondylar femur fracture.

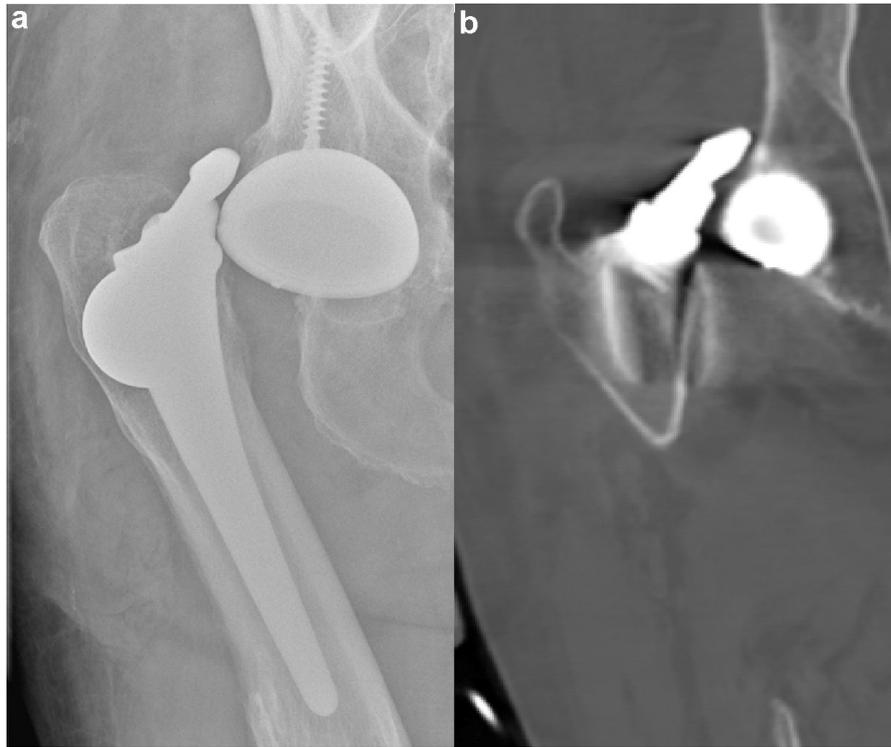
from the titanium neck. The neck on plain radiographs showed notching of the proximal inferior portion of the taper junction (Fig. 3a). The implant was identified as a Zimmer M/L Taper Kinectiv titanium bimodular femoral component (Zimmer M/L Taper Hip Prosthesis with Kinectiv Technology, ZimmerBiomet, Warsaw, IN) with a titanium modular neck. Three-dimensional imaging was obtained because of the polytraumatic nature of the patient's presentation and to rule out an ipsilateral periprosthetic fracture.

This confirmed no fracture and demonstrated, with more clarity, the damage to the trunnion (Fig. 3b).

**Figure 3.** (a) Radiograph of the right hip demonstrating notching of the proximal inferior portion of the taper junction. (b) Computed tomography scan of the right hip demonstrating notching of the taper junction.

Neck retention was unacceptable with the degree of trunnion damage witnessed. Options at this point were en bloc removal of the stem likely requiring an anterior-based femoral osteotomy or further attempt at removal of the modular neck with subsequent replacement of a new titanium neck and a new ceramic femoral

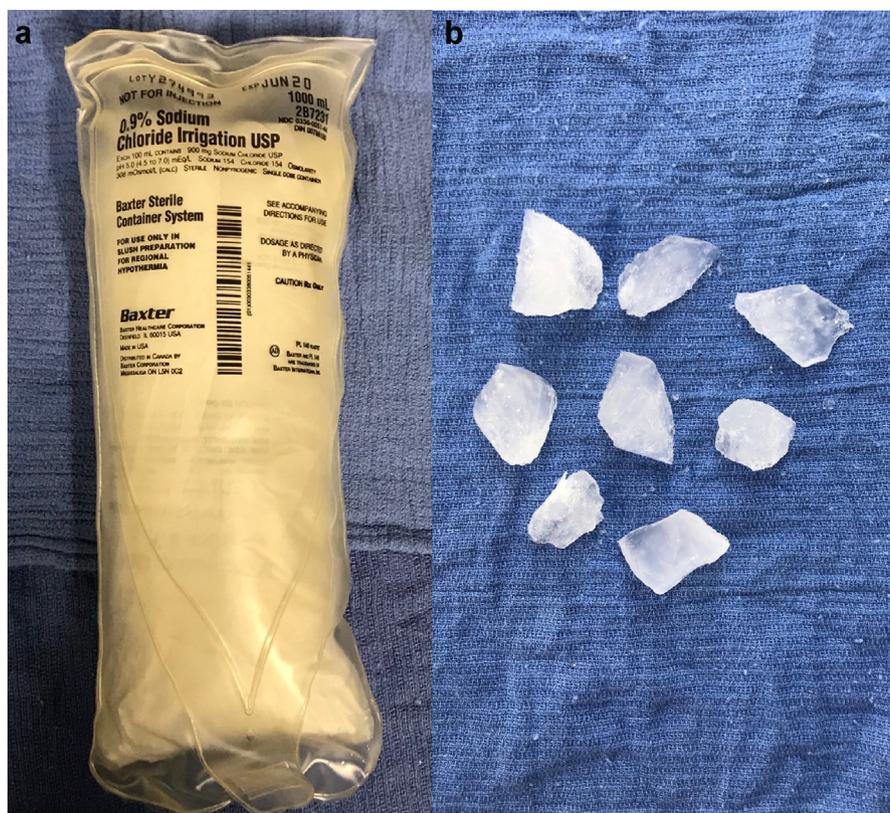
**Figure 4.** (a) Frozen sterile bag of normal saline. Bag cut and ice broken into pieces and placed around the modular neck, cryogenically separating the modular neck and stem junction. (b) The ice block broken down into manageable sizes that could be fit easily circumferentially around the neck.

head. Removal of the femoral stem would have added significant operative time and morbidity to a multiply injured and physiologically compromised patient. We decided to attempt one more alternative strategy for neck removal; using knowledge of thermoregulation and experience with mechanical engineering principles of shrink-fitting metals and thermal separation, we used sterile ice to cool the neck relative to the stem in hopes of contracting the metal for neck removal. The sterile ice comes in the form of frozen intravenous (IV) bags of sterile saline that are typically used in cardiac and transplant cases (Fig. 4a). We cut open the IV bag and broke the large ice block down into manageable sizes that could be fit easily circumferentially around the neck (Fig. 4b). This relatively rudimentary means of cooling is routinely used in thermoregulation during cardiac cases.

After 10 minutes of cooling the trunnion, we again attempted to remove the neck with the universal extraction system, and we found the neck to come out easily with 3 moderately forceful blows, a noticeable difference from the previous attempt. We inspected the female Morse taper junction in the stem; there was no obvious macroscopic damage of the Morse taper thread topography and no signs of metal debris, deformation, or corrosion. The male portion of this taper on the modular neck also appeared pristine without any discoloration or obvious damage. The femoral stem remained well fixed. Attention was then turned to the polyethylene liner that was exchanged. Interrogation of the acetabular component was unremarkable, and the component was retained as it was well fixed and reasonably well positioned on preoperative films. The head that had disassociated from the femoral stem was removed from the posterior thigh through the dislocation tract created through the disrupted posterior capsule. A small lateral accessory incision was used through which uterine forceps were inserted and used to lever the dislocated head cranial and anterior so that it could be grasped and removed through the anterior hip incision. We then placed a new titanium modular femoral neck of the same size and

Theoretically, cooling the modular titanium component of this implant with intraoperative ice bath allowed thermal shrinkage of the implant and allowed the titanium of the modular neck and the stem to cryogenically separate. This allowed for dissociation of the neck-stem interface with only moderately applied force. In this case, we were able to retain the well-fixed stem in a multiply injured patient and reduce the morbidity of this revision THA and, equally importantly, refrain from postoperative weight-bearing restrictions, which would certainly hinder recovery. This method of using sterile ice intraoperatively as an option to potentially cryogenically separate cold-welded components appears to be a safe, cost-effective technique and has the potential to avoid a larger and potentially unnecessary operation.

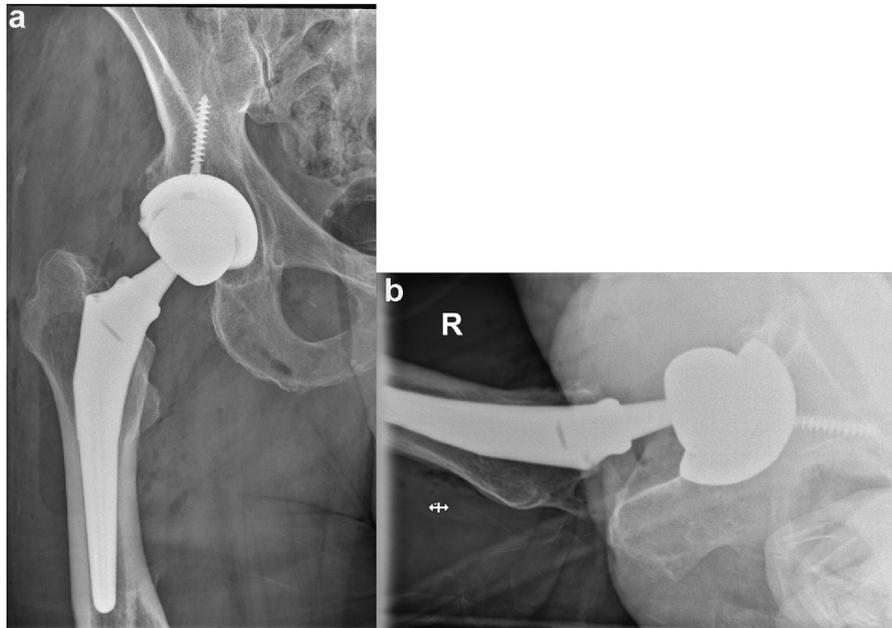
**Figure 5.** Postoperative anteroposterior radiograph (a) and lateral radiograph (b) of the right hip.

Although bimodular hip implants historically have had a poor track record, this particular stem has not been recalled, and modular titanium neck implants were available and ready for this case. While there have been a number of case reports of MACC at the head-neck junction of this specific 12/14 taper when used with cobalt-chromium heads, there has only been a single case report of possible MACC at the titanium-titanium stem-neck taper junction with this stem [25]. In this one case report, the presumed crevice corrosion seen was the black corrosion product seen on the modular neck at the neck-stem interface near the exposed shoulder of the neck, while the patient had obvious MACC at the head-neck junction with black corrosion products all around that male taper along with elevated cobalt and chromium ion levels while having undetectable titanium ion levels. Therefore, this stem has minimal risk for MACC at the neck-stem trunnion. Furthermore, when the titanium neck is coupled with a ceramic head, retention of this particular stem is a reasonable option in a complicated clinical scenario such as this one. However, we would be remiss to not also mention the fact that there have been several case reports in the literature of fracture of modular titanium femoral necks. Although the risk of MACC at the neck-stem junction may be lessened with these titanium femoral necks, this does not come without this slight added risk of fracture [6,10,11,26]. In this complicated 72-year-old patient with polytrauma, it was felt to be appropriate to place a new titanium neck with the same length and offset as the removed component and a new 40 ceramic head of the same length (Fig. 5a and b). Stability was found to be excellent with this construct in place. The wounds

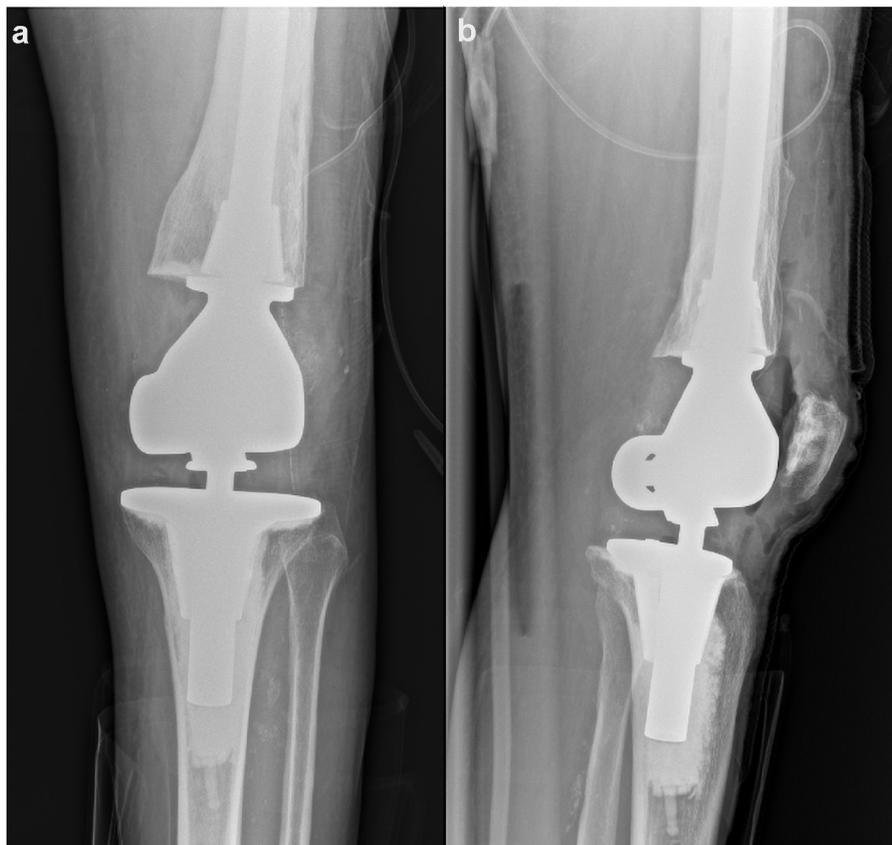
**Figure 6.** Postoperative anteroposterior radiograph (a) and lateral radiograph (b) of the left knee demonstrating revision TKA with a distal femoral replacing hinge.

were copiously irrigated and were closed in a layered fashion. We then proceeded to address his contralateral distal femur and performed a revision TKA with a distal femoral replacing hinge in this same setting (Fig. 6a and b). The patient tolerated the procedure well and began standing and ambulating with physical therapy while in the hospital as he was allowed to be weight-bearing as tolerated on his bilateral lower extremities. The patient was seen most recently at 8 weeks after surgery with a well-healed right hip incision and painless range of motion of his right hip. He continues to rehabilitate from his multiple other injuries because of the polytrauma nature of his injury. His follow-up radiographs do not show any evidence of dislocation or trunnion complications of his right hip.
