Article

Analysis of Cement Deterioration in Outdoor High-Voltage Insulator

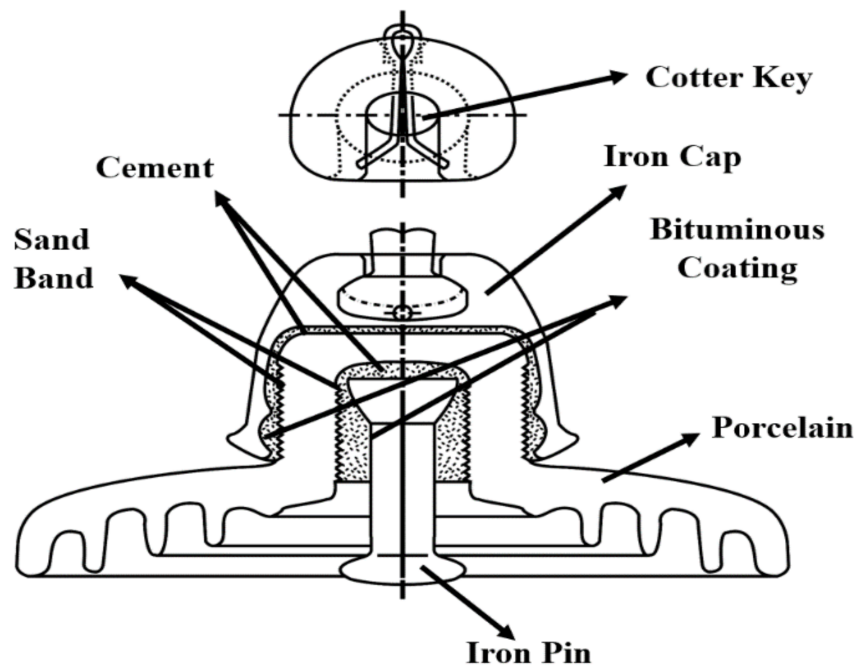
Figure 1. Cross section of suspension type porcelain insulator used for 154 kV transmission line.

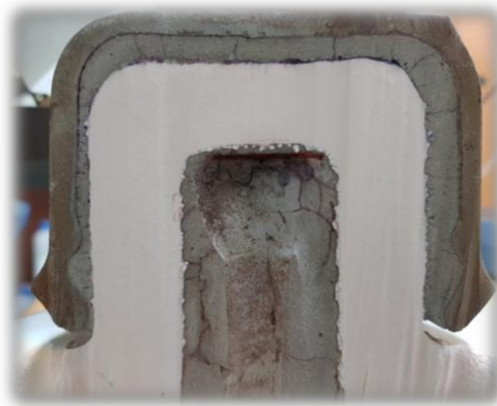
Figure 2. Cement paste surrounding cap of porcelain insulator.

In this study, we propose a method for diagnosing the degradation of cement paste in insulators and a method for diagnosing the lifetime of cement as depicted in Figure 2 [12]. An intensive analysis focusing on the cement life and not on the life of all parts of the insulator is performed. The method of diagnosing the life of cement includes measuring the pH variations by employing the universal indicator. The deterioration behavior of cement in the porcelain insulators is estimated using a universal indicator to observe the pH variation with respect to age [12–14]. The initial pH of the cement is 12–13 indicating alkaline characteristics. As degradation progresses, the hydrogen ion concentration

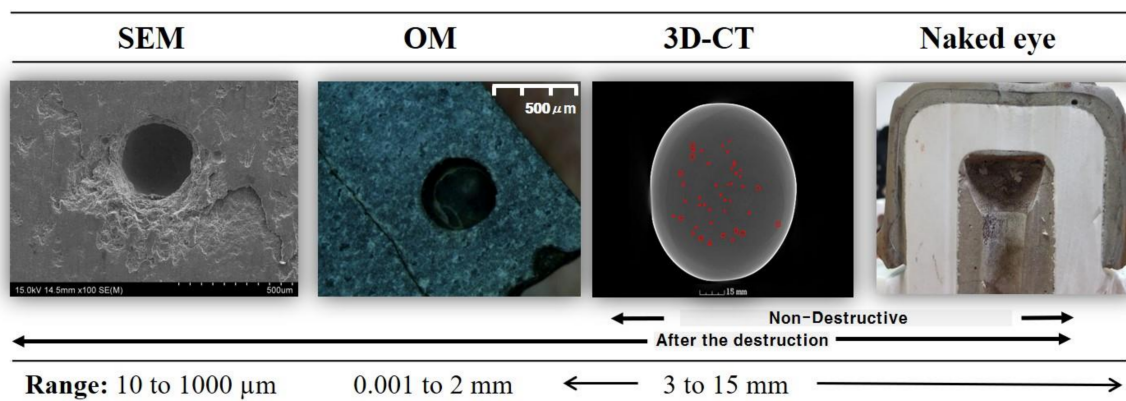
Figure 4. Pore size analysis according to the size of pores in cement.

size that can be measured and observed with SEM to the size that can be visible to the naked eye as shown in Figure 4 [17]. The smallest pores can cause a capillary phenomenon. Due to the soil moisture tension, there are several micro-sized capillary pores that can contain moisture, and water penetrates into these pores, which is the starting point of microcracks that occur, due to the alkali–silica reaction (ASR) [35]. Larger than the capillary pores are the pores of several hundred μm that can be measured with an optical microscope. The ASR causes the capillary pores to be cracked [36]. As the cracks and voids grow larger, the cracks grow in the size of tens to hundreds of millimeters, which can be measured using 3D-CT without damaging the sample as performed by authors [14]. However, as the porcelain insulator is a composite material of metal, cement, and ceramic, it is not easy to measure the cracks because of X-ray scattering. Thus, it has been advised to perform 3D-CT with a very high output power for the analysis [17]. Efforts are taken to produce as little pores as possible using air-entraining water-reducing agents. Some of these pores grow in size to a few millimeters, which are similar to entrapped air.

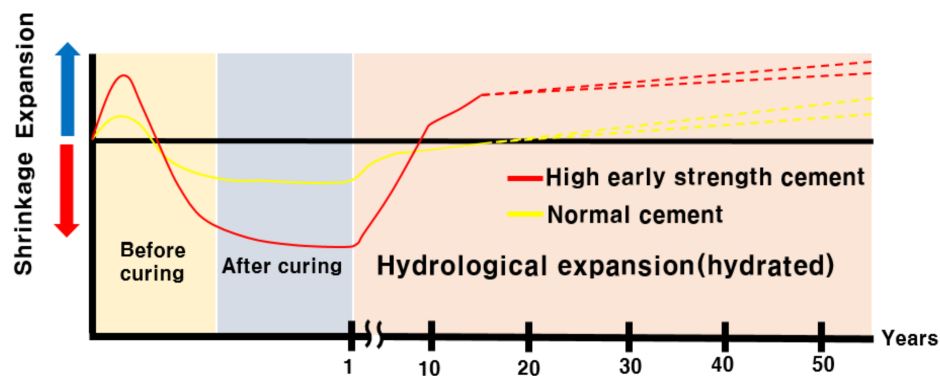
Figure 5. Contraction behavior, due to the service life of cement inside the porcelain insulator.

Figure 5 shows the shrinkage and expansion of cement inside the insulator with age with respect to normal and high-early-strength-cements. Manufacturers of porcelain insulators generally use the normal cement or high-early-strength cement, while may also use other types of cement. Less than one-year-old cement is not hardened completely. When the insulator is serviced after initial hardening, the cement may be rehydrated, due to moisture infiltration. When the compressive strength is elevated, and the cement is hardened by curing, moisture penetrates into the pores of porcelain and expands, because there is no coating film to prevent the penetration of moisture. It is difficult to define the number of years of use, after which that the crack may occur, due to expansion, because it depends on the service environment, leakage current if any, and the movement of ions. Swelling and cracking do not happen within a short period of time. The pH value declines, as the hydrogen ion concentration increases.

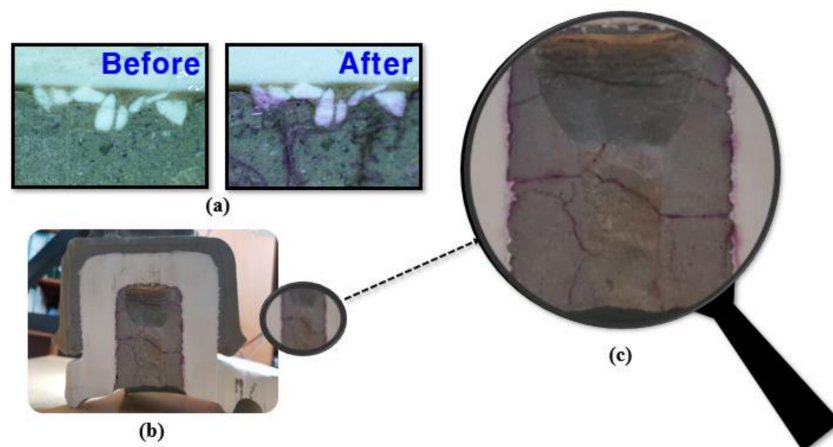
Figure 6. Crack detection using Fuchisine solution. (a) Before and after using fuchisine solution, (b) cross section after using solution, (c) enlarged cross section after using solution for visual inspection.

This can lead to swelling, which can eventually result in cracking and deterioration of mechanical properties. Degradation of mechanical properties, crevice, and swelling lead to cracks in the cement parts inside the insulator [40,41]. The results of using the fuchisine solution are shown in Figure 4. The solution is rosaniline hydrochloride, magenta with the chemical formula of $C_{20}H_{19}N_3$, HCl and soluble in water. It is mainly used to dye textiles or bacteria. If it becomes solid or thick, green crystals are formed. Therefore, it is diluted to 5% in water or ethanol [42]. Figure 6 shows the cracks before and after the use of the fuchisine solution. It can be observed that the cracks that were not visible to the naked eye before are visible, after the solution is used. The size of the cracks visible to the naked eye after using the solution is mostly in the range of 300–400 μm . Cracks of lesser size demonstrate a width of approximately 100 μm . As mentioned earlier, the formation of cracks is closely related to the pH values.

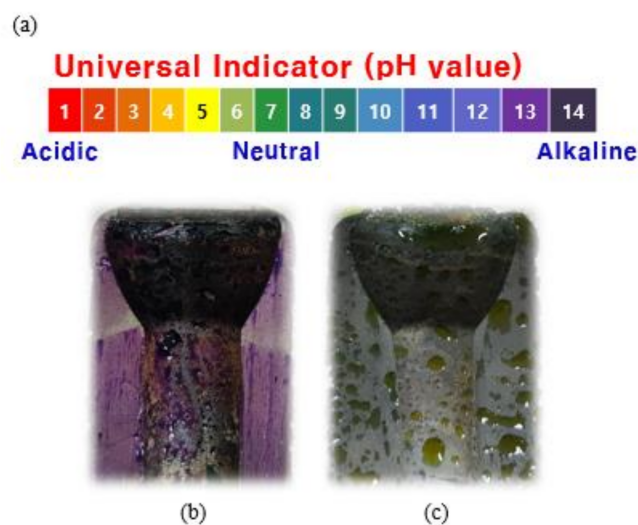
Figure 7. Color comparison of new and deteriorated products using the universal indicator on the insulator cement. (a) Color change by the pH value of the universal indicator, (b) purple color, due to the pH 12 of the new cement, (c) color change close to yellow, due to pH drop after 52 years use.

The change of pH in an insulator can be inspected using a universal indicator, and the color changes based on pH value, as shown in Figure 7a. This work considered two insulators, one new and other 52-year old porcelain insulator. Both were cut in half using a waterjet and sprayed with a universal indicator on the internal cement part, as shown in Figure 7b,c. In the case of new insulator depicted in Figure 7b, after the hardening of the cement, the pH is observed to be approximately 13.

In the second case, where the porcelain insulator has been used for 52 years has shown a pH of approximately 7 as depicted in Figure 7c.

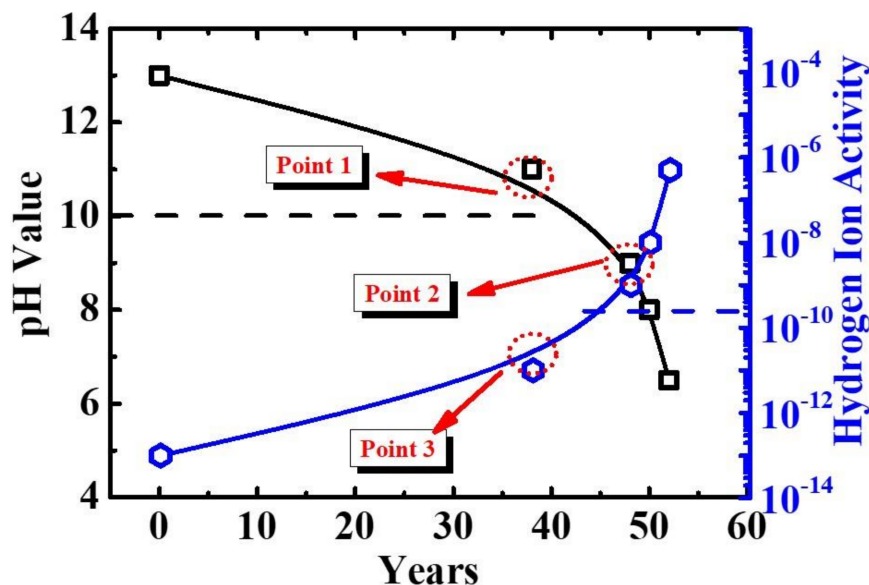
Figure 8. Changes in pH and H^+ according to the used period in the cement of porcelain insulator.

with age of the insulator are shown in Figure 8. When the pH drops under 9, the risk of mechanical properties increases at points 1 and 3, where the pH value is 10 and H^+ activity is 1×10^{-10} . The age of the section is approximately 38 years, which is when corrosion is likely to occur on the pins inside the insulator. Point 2 is where pH and H^+ activity intersect, pH drops under 9, and H^+ activity is 1×10^{-9} . It is the point, at which the alkalinity of cement drops sharply.

The age is approximately 42 years, which is when the deterioration of cement proceeds rapidly. At the age of 48 years, the mechanical strength of cement is exhausted, pH value is 7, and H^+ activity is 1×10^{-7} . The results of the study showed that the cement deterioration showed a decrease in pH, which is similar to that observed in the building. However, in the case of the insulator, the cement part

is not coated. Therefore, moisture penetration into the capillary pores of the hardened cement is easier. Rehydration causes the cracks to expand and enlarge. As shown in Figure 8 the pH value decreases with age, and the cause of expansion is described in detail as follows:

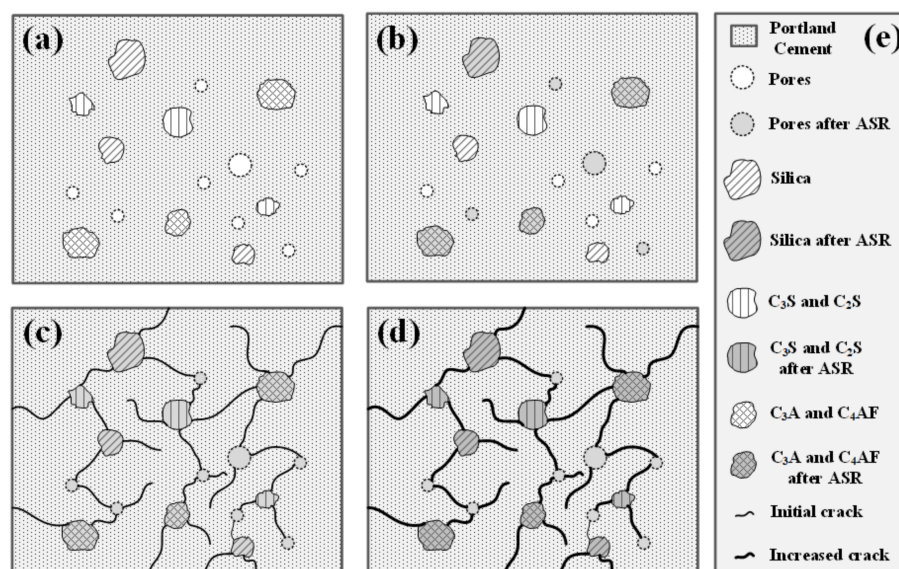
Figure 9. Diagram showing the alkali silica reaction mechanism of cement.

As pH decreases and internal corrosion starts, the processes related to cracking, expansion, and deterioration of cement happen, which are shown in Figure 9. Pores corresponding to the silica structure and capillary pores formed in Portland cement are demonstrated in Figure 9a. As the cement is cured at a high temperature of 1260–1450 °C, minerals, such as crystal phase of tricalcium silicate (Ca_3SiO_5 , $3\text{CaO} \cdot \text{SiO}_2$), alite phase C_3S , belite phase C_2S , crystal phase of dicalcium silicate (Ca_2SiO_4 , $2\text{CaO} \cdot \text{SiO}_2$), aluminate phase of tricalcium aluminate ($\text{Ca}_3\text{Al}_2\text{O}_6$, $3\text{CaO} \cdot \text{Al}_2\text{O}_3$) containing trace silica, magnesium, sodium and potassium are produced. The ferrite phase C_4AF crystal phase of tetra calcium aluminoferrite ($\text{Ca}_4\text{Al}_2\text{Fe}_2\text{O}_{10}$, 4CaO , Al_2O_3 , Fe_2O_3), a chemically resistant compound contained in Portland with approximately 10% of C_3A , is present.

Figure 9b shows that some water penetrated, and water is contained in pores corresponding to the capillary pores of cement. Four crystalline phases (C_3S , C_2S , C_3A , and C_4AF) react with water to

cause cracks, which is shown in Figure 9c. The deterioration proceeds, and the crystal phase undergoes ASR, due to moisture infiltration in accordance with steps 1 and 2 described earlier.

This is shown in Figure 9d. As a result, the insulator cement cannot guarantee the maintenance of mechanical properties, which is its primary role. The specific spots of cracks can be analyzed using SEM. However, it is very difficult to locate and analyze the part, where ASR has occurred [47,48].

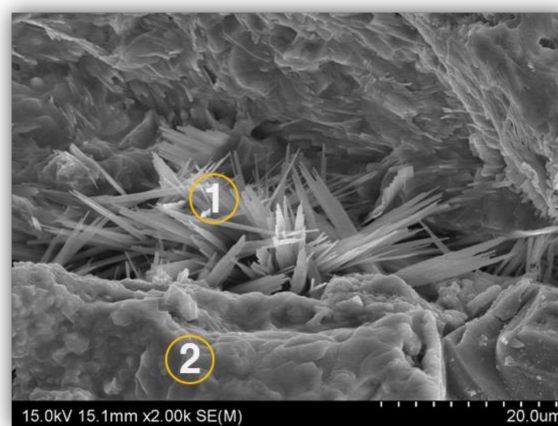
Figure 10. SEM image analysis of cracks in the insulator cement used for 48 years.

Figure 10 shows the results of the analysis of cracks and expansions caused by ASR in the deteriorated cement of the insulator that was used for 48 years. It can be observed that the cracks in the cement inside the insulator has caused some breakage. Figure 11 EDS analysis of alkali–silica reaction (ASR) in the insulator cement used for 48 years has been depicted.

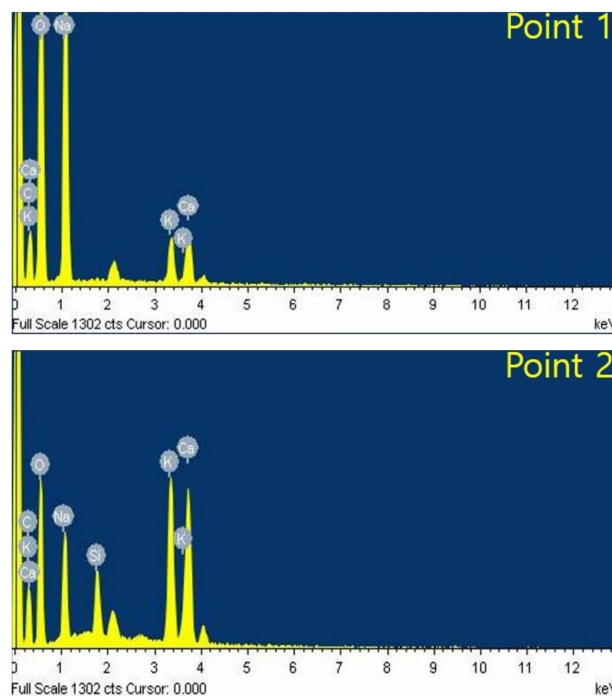
Figure 11. EDS analysis of alkali–silica reaction (ASR) in the insulator cement used for 48 years.

The content of elemental components is shown in Table 3 for range 1, in which cracking occurs and range 2, in which cracking does not occur.

In the case of crack 1, the ASR decreases and Si, K, and Ca decrease by 2.71%, 5.99%, and 6.19%, respectively. Reactive component Na element increases by 9.88%. It can be observed that $\text{Na}_2\text{SiO}_3 \cdot x\text{H}_2\text{O}$ was formed due to external moisture penetration. The corrosion of cement implies that the mechanical properties of cement have considerably deteriorated. In severe cases, corrosion of the internal pins starts, which poses the risk of mechanical desorption of the porcelain insulator, when the tower is being serviced [49,50].
