Pulsatile lavage irrigator tip, a rare radiolucent retained foreign body in the pelvis: a case report

CASE REPORT

Camille L Connelly and Michael T Archdeacon*

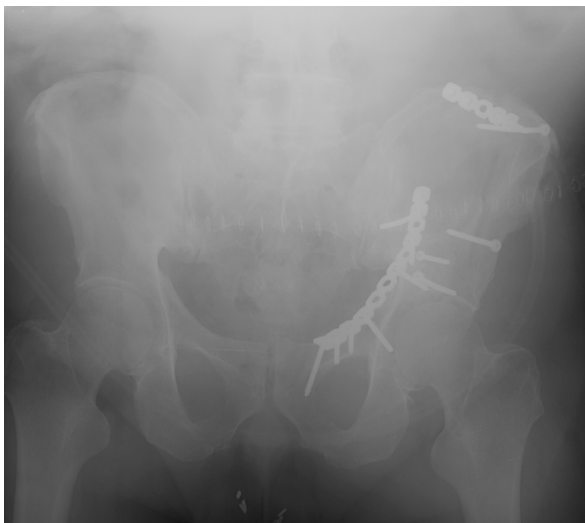
Figure 1 Immediate postoperative AP and oblique pelvic radiographs demonstrating near anatomic reduction status post ORIF.

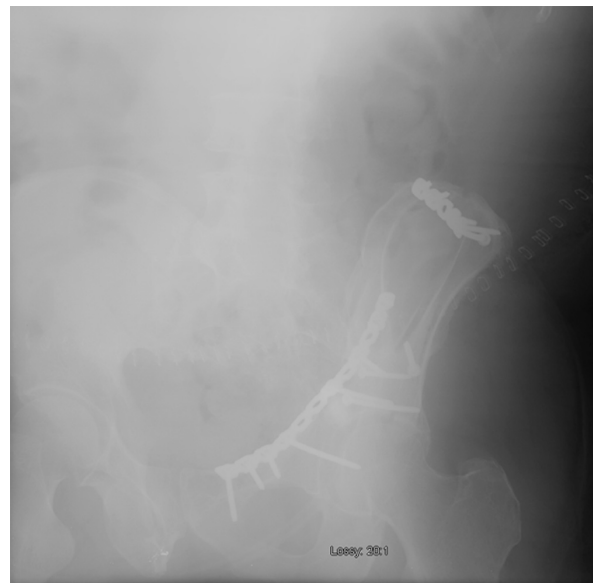
Figure 3 Immediate postoperative AP and oblique pelvic radiographs demonstrating near anatomic reduction status post ORIF.

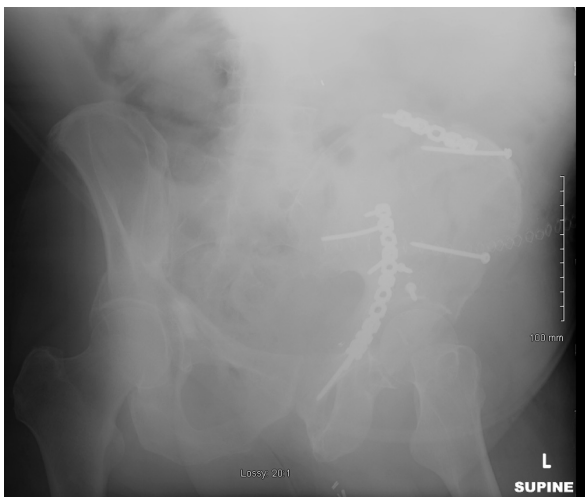
Figure 2 Immediate postoperative AP and oblique pelvic radiographs demonstrating near anatomic reduction status post ORIF.

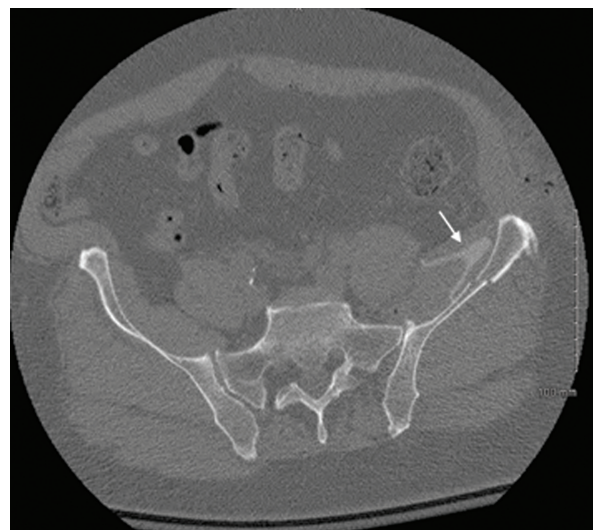
A standard postoperative CT of the pelvis was obtained as is routine at our institution. This revealed a concentric reduction of the hip joint without intra-articular implant penetration. However, the attending orthopaedic surgeon noted an ipsilateral irregularly shaped hyperdensity in the left iliacus muscle and operative bed. The discrepancy was measured at 250-300 Hounsfield units (HU) and appeared without significant associated streak artifact (Figure 4 and Figure 5, white

arrows). It was not present on the preoperative CT scan and was not detectable on any of the preoperative or postoperative plain radiographs. Thus, suspicion was raised for a retained foreign body versus an atypical hematoma. Based on the imaging characteristics, a retained foreign body was favored and exploratory revision surgery was recommended.

Figure 4 Postoperative axial and coronal pelvic CT scans showing an irregular, hyperdensity (white arrow) in the left iliacus muscle.

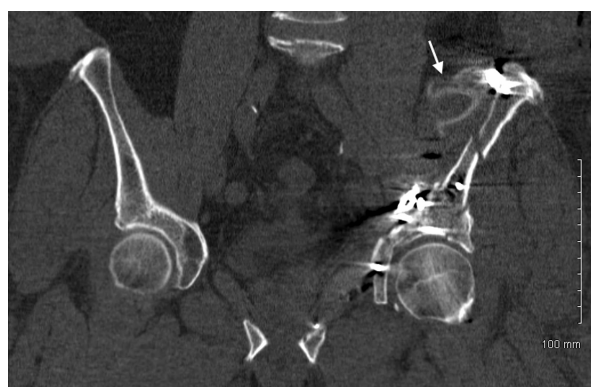
Figure 5 Postoperative axial and coronal pelvic CT scans showing an irregular, hyperdensity (white arrow) in the left iliac muscle.

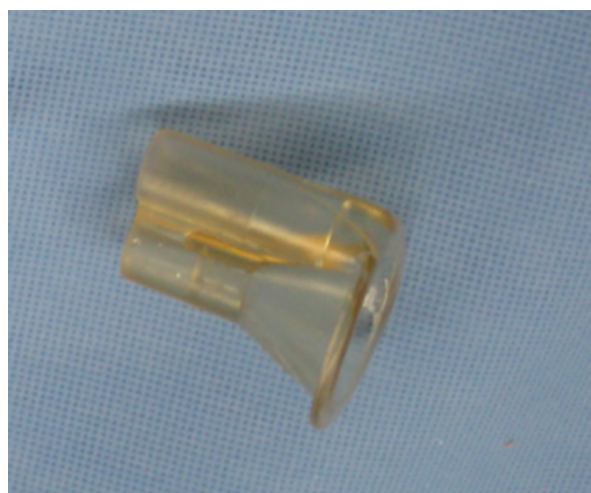
Upon wound exploration, a retained foreign body was confirmed and identified as the plastic tip from the

pulsatile lavage unit that had been used for wound irrigation during the first procedure (Interpulse High Flow Tip model 210-14, Stryker, Kalamazoo, MI) (Figure 6). This was removed without complication. Postoperative neurovascular examinations were intact and unchanged from previous. The patient was discharged on hospital day eight in stable condition.

Figure 6 The retained foreign body was identified as the nozzle tip from the pulsatile lavage irrigation system.

Following this event, a root cause analysis was performed to determine the precipitating factors, and to prevent recurrence of this complication. The first issue identified was a process-related error involving surgical equipment modification. In the experience with the Interpulse Powered Lavage System (Stryker, Kalamazoo, MI) at our institution, it was perceived that the irrigation time in operating room was longer than desired. It was also noted that by removing the central “filter cap” in the tip of the irrigator (Figure 7 and Figure 8, white arrow) that a higher flow could be achieved, reducing irrigation time. In operating room time trials this difference was determined to be approximately 45 seconds for each 3-liter bag of saline. Thus, it had become standard practice in our operating rooms to remove this component on the back table, prior to use. However, in light of this event, we have discontinued this practice. We suspect that the central filter cap may add some stability to the fixation of the nozzle tip on the lavage apparatus. Thus, removing this piece may have contributed to the dislodgment of the tip within the pelvic wound. Still, we are not aware of any other events or close-calls with a dislodging irrigator nozzle tip at our institution or in the literature.

While we hope that eliminating this practice of instrument modification will prevent any similar events in the future, we have also instituted several other preventive measures. Because the tip was not a recognized risk for dislodgement and becoming a separate piece, it was not individualized as part of the operative count. Therefore, the second identified root cause issue regards adding lavage nozzle tips to the operative count as an early warning. Additionally, thorough wound inspections will

Radiolucent retained foreign bodies are not easily detected and there is potential for uncounted components to become unintended retained foreign bodies. When using powered lavage systems we advise against equipment modification. We also advocate the addition of the nozzle tip to the countable items list and recommend thorough inspection and palpation of surgical wounds immediately prior to closure.

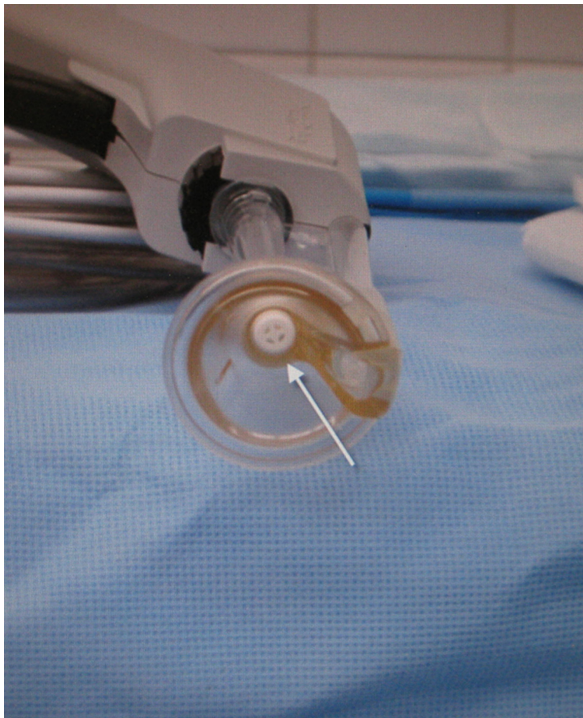
Figure 7 An end-on view of the pulsatile lavage nozzle with the central filter cap (arrow).

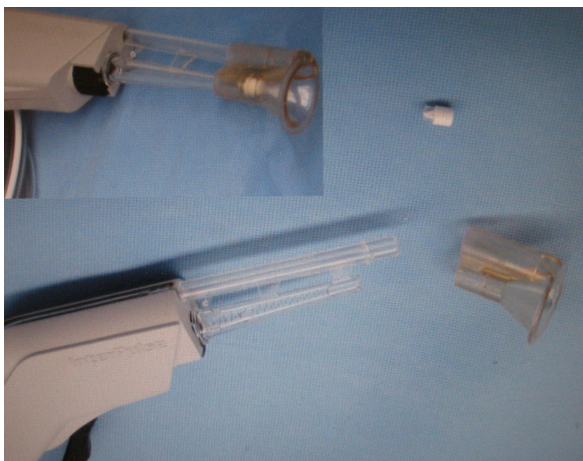
Figure 8 The pulsatile lavage system with disassembled and assembled (inset) components.
