Pseudotumor in Large Diameter Head Metal-on-metal Total Hip Replacement*

Rev Bras Ortop 2019;54:87–89.

The authors describe a case of a large diameter head metal-on-metal total hip replacement that evolved with an inflammatory pseudotumor formation. The diagnosis was established by magnetic resonance imaging (MRI) with suppression of the metal artifact. The treatment consisted on the resection of the abnormal tissue and on the revision to a ceramic on cross-linked polyethylene hip replacement. To this date, no similar case has been reported, in Portuguese language, in the PubMed, Scielo, and Lilacs databases.

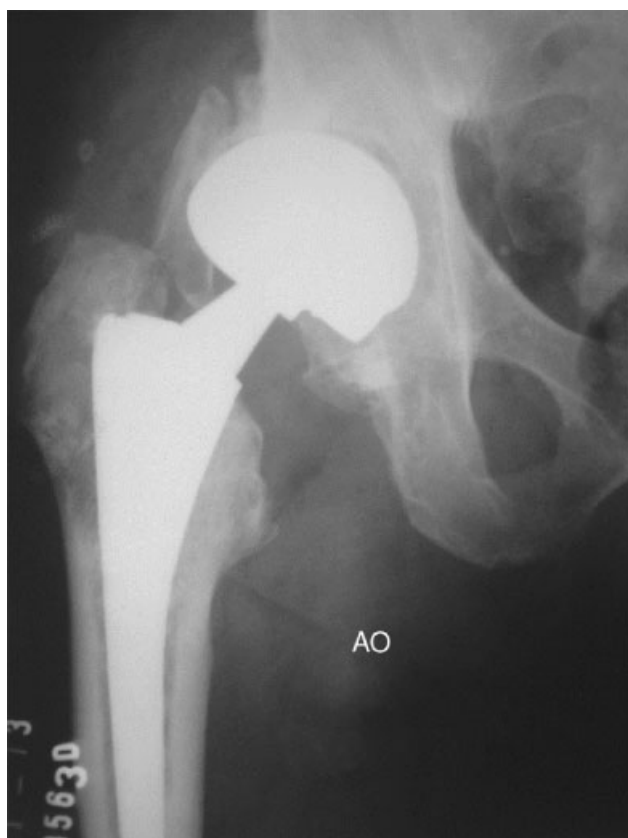
Fig. 1 Preoperative image, 5-year evolution.

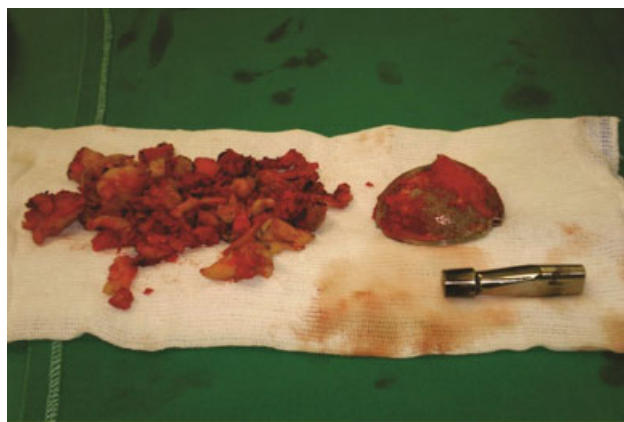
Fig. 3 Extensive mass of resected tissues.

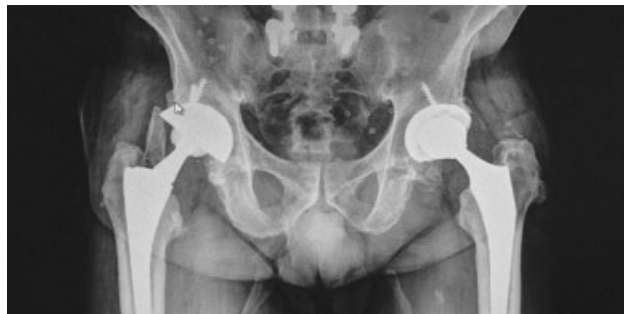
Fig. 4 Right-sided revision, 12 months postoperative.
