# Effect of X-ray dose rates higher than 8 Gy/min on the functioning of cardiac implantable electronic devices

**Keywords:** cardiac implantable electronic devices; malfunction; radiotherapy; dose rate

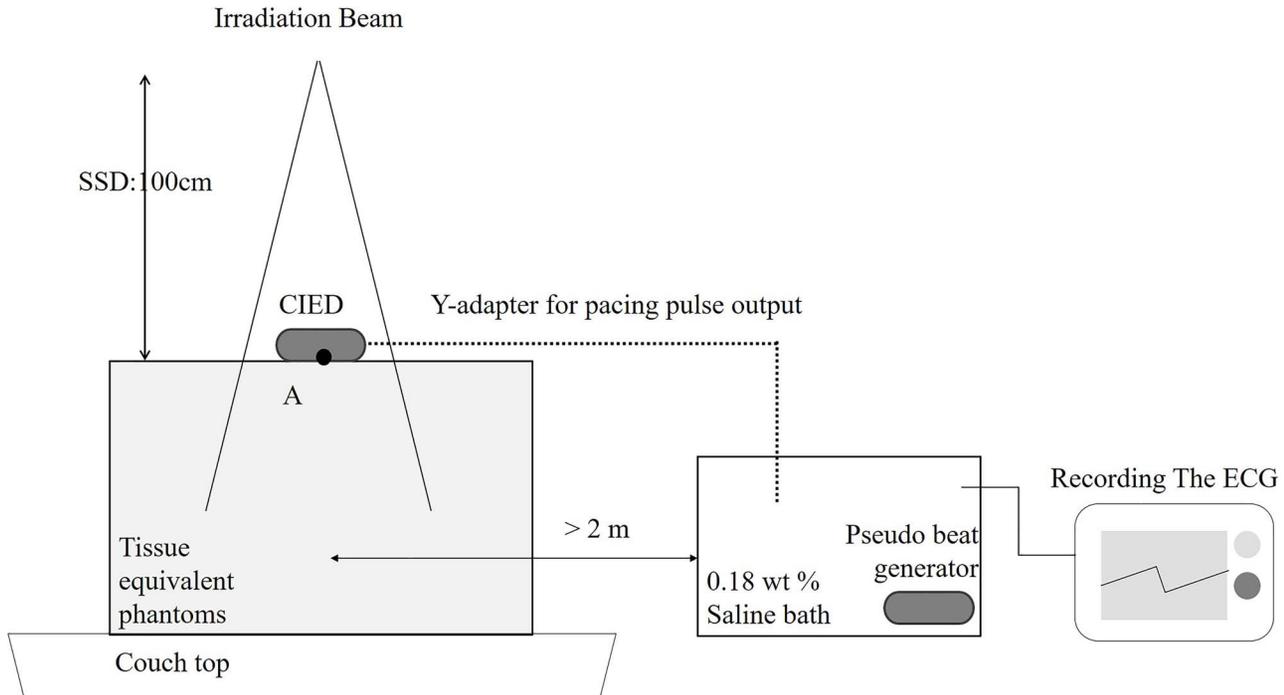
**Fig. 1.** Experimental scheme of a CIED. A, The center of the radiation field at the beam isocenter of a  $10 \times 10 \text{ cm}^2$  field at the surface of tissue equivalent phantoms with a source-to-surface distance of 100 cm. The pacing pulse output for the Y adapter was recorded by the electrocardiogram via electrodes installed in the water tank.
