Leaflet fracture and embolization from an On-X mechanical mitral valve

CENTRAL MESSAGE

We report the case of a 26-year-old male who presented with cardiogenic shock due to leaflet fracture and embolization from an On-X mitral valve prosthesis that had been implanted just 1 year earlier.

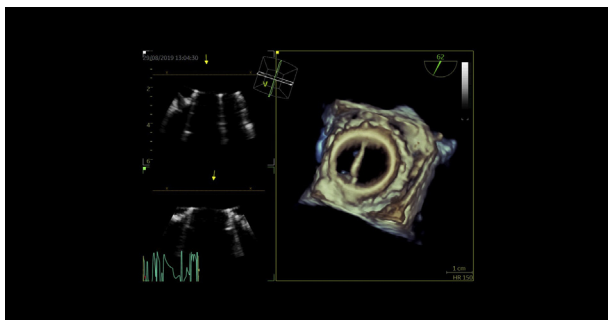
He was taken directly from the emergency room to the cardiac catheterization laboratory, where fluoroscopy revealed a single leaflet opening (Figure 1, A, and Video 1) and TTE confirmed the single moving leaflet and significant mitral regurgitation in the mitral valve prosthesis (Figure 1, B). Intravenous thrombolysis was administered on the suspicion of acute valve thrombosis, with no beneficial or adverse effects.

The next morning, the patient was still in cardiogenic shock and was stabilized with an intra-aortic balloon pump. Repeat TTE raised a suspicion that the nonvisualized leaflet was not in situ, which was later supported by transesophageal echocardiography (Figure 1, C, and Video 1). Plain X-ray of the abdomen could not visualize any escaped leaflet. Thus, he was taken directly to the operating room for emergency mitral valve surgery, which confirmed the

FIGURE 1. Fluoroscopy (A), transthoracic echocardiography (B), and transesophageal echocardiography with 3D reconstruction (C) of a patient in cardiogenic shock showing the mitral prosthesis with 1 missing leaflet and significant regurgitation. D, After emergency mitral valve replacement, the explanted prosthesis with 1 leaflet clearly missing. (Photo credit: Øystein Horgmo, University of Oslo.)

diagnosis of leaflet escape. The old prosthesis was explanted (Figure 1, D) and replaced with a new prosthesis of the same size and brand.
