Assessment of Sinkholes Investigations in Jangseong-Gun Area, South Korea, and Recommendations for Similar Studies

Abstract: This paper reviews the site investigation field data and access work performed between 2016 and 2019 in the study area located close to Gun-dong mine. The research was aimed at defining the cause of sinkholes and their relationship with the underlying karstic limestone bedrock and nearby mining activities. Only a limited number of small sinkholes appeared in 2014, 2016, and 2018 in the agricultural land close to the limestone mine. The previously open pit mine started its underground operations in 2007. Since then, the mine has developed, and is now comprised of, large underground excavations at several levels below the surface. The studies carried out concluded that the appearance of sinkholes may be related to a general lowering of the groundwater table because of nearby agricultural and mining activities and also due to over-extraction of water due to increased urban use. Whilst these are the best determinations, this paper identifies missing elements of the previous investigations mentioned above, some issues with the interpretation of poorly prepared bo

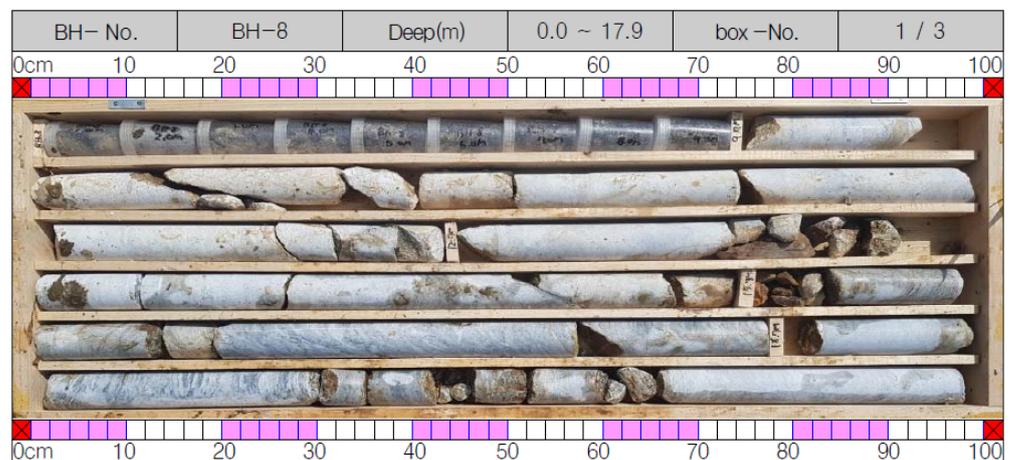
Figure 16. A core box from the present research.

The core box photographs show slightly different rock conditions than those described in the borehole logs. This is due to the way core boxes were prepared and pessimistically interpreted. The main factors leading to the pessimistic interpretation may be summarized as follows:

All borehole scans obtained using a BIPS camera showed the presence of apparent fractures, ranging from open, to partially or fully filled with clay and rock debris. However, no open cavities of any significant dimensions were detected. The rock cores from the boreholes in the study area, as detailed in Figure 16, confirm the above conclusion.

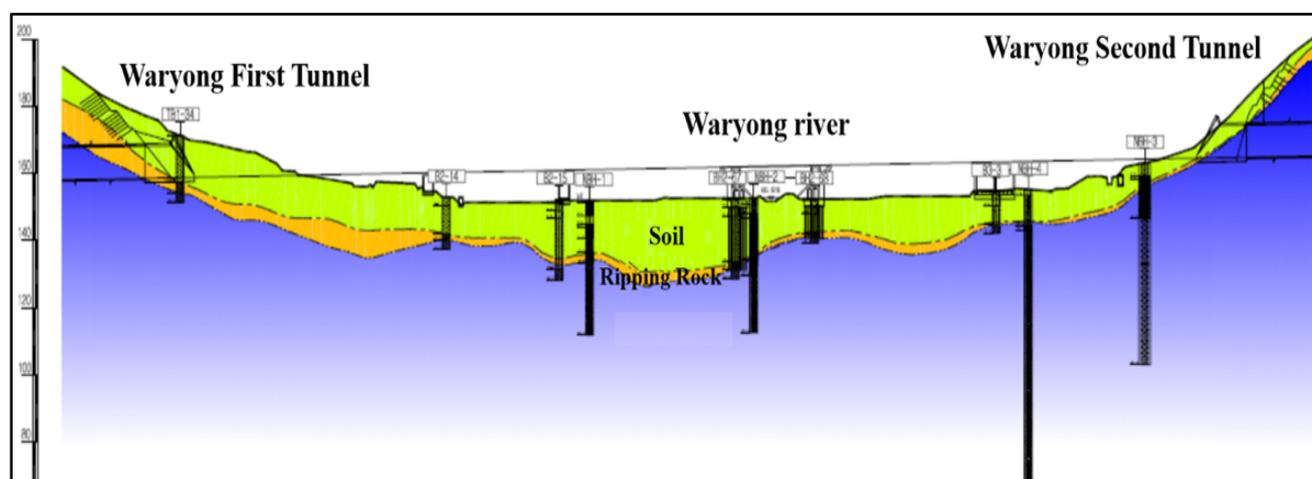
- By not adjusting the resistivity profiles for distortion in the electrode spacing and elevation, the railway embankment appears as a downward low-resistivity corridor (Figure 12b). This is not borne out by the borehole data and the longitudinal geological section along the railway embankment (Figure 19).

No significant cavities were recorded in the boreholes during the investigation of the high-speed railway by Korea Railroad Research Institute in 2016. Borehole logs prepared based on the recovered cores are comprehensive and provide a realistic picture of underground conditions along the railway embankment, as interpreted in the longitudinal section, and as given in Figure 19.

**Figure 19.** Longitudinal cross section along the railway embankment.

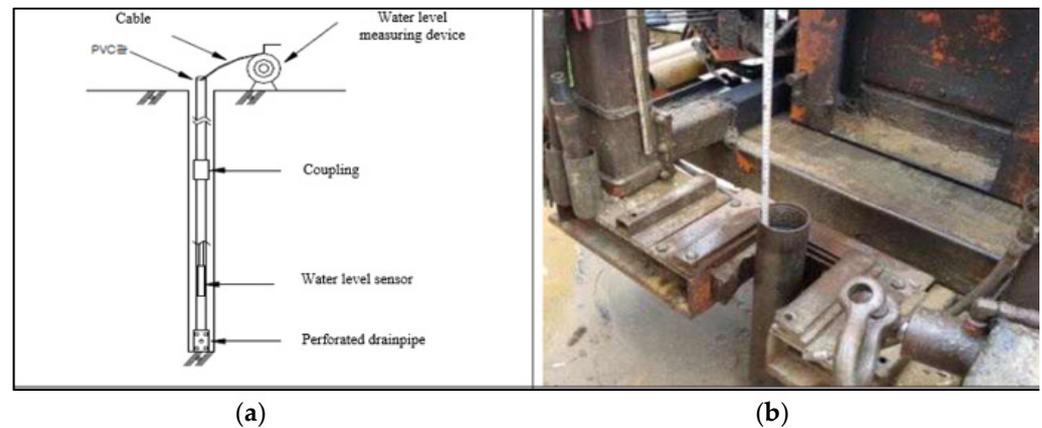
There are no historical groundwater monitoring data in the study area. During investigations, the depth from the borehole collar to groundwater levels was measured every 24 to 72 h in each borehole, after completion of the drilling operation. The equipment used is shown in Figure 25. Unfortunately, no piezometers were installed, which could have allowed monitoring of seasonal changes in local aquifer conditions over a long-term

period. It should also be noted that variations in piezometric pressures with depth in open boreholes cannot be determined without fit for purpose piezometers. As such, potentially very useful information relevant to the sinkhole formation was lost. There is only a minor cost for piezometer installation once a borehole is in place. As such, normally all accessible boreholes should be fitted with piezometers for long-term monitoring.

Figure 25. Measurement of groundwater level, (a) typical detail, (b) in the study area.

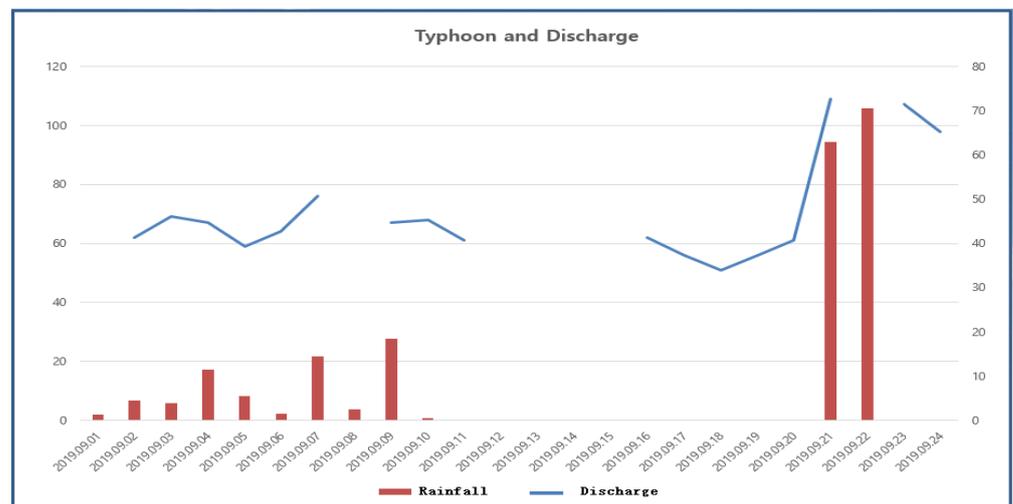
There was an exception during typhoons. Typhoon Lingling brought rain and strong winds to the Jangseong area between 31 August and 7 September 2019. Heavy downpours occurred during the latter part, after the strong winds had died down. On the other hand, Tapa was a typhoon that hit the area between 21 and 22 September 2019 with heavy concentrated rains (>130 mm in 2 days). During this period, no pumping was done, due to the weekend and Chuseok holidays. However, there was high discharge from the mine during the Tapa downpour in the short term. Figure 28 shows the relationship between precipitation and pumping data of the Typhoons Lingling and Tapa.

Figure 28. Increase in precipitation during typhoons.

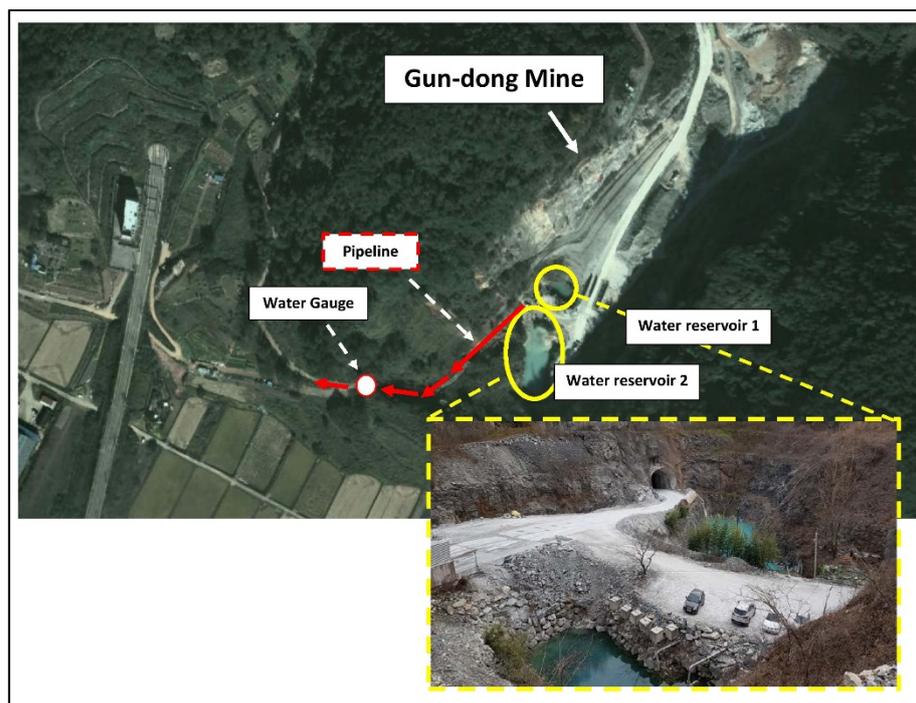
It should be noted that the surface drainage was diverted away from the mine by constructing a dyke to prevent inundation or flooding of the mine. This prevents excessive water ingress into the mine.

Figure 29 shows the water supply and drainage arrangements in Gun-dong mine. The metered pumping discharge and V-notch measurement show the approximate amount of water being used in the mine. The wastewater of the mine is stored in a small reservoir, as shown. Water which is used in the lower levels of the mine is also stored and pumped out to the higher levels and used in mining activities. Residual water from the mine is pumped back to the reservoir situated just outside the first level of the mine. The drainage and pumping pipes are 150 mm in diameter. Additionally, and in case of heavy rain a 100 HP motor pump is used to pump excess water to a nearby tributary of the river.

Figure 29. Drainage system of the Gun-dong mine.
