Case report

Metallosis and Corrosion Associated With Revision Total Knee Arthroplasties With Metaphyseal Sleeves

Joshua P. Rainey, MD, Jeremy M. Gililland, MD, Christopher L. Peters, MD, Michael J. Archibeck, MD, Lucas A. Anderson, MD, Christopher E. Pelt, MD *

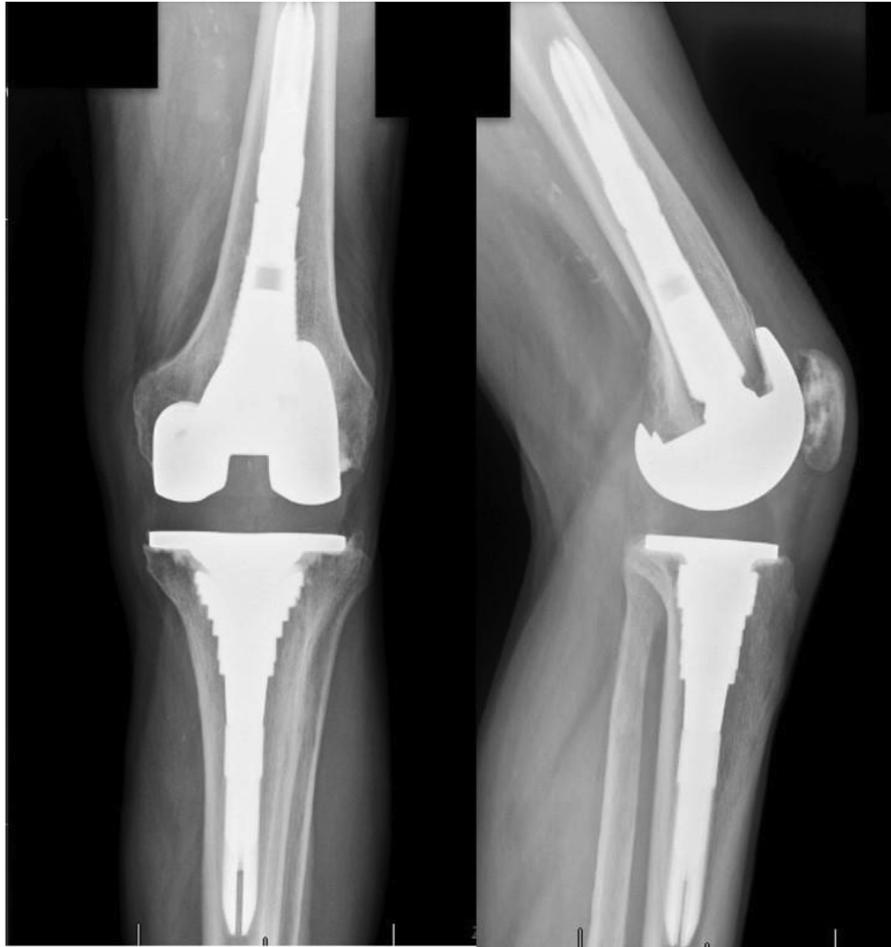
Figure 1. Left revision total knee arthroplasty with Sigma TC3 knee system.

An 87-year-old patient presented to our clinic as a referral for ongoing left knee pain following TKA. He underwent a primary left TKA in 2015 with unknown implants. He then underwent revision TKA several months later for tibial loosening with a Sigma TC3 knee system (DePuy, Warsaw, IN) (Fig. 1). Following his revision, he suffered from lateral-sided knee pain. Initial workup 4 years following his original revision TKA yielded a C-reactive protein (CRP) of 0.2 mg/dL and erythrocyte sedimentation rate (ESR) of 4 mm/h. Aspiration of his left knee resulted in 111 WBCs with 44% polymorphonuclear leukocytes (PMNs). Serum metal ions resulted in a Co level of 1.9 $\mu\text{g/L}$ and Cr of <1 $\mu\text{g/L}$. Given the concern for possible metallosis, the patient was asked to return in 6 months for repeat evaluation. At repeat evaluation, CRP was 0.1 mg/dL, and ESR was 4 mm/h. Serum metal ions were not processed at that time. However, synovial ions were notable for a Co level of 30 $\mu\text{g/L}$ and Cr level of 1.3 $\mu\text{g/L}$. A triple-phase bone scan was obtained and demonstrated increased mild-to-moderate uptake at the lateral aspect of the femoral implant (Fig. 2). The diagnosis of taper corrosion of the femoral side of his TKA was presumed, and he subsequently underwent a femoral revision. The femoral offset

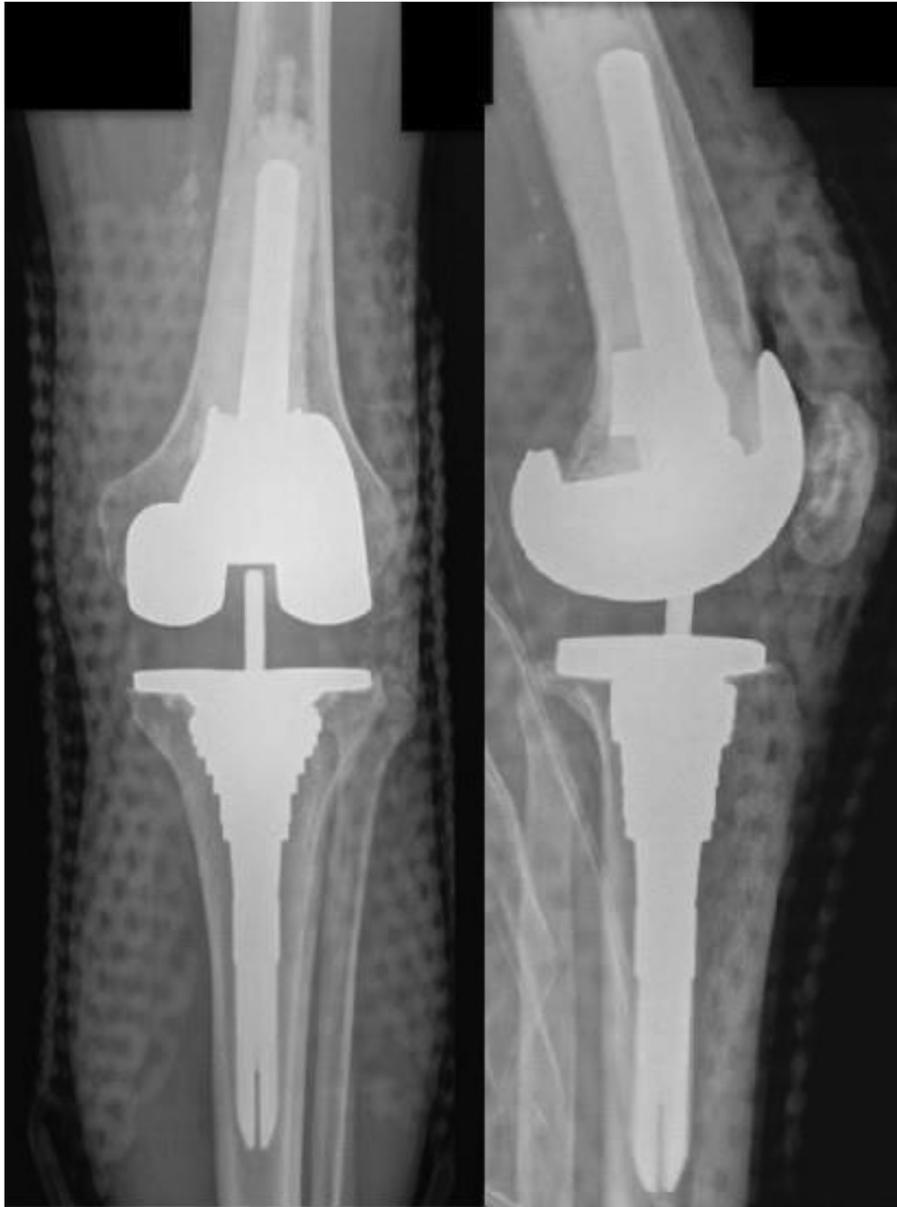
Figure 5. Postoperative films after femoral revision with a short, cemented stem and metaphyseal cone. Implants appear well-fixed without radiolucent lines.

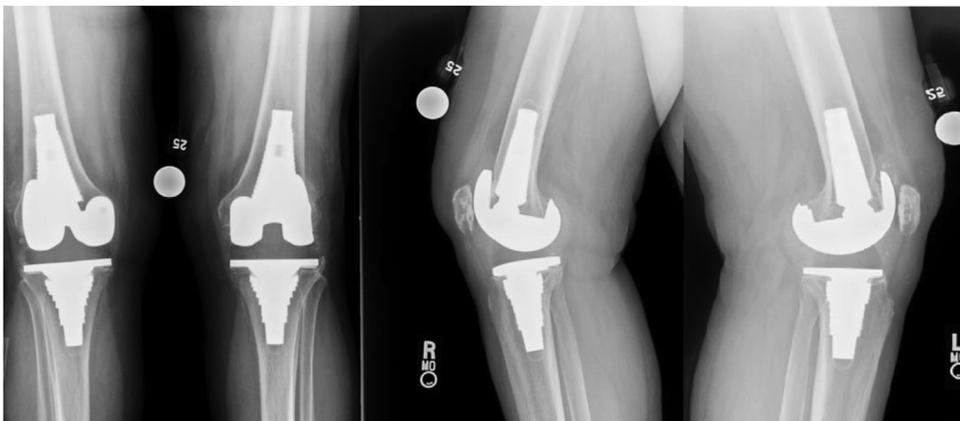
Figure 6. Bilateral revision total knee arthroplasties with Sigma TC3 knee systems.

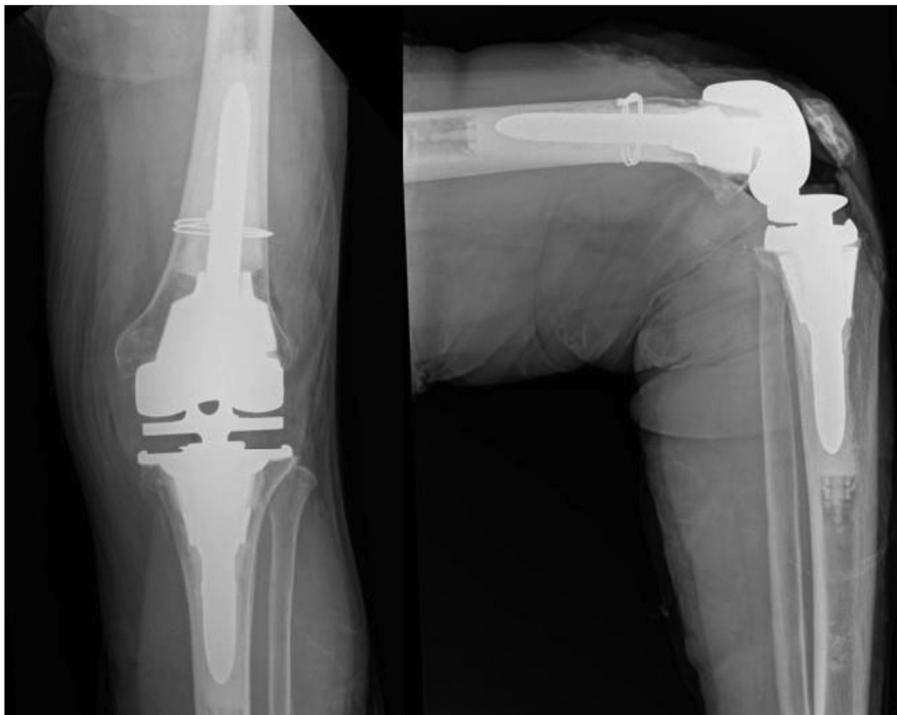
Figure 10. Postoperative films of the left total knee revision with short, cemented stems with impaction bone grafting and metaphyseal cone fixation with a hinged implant. Implants appear well-fixed without radiolucent lines.

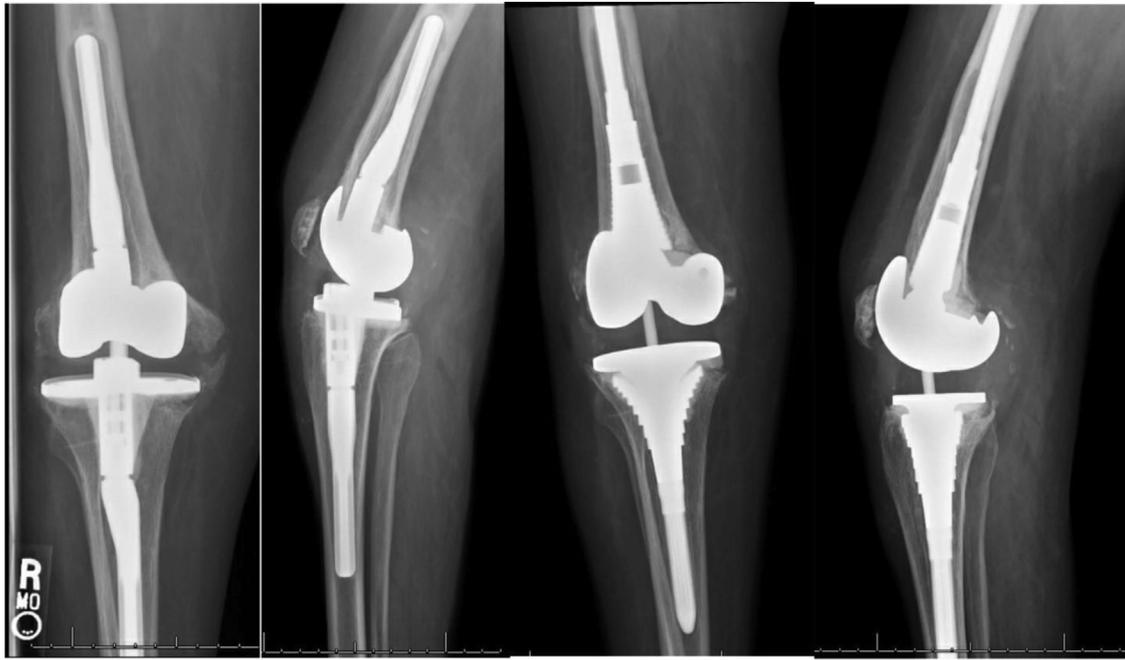
Figure 11. Preoperative and postoperative (1 year) images after revision to DePuy Sigma TC3 revision TKA with femoral and tibial metaphyseal sleeves. Revision was performed for aseptic loosening of a prior revision right TKA, as shown.

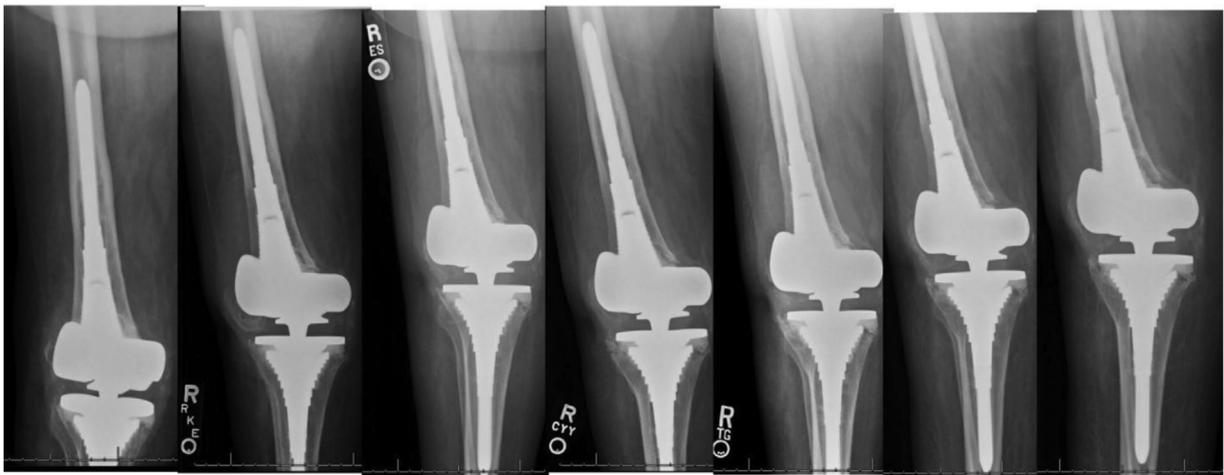
Figure 14. Serial anteroposterior radiographs at 6 weeks, 1 year, 2 years, 3 years, 4 years, 5 years, and 6 years demonstrating the well-fixed appearance of the femoral and tibial components.

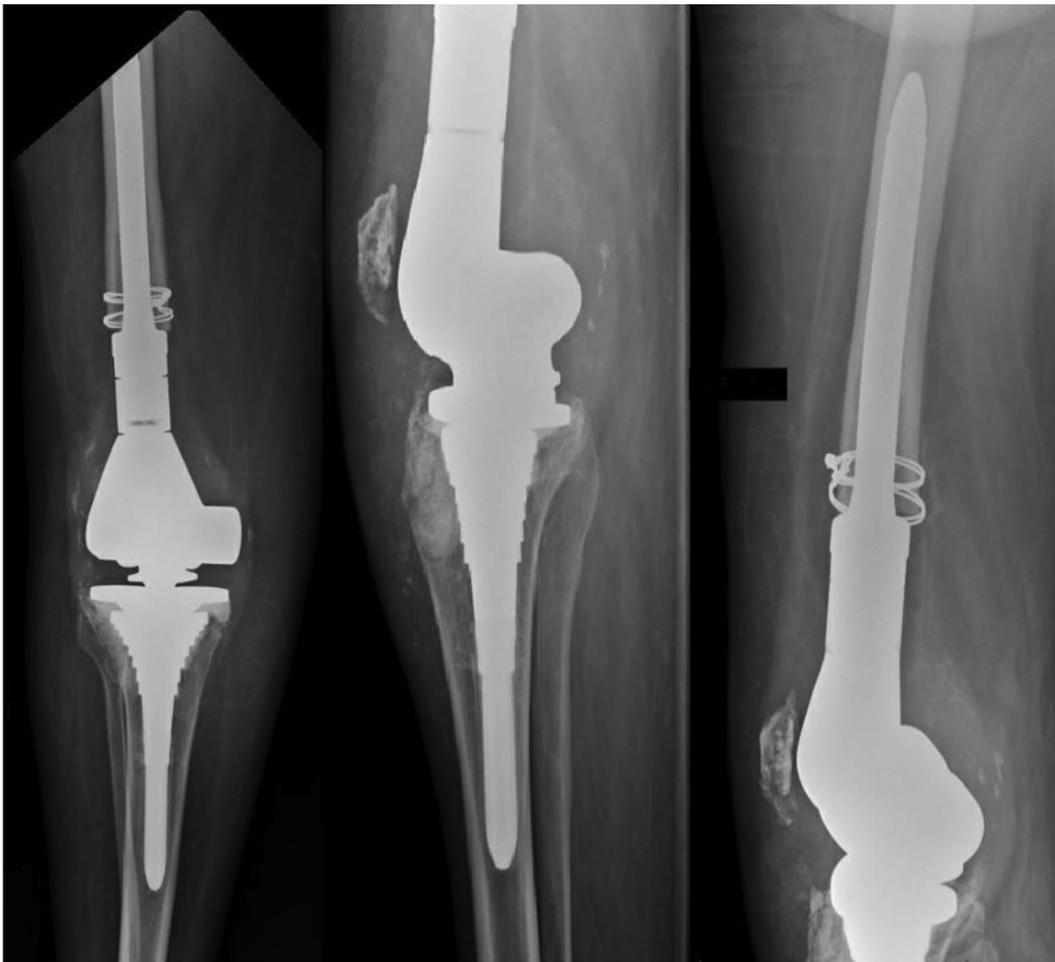
Figure 17. Postoperative films of the fully porous stem segmental distal femur replacement. Implants appear well fixed without radiolucent lines.

(DePuy, Warsaw, IN) (Fig. 17). The patient is doing well after his recent surgery and 5-month postoperative visit.

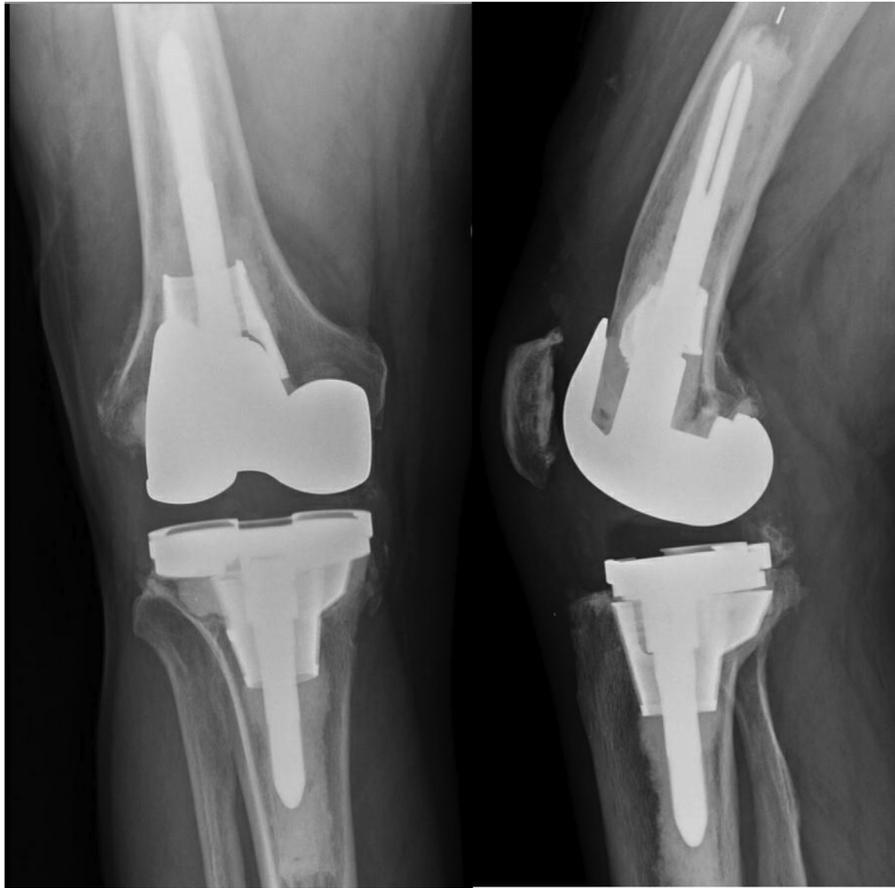
Figure 26. Postoperative anteroposterior and lateral radiographs of the most recent revision total knee arthroplasty using an oxidized zirconium femoral component along with fully cemented stems and metaphyseal cones.

component also demonstrated corrosion at the femoral trunnion and sleeve (Figs. 24 and 25). The femoral offset adapter and locking bolt were intact, without fracture or loosening. Three months later, he was taken for stage 2 reimplant. His prior medial tibial mass had completely resolved. Short, cemented stems and cones with an oxidized zirconium (Oxinium, Smith and Nephew, Memphis, TN) femoral component were used for his revision TKA (Fig. 26). He was doing well at his 15-month postoperative visit.
