## CASE REPORT

## A worn Björk–Shiley prosthetic valve without valve dysfunction observed during ascending aortic replacement

*Clinical Case Reports* 2014; 2(5): 180–182

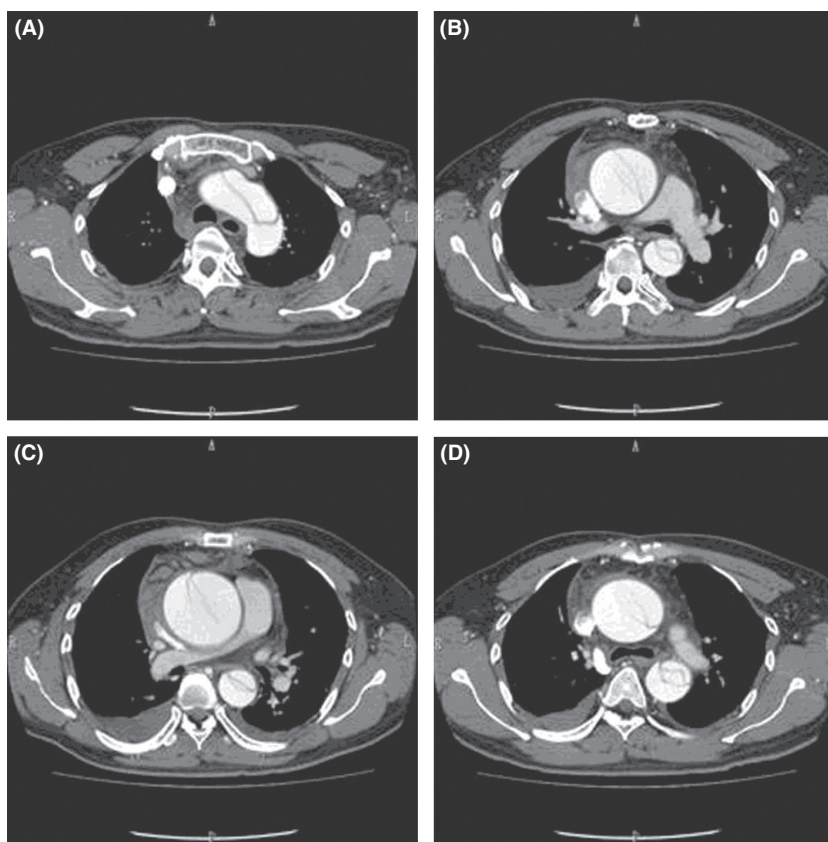
**Figure 1.** Preoperative Chest computed tomography. The ascending and descending aortae were dissected, including the aortic arch (A–D). The aortic root was dilated (D) and bilateral pleural effusion was present (B, C, and D).
