Localized Corrosion Occurrence in Low-Carbon Steel Pipe Caused by Microstructural Inhomogeneity

Abstract: In this study, the cause of failure of a low-carbon steel pipe meeting standard KS D 3562 (ASTM A135), in a district heating system was investigated. After 6 years of operation, the pipe failed prematurely due to pitting corrosion, which occurred both inside and outside of the pipe. Pitting corrosion occurred more prominently outside the pipe than inside, where water quality is controlled. The analysis indicated that the pipe failure occurred due to aluminum inclusions and the presence of a pearlite inhomogeneous phase fraction. Crevice corrosion occurred in the vicinity around the aluminum inclusions, causing localized corrosion. In the large pearlite fraction region, cementite in the pearlite acted as a cathode to promote dissolution of surrounding ferrite. Therefore, in the groundwater environment outside of the pipe, localized corrosion occurred due to crevice corrosion by aluminum inclusions, and localized corrosion was accelerated by the large fraction of pearlite around the aluminum inclusions, leading to pipe failure.

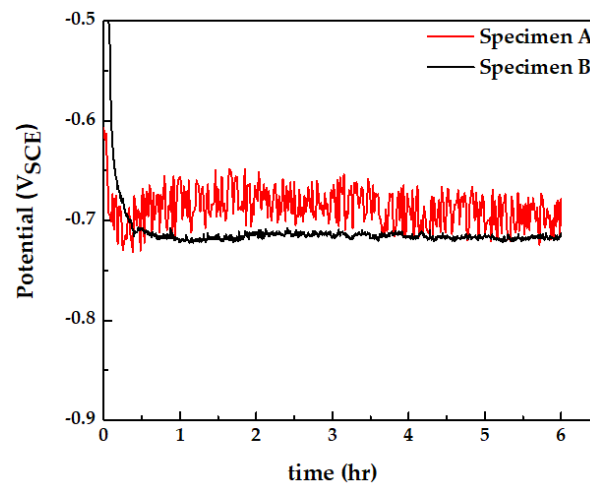
Figure 9 shows the open-circuit potential (OCP) of specimen A and specimen B in the groundwater solution. Specimen A had a higher E_{corr} than specimen B, and had a relatively large potential fluctuation of approximately 50 mV. Specimen A has a higher E_{corr} due to a larger fraction of pearlite, which has a relatively noble potential compared to ferrite. Pearlite has a higher E_{corr} than ferrite due to an increase in cathodic sites that cause oxygen reduction ($\text{O}_2 + 2\text{H}_2\text{O} + 4\text{e} = 4\text{OH}^-$) [31,32]. In addition, due to the higher corrosion activity caused by larger fraction of pearlite and presence of Al inclusions, OCP fluctuation is shown on specimen A [33,34].

Figure 9. Open-circuit potential of specimen A (pitting corrosion region) and specimen B (uniform corrosion region) with immersion time in the groundwater at 60 °C.

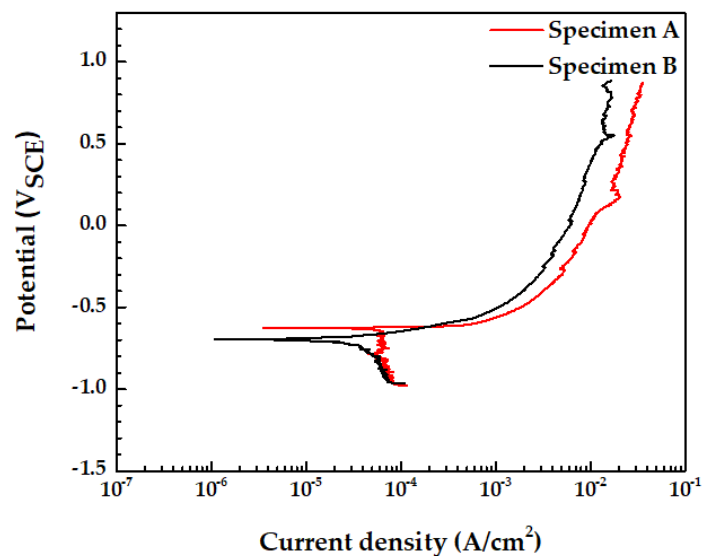
Figure 10 and Table 6 show the results of the potentiodynamic polarization test of specimen A and specimen B in the groundwater solution. The corrosion current density was controlled by the oxygen reduction reaction [31]. The corrosion current density was analyzed using the Tafel extrapolation method. Once the corrosion current density was determined, the corrosion rate can be calculated using the following equation [11]:

E_{corr} (mV _{SCE})	i_{corr} (A/cm ²)	Corrosion Rate (mm/yr)
Specimen A	−621.04	6.47×10^{-5}	0.75
Specimen B	−704.63	3.33×10^{-5}	0.39

Figure 10. Potentiodynamic polarization curves of specimen A (pitting corrosion region) and specimen B (uniform corrosion region) in the groundwater at 60 °C.

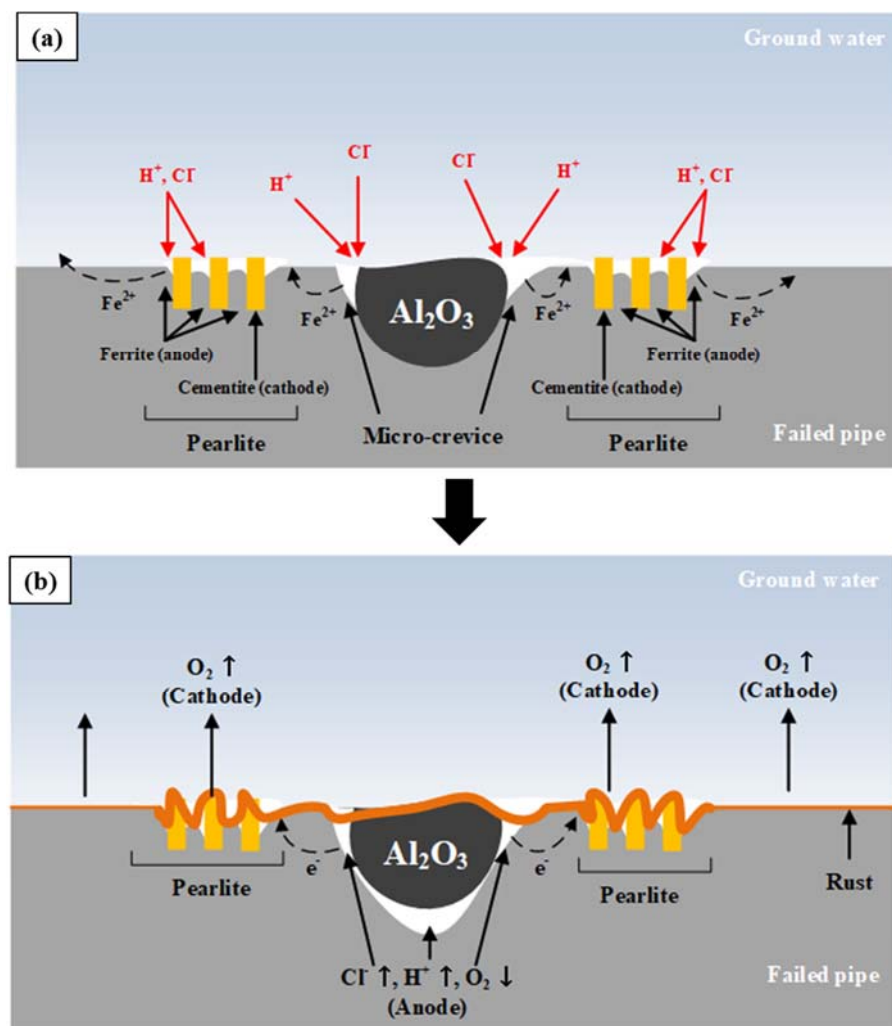
Figure 12 shows the failure mechanism of the failed low-carbon steel pipe due to the Al inclusions and a large amount of pearlite formed locally during the steelmaking process. Due to the coefficient of thermal expansion differences between Al and Fe, microcrevices form around Al inclusions during the pipe manufacturing process. As crevice corrosion is initiated, pH drops and Cl^- ions are concentrated in the microcrevice to maintain charge neutrality [19]. The concentration of Cl^- ions further accelerates crevice corrosion and corrosion products accumulate on this part of the pipe. Additionally, oxygen-concentration cells form, which accelerate localized corrosion, and eventually the Al inclusions fall off [19,29].

The large fraction of pearlite has a higher corrosion rate due to microgalvanic corrosion between the surrounding pro-eutectoid ferrite and pearlite, and between cementite and ferrite in pearlite [19,24]. Due to the relatively accelerated corrosion rate of the large fraction of pearlite near the Al inclusions, the concentration of Cl^- ions into Al vicinity and the accumulation of corrosion products are accelerated. This promotes the formation of an oxygen-concentration cell in the vicinity of the Al inclusion.

However, the presence of a large fraction of pearlite alone cannot cause localized corrosion such as pitting. The cementite inside the pearlite locally accelerates the surrounding ferrite corrosion by microgalvanic corrosion, but over time, the rust is covered by the dissolution of ferrite, and the corrosion proceeds in the form of a uniform corrosion [19]. In other words, a large fraction of pearlite accelerates corrosion locally, but cannot lead to pitting corrosion. That is, the large fraction of pearlite accelerates crevice corrosion via Al inclusions and promotes the formation of oxygen-concentration cell, thereby accelerating localized corrosion in the vicinity of the Al inclusions.

Figure 12. Failure mechanism of the failed low-carbon steel pipe based on aluminum inclusion and the larger phase fraction of the pearlite: (a) initial stage, and (b) later stage.
