Case report

Nontraumatic Tibial Polyethylene Insert Cone Fracture in Rotating-Platform Total Knee Arthroplasty

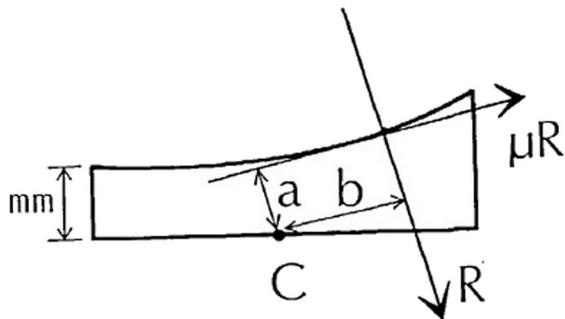
**Figure S1.**

$$M = Rb + \mu Ra$$

Appendix 1: Calculation of the rocking moment (M) which is the sum of the moments around the centre (C). The forces acting at the surface of the polyethylene liner are R and μR . a and b are the distances of the vector to the centre of the tibial component.
