Case report

Nontraumatic tibial polyethylene insert cone fracture in mobile-bearing posterior-stabilized total knee arthroplasty

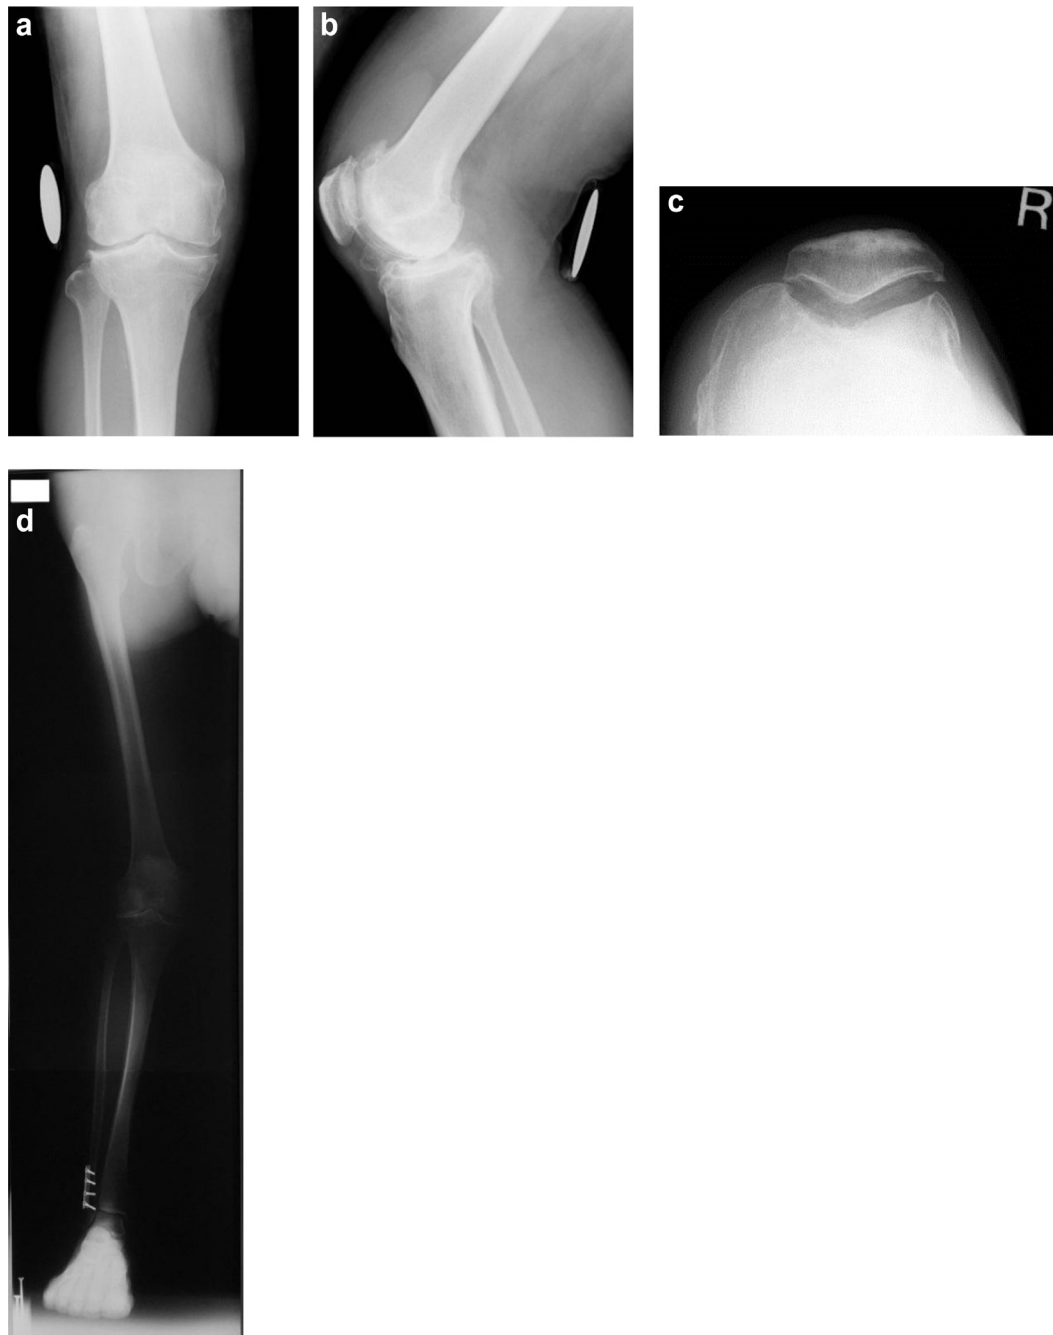
Figure 1. Preoperative radiographs. (a) Anteroposterior, (b) lateral, (c) Merchant, and (d) full-length.

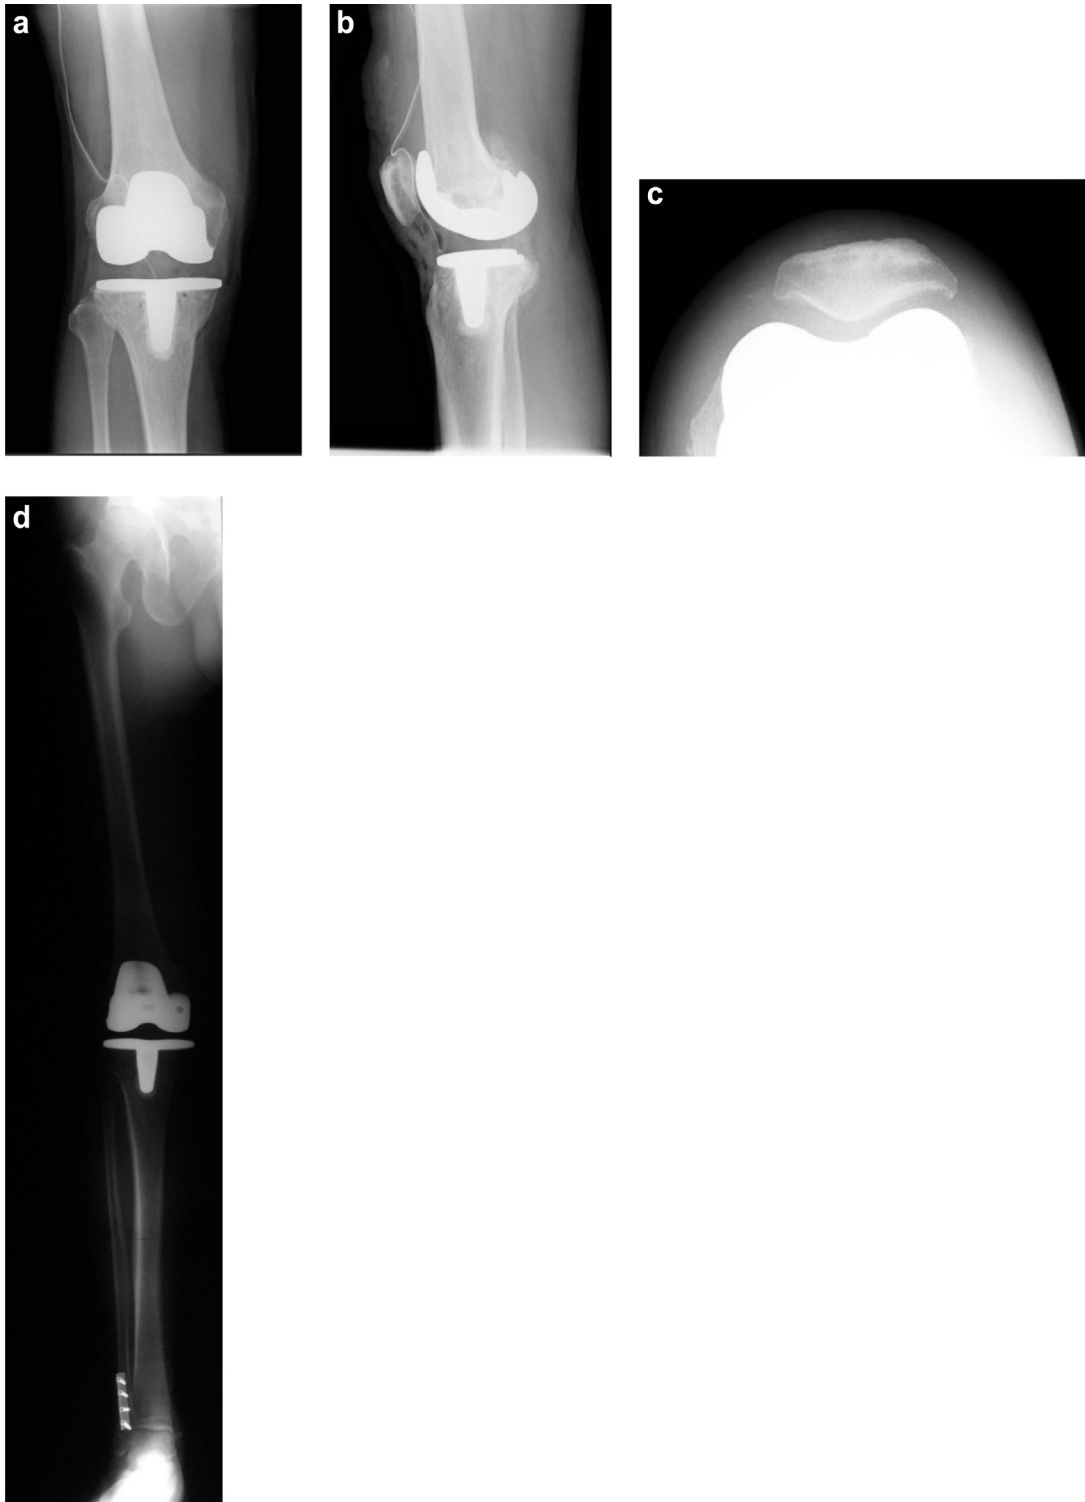
Figure 2. Postoperative radiographs. Only axial view was photographed after an operation for one week. (a) Anteroposterior, (b) lateral, (c) Merchant, and (d) full-length.
