# Coronary balloon catheter tip damage. A bench study of a clinical problem

## Abstract

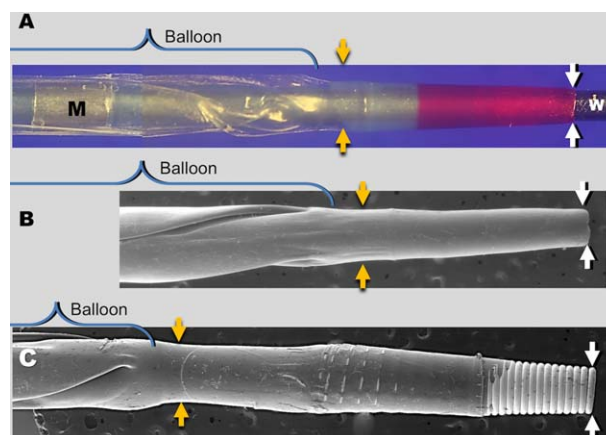
The structure of the distal end of a percutaneous coronary interventional balloon is shown in Figure 2. The balloon shaft that houses the interventional wire tapers toward the distal tip which is the lesion entry point. The balloon is attached to the shaft at the proximal end of the tapered tip (Figure 2).

**FIGURE 2** Balloon tip design. The upper panel is a photograph and the lower panels are scanning electron microscopic images of the distal ends of PCI balloons. White arrows indicate the distal tip (entry profile), and the yellow arrows the zone of balloon attachment to the shaft.  $W = 0.014''$  wire,  $M$  = distal balloon radio-opaque marker. The Flexx2 tip design of the Galant balloon (Medinol, Israel) (Panel C) is very different from other designs as it has metal coils reinforcing the tip

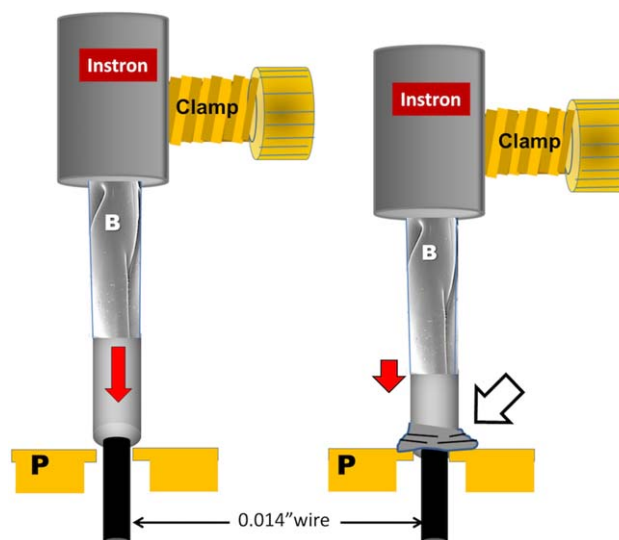
The apparatus used to measure the force required to shorten balloon tips by 0.5 mm is depicted in Figure 3 and described in the legend. Balloon tips of 3 examples of 2.5 mm nominal diameter balloons from

**FIGURE 3** Apparatus for measuring the force required to shorten a balloon tip by 0.5 mm. A hole fractionally larger than a standard 0.014'' percutaneous interventional wire ( $w$ ) was drilled in a base plate ( $P$ ). A balloon catheter ( $B$ ), advanced over the wire was fixed using the screw clamp so that there was no movement of balloon relative to the wire. The catheter tip rested on the plate ( $P$ ). The clamp was attached to an instron universal testing machine and the force required to shorten the balloon tip by 0.5 mm measured. Flaring of the balloon tip is indicated by the open arrow

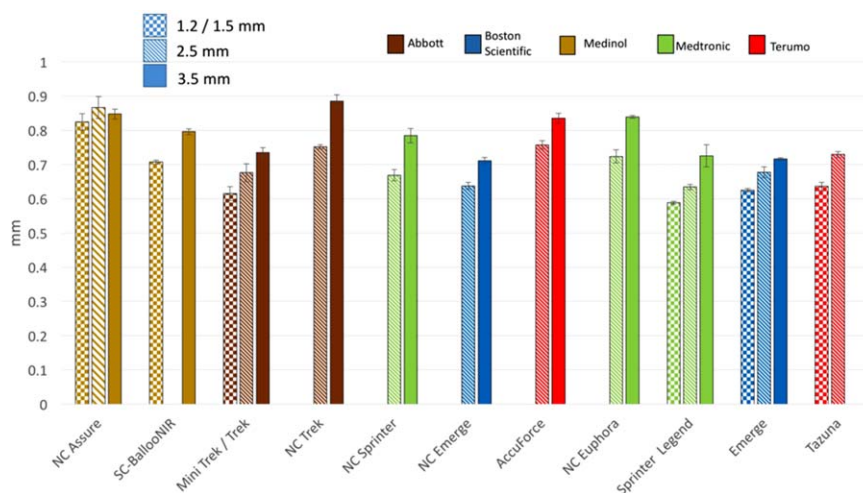
No difference in distal balloon catheter tip width (entry profile) was found between the 1.2, 1.5, 2.5 and 3.5 mm nominal diameter balloons of the same design (Figure 6). A balloon with a nominal diameter of 3.5 mm has the same tip width (entry profile) as that of a 1.2/1.5 or 2.5 mm nominal balloon diameter of the same design. The balloon tips of different designs had different diameters.

**FIGURE 6** Balloon tip widths (entry profiles) for 1.2/1.5, 2.5, and 3.5 mm balloons. Diameters of balloon tips of different nominal balloon diameters of the same design are the same. For instance, Sprinter Legend of nominal balloon diameters 1.5, 2.5, and 3.5 mm all had the same tip width. Balloons of different designs may have different tip widths. For instance, the Trek and Sprinter balloon tips were wider than the Emerge balloon tips. The Medinol Flexx 2 had the largest catheter tip entry profile

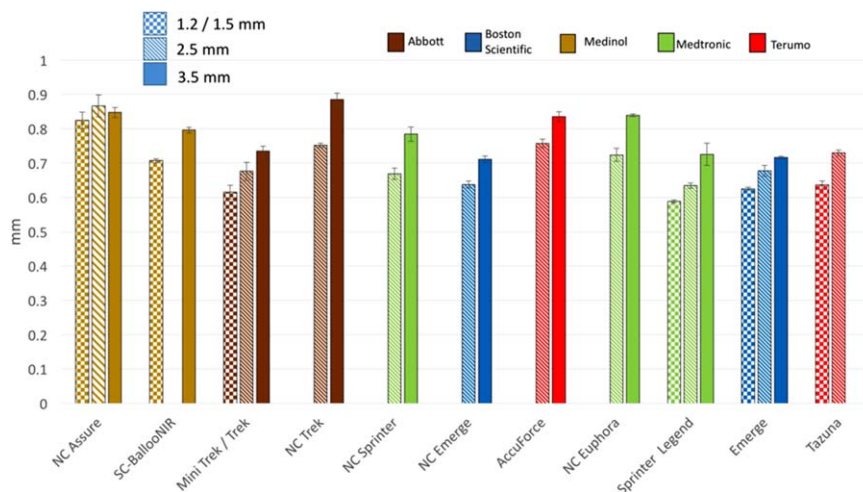
For each balloon design, the width at the level of balloon material attachment (Figure 2) is greater for non-compliant balloons than semi-compliant balloons and increases with increasing nominal balloon diameter (Figure 7).

**FIGURE 7** Balloon tip width at the level of attachment of balloon material for different balloon designs. For each balloon design, the width at the level of balloon material attachment (Figure 2) increases with increasing nominal balloon diameter (Figure 7). For the Sprinter and Trek designs, but not the Emerge designs, the non-compliant balloons have a wider diameter at the level of balloon attachment than the semi-compliant designs presumably because of the thicker non-compliant balloon material
