## A new type of silica-induced “moundless” pitting corrosion in copper observed in Japan

Masahiro Sakai

College of Design and Manufacturing Technology, Muroran Institute of Technology, 27-1 Mizumoto, Muroran, Hokkaido, Japan

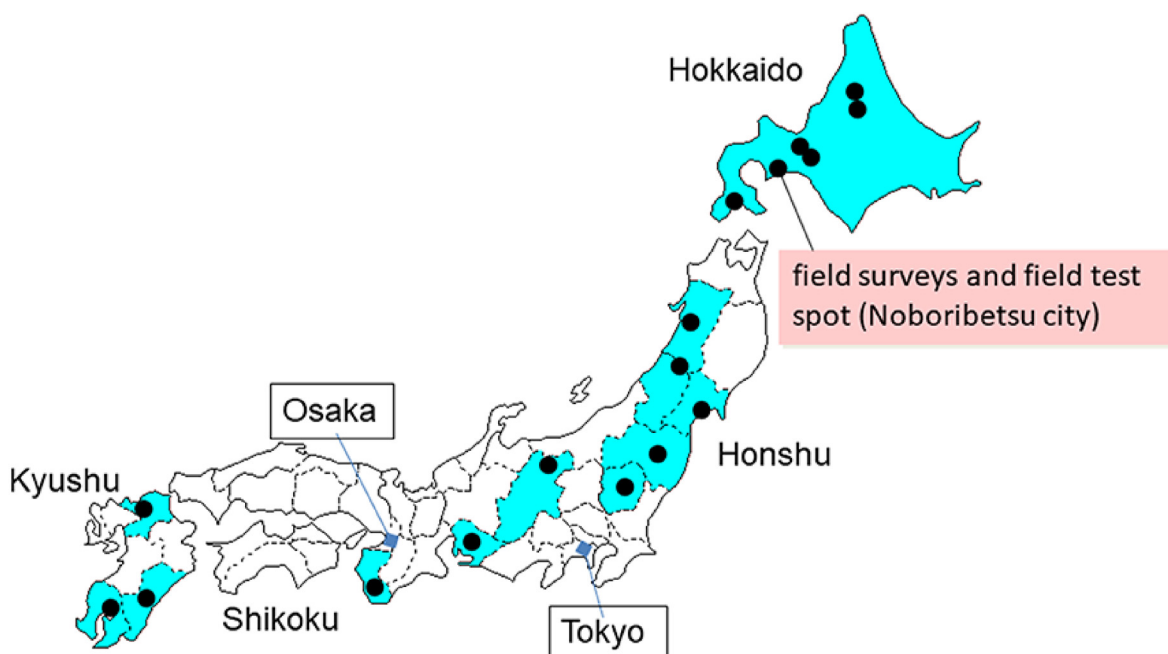
**Figure 1.** Locations of water leakage accidents caused by the moundless pitting corrosion of copper tubes in Japan.

Figure 1 shows the locations of water leakage accidents caused by the moundless pit corrosion of copper tubes in Japan. Noboribetsu City in the

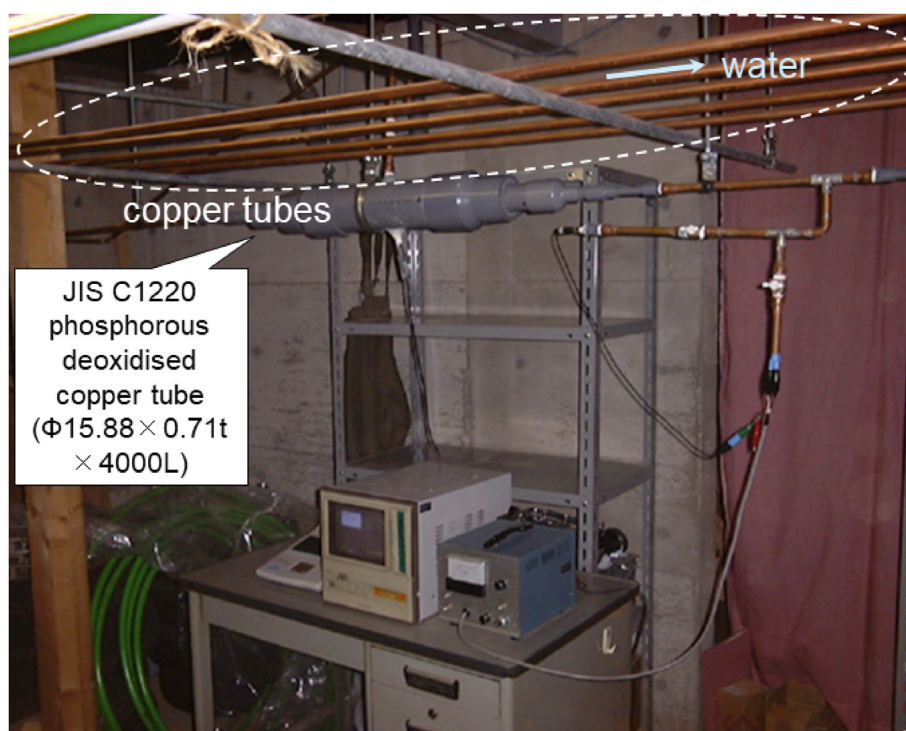
**Figure 2.** Appearance of field test system installed in the basement of a local plumbing contractor. Five copper tubes measuring 4000 mm in length were connected with brazing joints, and the water inside the tubes was replaced once per week.

Figure 2 shows a field test centre installed in the basement of a local plumbing contractor. Five copper tubes composed of JIS H3300 C1220 phosphorus-deoxidised copper and measuring 15.88 mm in diameter, 0.71 mm in thickness, and 4000 mm in length, were used. These five copper tubes were connected in series using brazing joints and installed parallel to the ground. Tap water was introduced into tubes at full water level and was allowed to remain stagnant, being replaced once per week by opening a hand-valve. All tubes were removed from the installation four years later and cut axially with a band saw to separate into the top (ceiling) and bottom (ground) sections. The insides of these tube

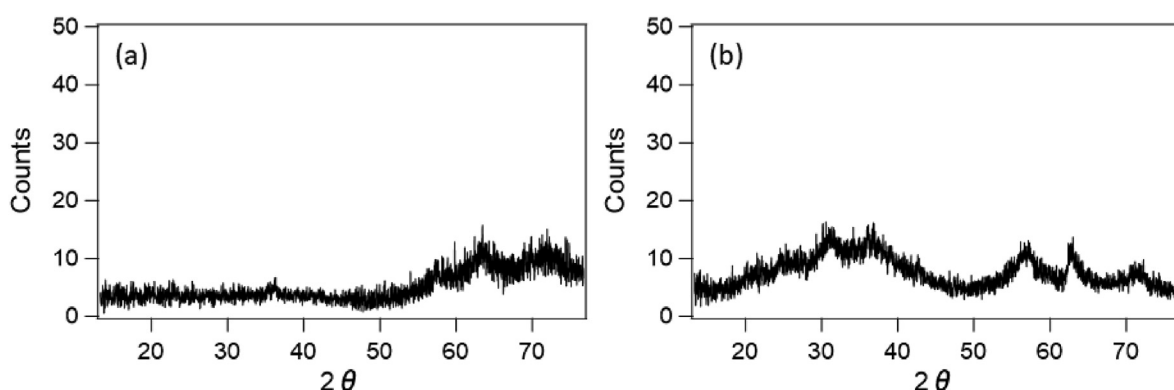
**Figure 5.** XRD patterns of the verdigris collected from around the moundless pit mouth of houses a and b.

Figure 5 shows XRD pattern of the verdigris around the pit mouth, wherein the broad pattern and lack of any specific peaks indicates that this verdigris is amorphous. In addition, Figure 6 shows the FT-IR pattern of the verdigris along with that of the amorphous copper-containing silicate mineral chrysocolla ( $\text{Cu}_2\text{H}_2\text{Si}_2\text{O}_5(\text{OH})_4 \cdot n\text{H}_2\text{O}$ ). Upon

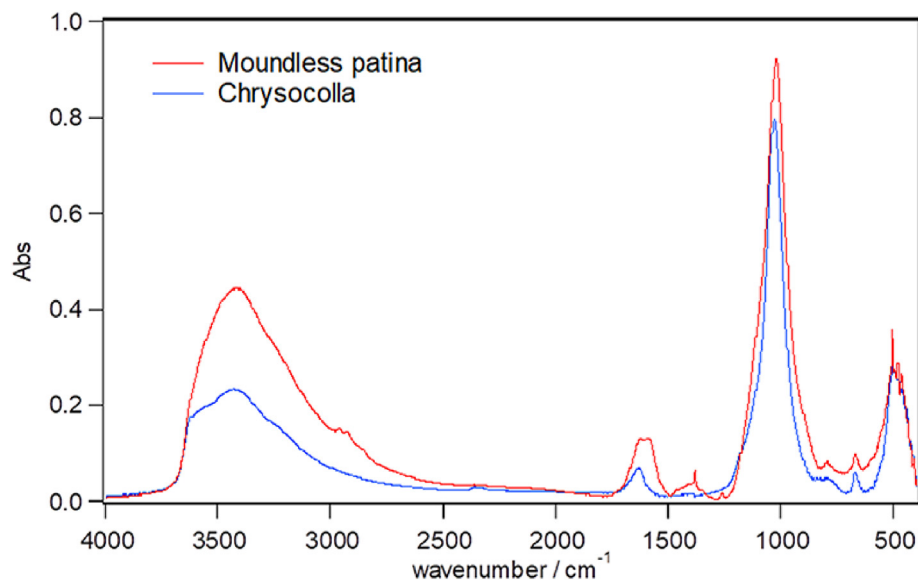
Figure 6. FT-IR spectrum of the verdigris around the moundless pit mouth. The corresponding spectrum of chrysocolla is also provided for comparison.

comparison, it appears that the verdigris of around the pit mouth is composed of chrysocolla.

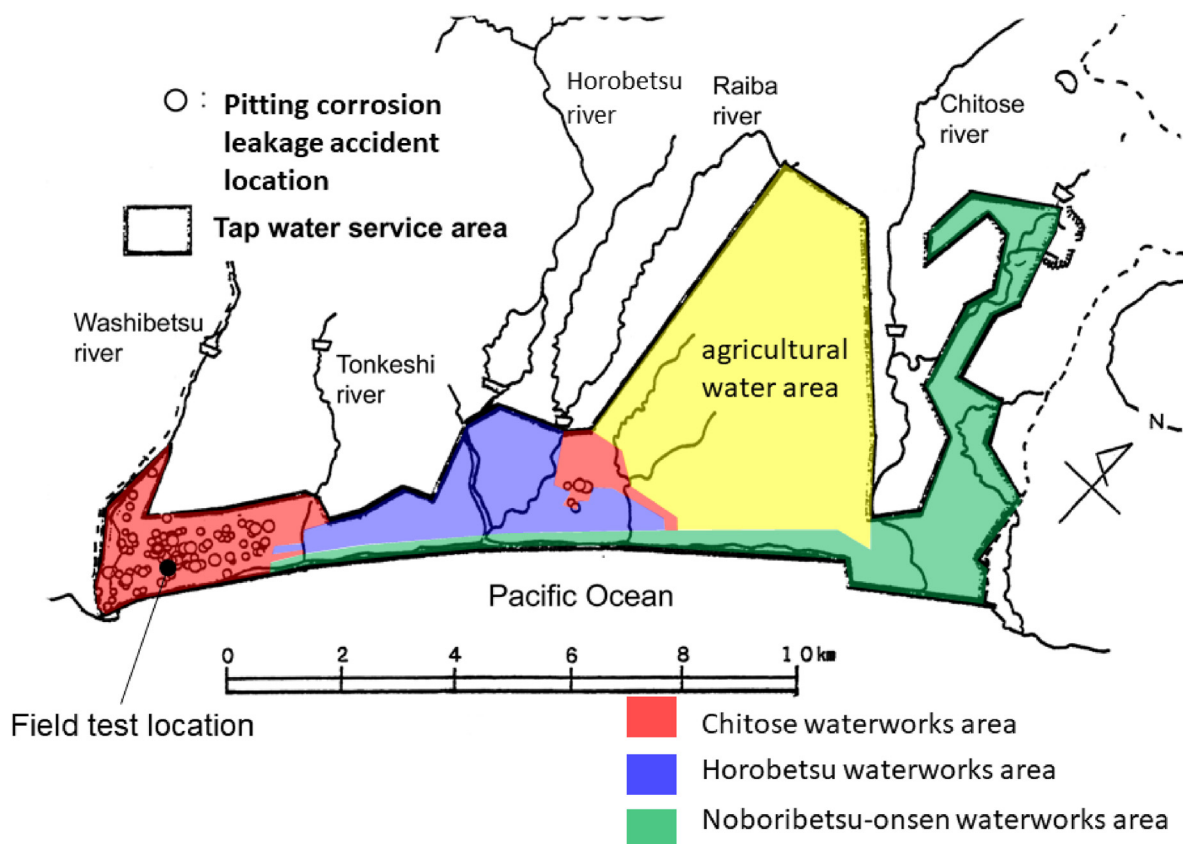
Figure 7. Map of the tap water service area and the locations of water leakage accidents caused by moundless pitting corrosion in Noboribetsu City. The tap water in Noboribetsu City is distributed from three water treatment plants, namely the Chitose, Horobetsu and Noboribetsu onsen plants.

Figure 7 shows an outline of the tap water service area in Noboribetsu City along with the locations of the water leakage accidents caused by moundless pitting corrosion. At the time of this investigation, the tap water provided to Noboribetsu City was distributed from three waterworks, namely Chitose, Horobetsu, and Noboribetsu-onsen. As can be

seen from the figure, the main concentration of leakage accidents correlated with the Chitose waterworks area, with no such accidents being reported in the Horobetsu and Noboribetsu-onsen waterworks area. These results therefore suggest that the water quality is a key factor

in terms of the initiation and propagation of moundless pitting corrosion in Noboribetsu City.

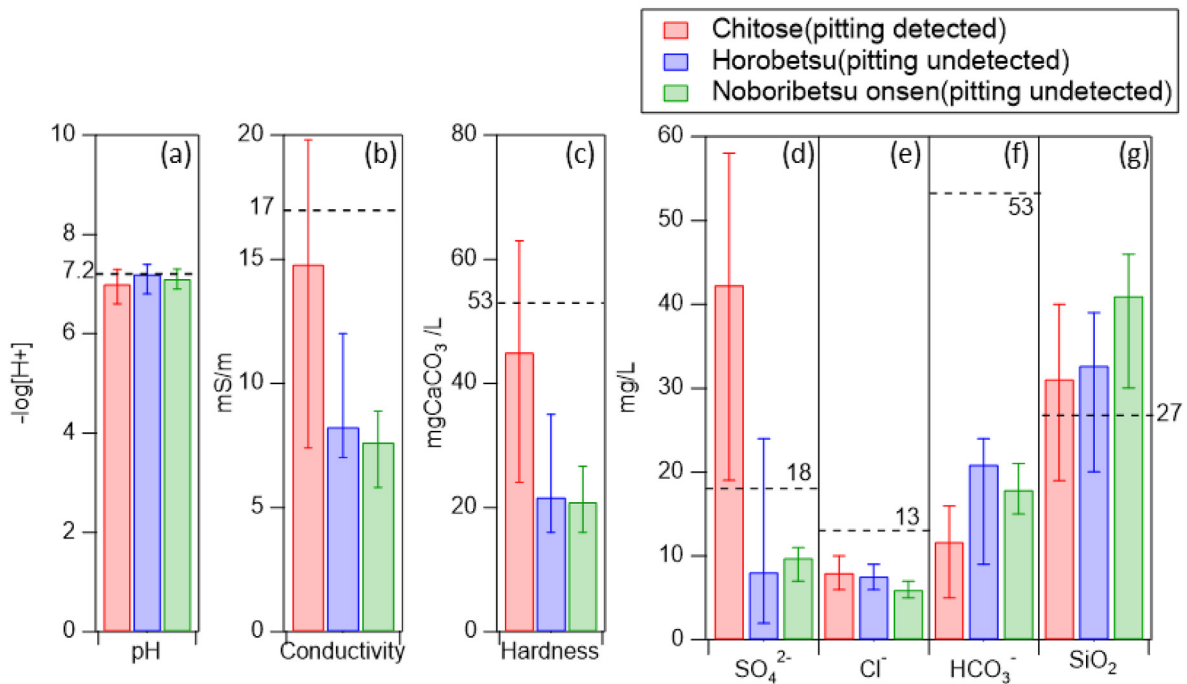
**Figure 8.** Water quality factors of the three water systems in the Noboribetsu area of the Hokkaido Prefecture (horizontal broken lines refer to the average levels for Japanese tap water). (a) pH, (b) electric conductivity, (c) hardness, (d) sulfate ion concentration, (e) chloride ion concentration, (f) bicarbonate ion concentration, (g) silica content.

Figure 8 shows a comparison of the water qualities among the three water supply systems in Noboribetsu City, wherein the average level of

each factor is also indicated, as determined from the database for Japanese tap water [20]. As indicated by the data presented in Figure 8, a silica level of 30–40 ppm was observed for all three water systems, which is higher than the average Japanese level (27 ppm). However, the silica level in the Chitose water system was 10 ppm lower than that in the Noboribetsu-onsen water system, where no moundless pitting accidents

were reported. Thus, although a high silica level might be one of the factors correlated with moundless pitting, it is certainly not a decisive factor for its initiation. It is also noteworthy that the bicarbonate ion concentration is lower than the Japanese average level of 53 ppm for all the three Noboribetsu water systems. It has been claimed that bicarbonate possesses a pH buffering effect, and could therefore decelerate pitting propagation by minimising the pH shift of the water retained in the pit [8, 16]. Thus, pitting propagation might proceed more rapidly in water with a comparatively low bicarbonate level. A high concentration of chloride ions is also believed to be detrimental in terms of the copper pipe stability to pitting. However, in all cases, the chloride ion levels were <10 ppm, which is lower than the Japanese average of 13 ppm. Indeed, the differences in levels of silica, bicarbonate ions, and chloride ions among the three Noboribetsu water systems were not significant, and so it was considered that the sulfate ion may be a key factor in determining the degree to which moundless corrosion took place the various water systems examined herein. Indeed, the Chitose water sample was found to contain a high sulfate ion concentration of 42 ppm, which is five times higher than those of the Horobetsu and the Noboribetsu-onsen water systems, and twice as high as the Japanese average. High sulfate ion in water promotes the pit propagation rate [21]. It can also be seen from Figure 8 that the electrical conductivity and hardness of the Chitose water were approximately twice as high as those of the Horobetsu and Noboribetsu-onsen water samples. It was therefore considered that moundless pitting in Noboribetsu City was promoted by a comparatively high silica concentration (>30 ppm), a relatively high sulfate ion concentration (>40 ppm), and a low bicarbonate ion concentration (<10 ppm).

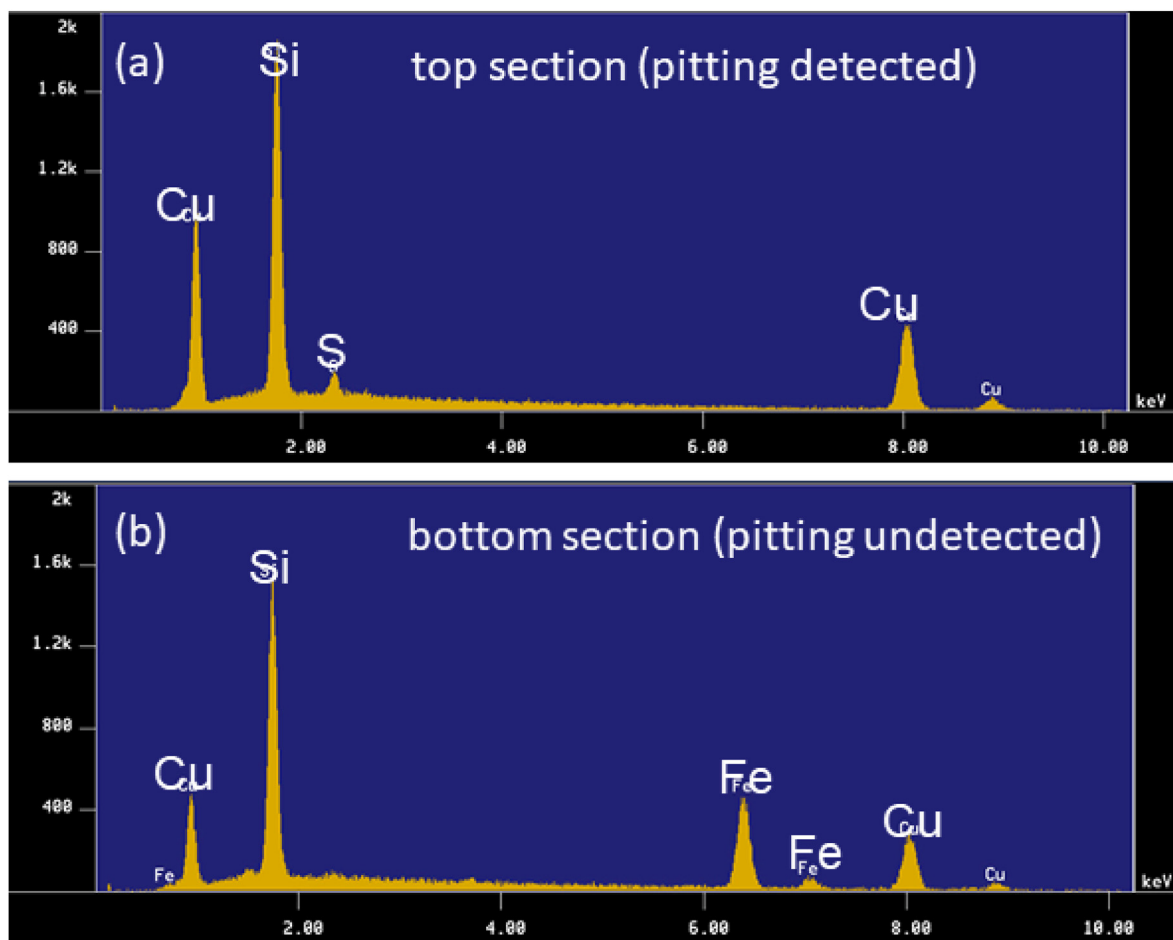
**Figure 11.** EDS spectra of the tube specimens shown in Figure 9, i.e., (a) the top (ceiling) section where pit formation was observed, and (b) the bottom (floor) section of the pit where the greenish white scale was observed.

We then performed EDS on both the tube sample containing moundless pits (i.e., the top component of the tube shown in Figure 9(a)) and the tube sample bearing a greenish white scale (i.e., the bottom component of the tube shown in Figure 9(a)). As presented in Figure 11, for the top (ceiling) region of the copper tube, Cu, Si, and S were detected by EDS analysis, whereas Fe, Cu, and Si were detected in the bottom (floor) region. The detected Fe represents the corrosion product of iron arising from the ductile cast iron pipe used in the tap water transportation line from the waterworks to each houses. This result indicates

that the greenish white scale formed by the reaction of Fe and Si in the water, and its subsequent deposition on the inner bottom surface of the copper tube. This scale of compound made from Fe and Si protected the copper surface, and so no moundless pits were formed on the bottom surface. Figure 12 shows typical EPMA maps for the elemental distribution profiles of the scale surrounding the moundless pit during the field test. More specifically, the condensation of Si was confirmed, and so we speculated that the scale film was formed from a silica component present in water. We suspected that the formation of this silica film was one of the key factors in initiating formation of the moundless pit.

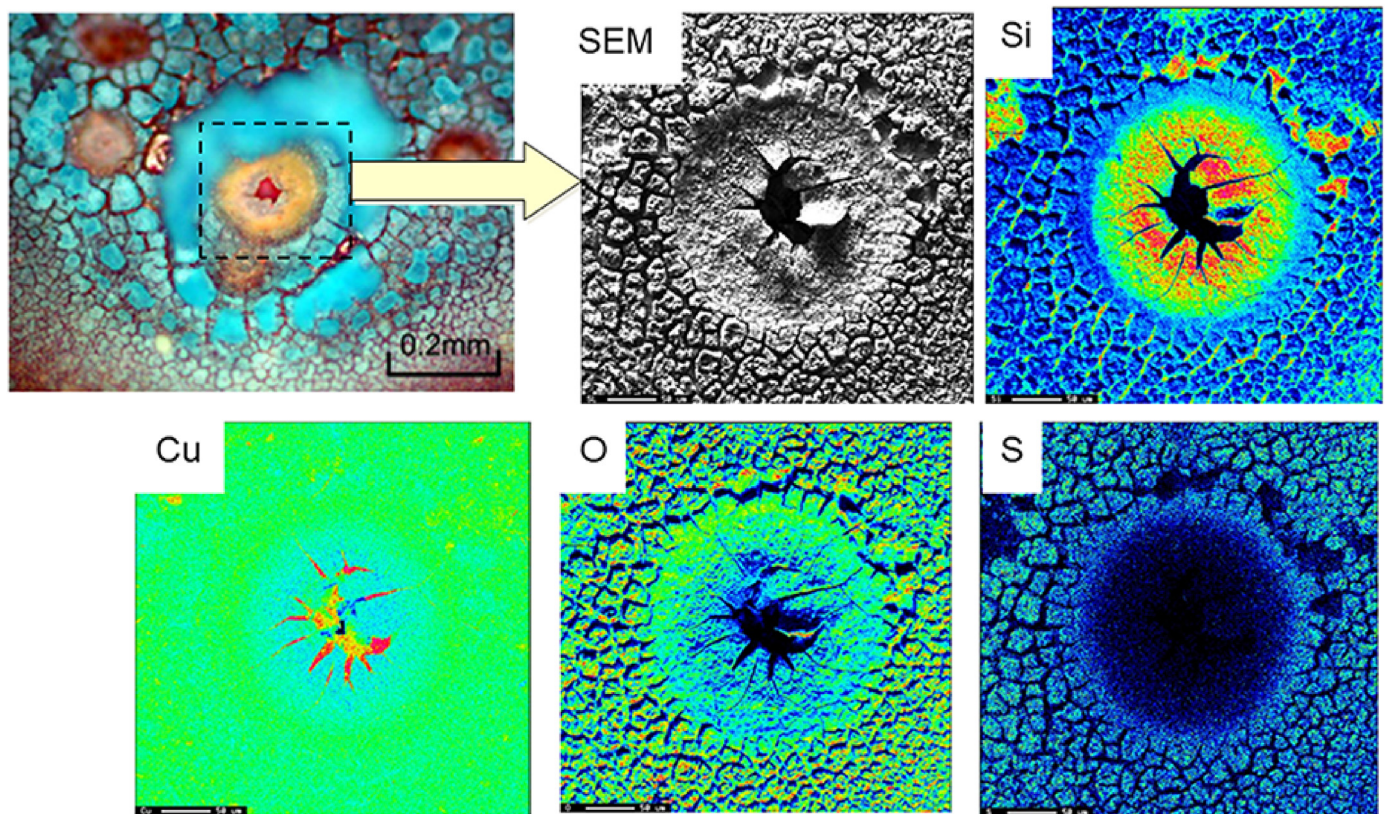
Figure 12. EPMA mapping of the elements present around a moundless pit. The elements analysed are Si, Cu, O, and S.

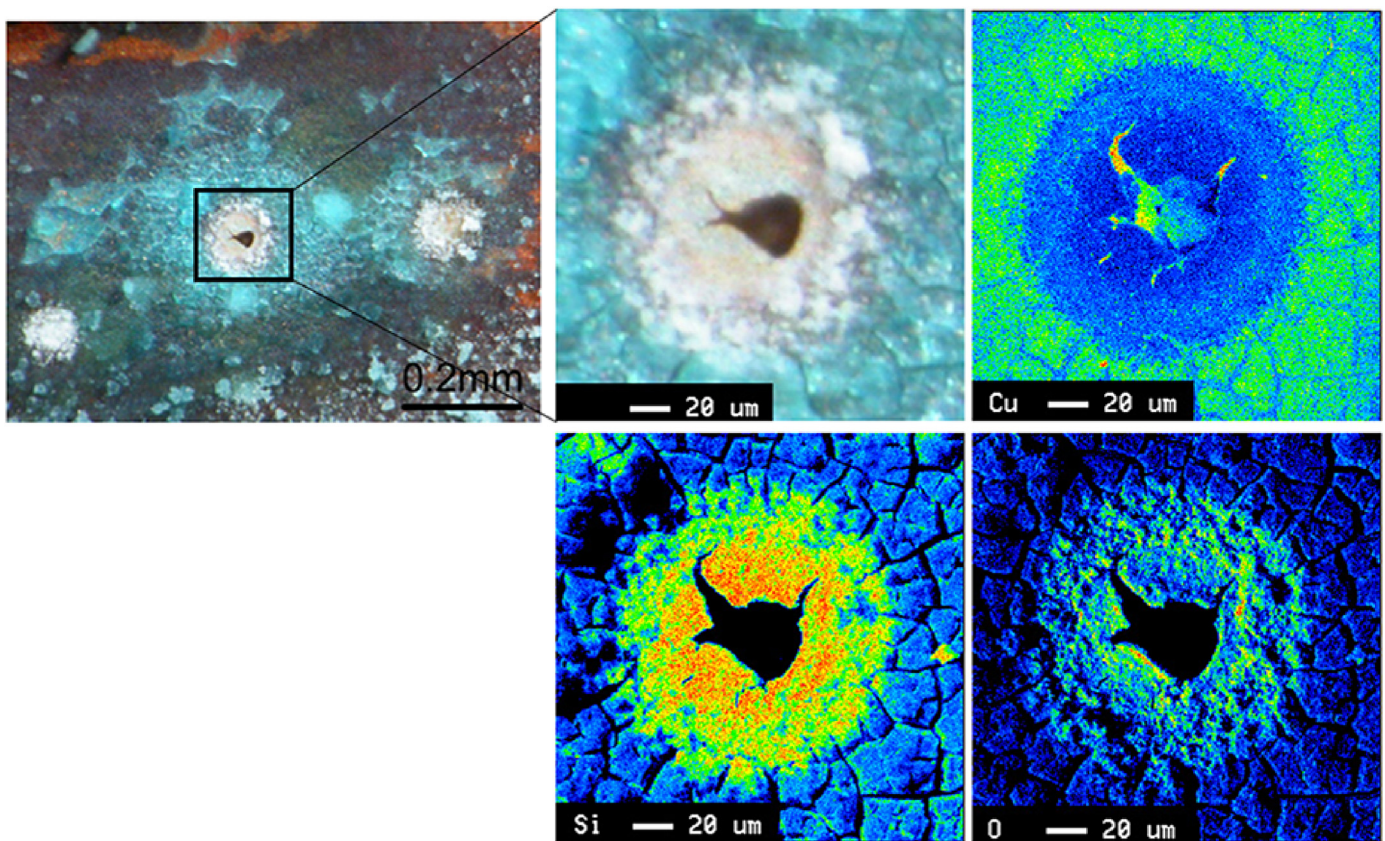
**Figure 15.** EPMA mapping of the elemental distributions around a moundless pit formed during the laboratory test using synthetic freshwater. The elements analysed are Cu, Si and O.

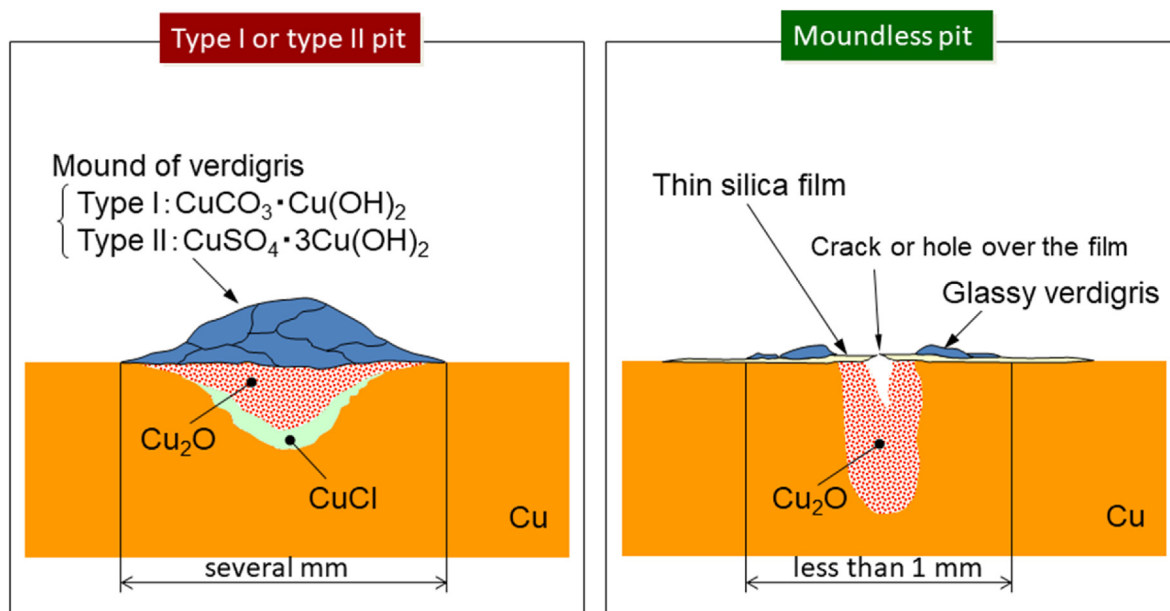
**Figure 16.** Schematic representation of the type I and type II pits (left-hand panel) and that of a moundless pit (right-hand panel).

From the results of the field and laboratory tests, the constitution of the moundless pit was estimated, as shown in the right-hand panel of Figure 16. The left-hand panel of Figure 16 gives the constitutions of the
