# Durability and Degradation of PVC-P Roofing Membrane—Example of Dynamic Fatigue Testing

Andrej Ivanič and Samo Lubej \*

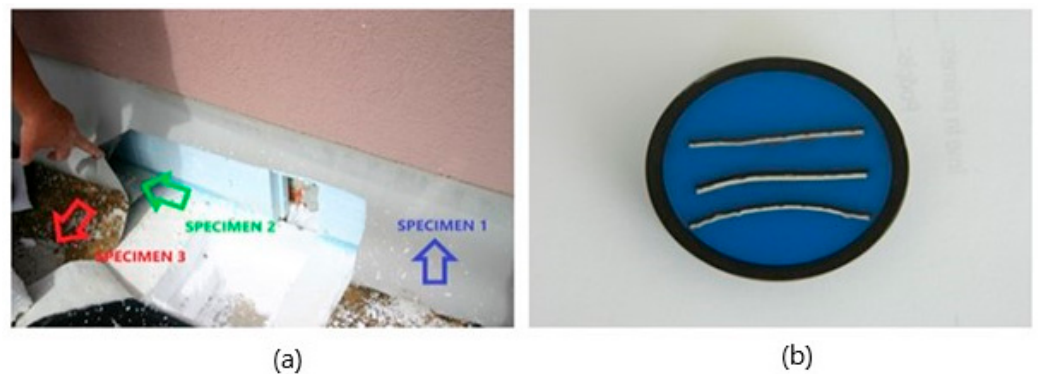
The sampling location chosen at the roof attic, where the waterproofing transitions from horizontal to vertical, was chosen on purpose. Two Specimens were obtained at this roof location, of which the vertically laid part of the waterproofing was exposed to insolation, but the horizontal part was not, as it was covered with polyester felt and a layer of gravel between installation and sampling. Unfortunately, the termination of the transition of the waterproofing from the horizontal to the vertical direction was not carried out according to the rules of the roofing and carpentry trade because of the lack of mechanical fixing at this transition. Additionally, the vertical termination did not have a separating layer of polyester felt between the thermal insulation layer on the attic and the waterproofing. The contractor also failed to cut off the excess waterproofing at the vertical transition at this point. For this reason, at this location, a Specimen of the waterproofing, which was not exposed to the insolation, was also obtained. The sampling location is shown in Figure 2a. The waterproofing pieces Specimen were prepared for mechanical testing and microscopy.

**Figure 2.** Demonstration of the PVC-P membrane sampling at the facility (a); the Specimen produced for analysis on the stereo optical microscope (b).

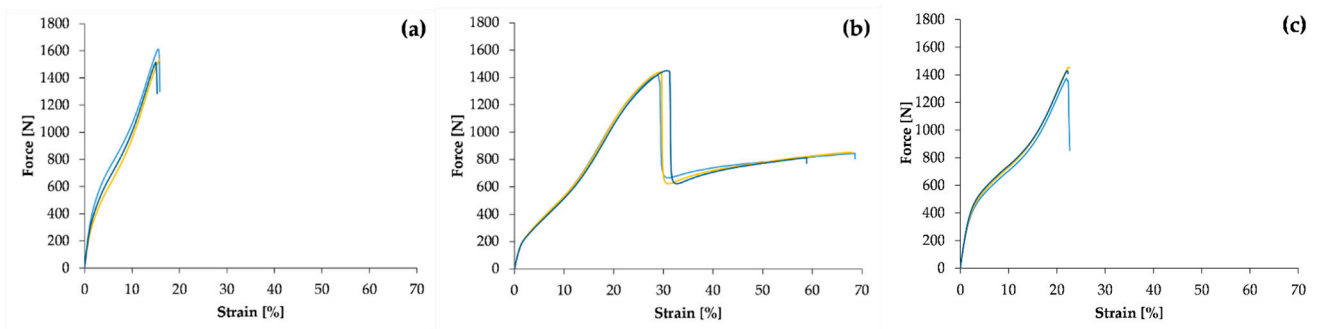
Figure 3. Representative tensile test curves for Specimens 1 (a), 2 (b) and 3 (c).

The tensile force then causes very large plastic deformations until the material fractures. The value of the stress at which fracture occurs is defined as the tensile strength for polymeric materials. This form of stress/strain curves is typical for viscoelastic materials [24]. The curve for Specimen 1 has the steepest slope. It should be noted that it is the only Specimen that has been subjected to insolation and direct contact with EPS. The mechanical behaviour of polymeric materials changes with ageing. Plastomers subjected to the ageing process are characterised by a significant increase in the slope of the curve in the linear yield range. This is due to an increase in the stiffness of the material as the material hardens, but a decrease in elongation at break, which averages 15.82%. The decrease in elongation at break is due to microstructural changes associated with ageing of the material, which are usually due to the degradation of the polymer chains [25]. The elongation at break is a very important mechanical quantity. Microstructural changes are also associated with reduced ductility of the material [26,27]. Khemici et al., in their studies concerning the temperature ageing of PVC between 39.5 and 80 °C, state that the modulus of elasticity increases with ageing time. A higher modulus of elasticity of a material means a lower elasticity of the material, which they attribute to the effect of a decrease in molecular mobility associated with structural relaxation, accompanied by a decrease in the free volume in the material [28]. Our measurements of the secant modulus at a force of 350 N confirm this, as we measured a modulus of 3.55 MPa for Specimen 1, 1.12 MPa for Specimen 2 and 3.43 MPa for Specimen 3.

Comparing the curves for Specimen 2 with those for Specimen 1 and 3 in Figure 3, it is clear that Specimen 2 has retained a certain degree of elasticity as the elongation at break for these Specimens is on average 65.19%, for Specimen 3, the average is 22.6%, and for Specimen 1, the average is at least 15.82%. Specimens 2 and 3 were not subjected to the same temperature stress as Specimen 1 between installation and test because they were protected by EPS thermal insulation. The measured tensile breaking forces of the Specimens are higher than the declared values. The average force measured on Specimen 1 was 1558.49 N, on Specimen 2 it was 1433.96 N and on Specimen 3 it was 1419.85 N. The results obtained show that the strength and stiffness of the Specimens increase due to thermal ageing but their overall deformation capacity decreases, which is consistent with the findings of Garrido M. et al. [20].

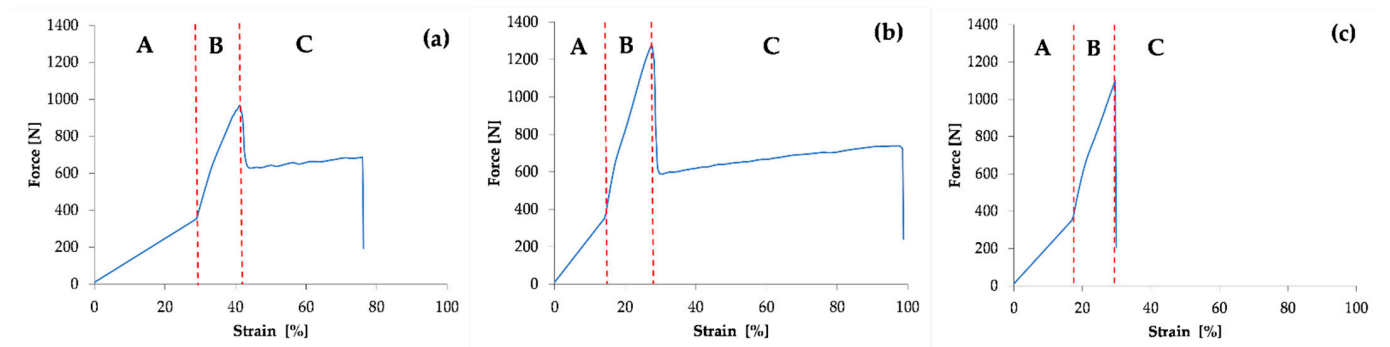
**Figure 4.** Working curves of dynamic tensile test for Specimens 1 (a), 2 (b) and 3 (c).

The load-bearing capacity of polymer materials depends not only on the material properties but also on the type of mechanical load. If a material is loaded dynamically, then it behaves differently from a static load. The curves shown in Figure 4 give the force versus specific strain relationship for a tensile test with a cyclic load of 150,000 cycles. The measured mechanical characteristics are given in Table 2 for each individual Specimen. Region A—representing a load of up to 400 N with a tensile testing head feed rate of 200 mm/min and then cyclic loading in the range 300/400 N at a frequency of 1 Hz—is determined by measuring the specific strain  $\varepsilon_A$ . The  $\varepsilon_A$  values for Specimen 2 and 3 are 14.28% and 17.02%, respectively. After the cyclic loading, each Specimen was tensile tested to fracture. Again, the tensile testing head feed rate was 200 mm/min. The specific strain at maximum force,  $\varepsilon_B$ , and the specific strain at break,  $\varepsilon_C$ , of the Specimen were measured. The value of  $\varepsilon_B$  is the highest for Specimen 1 at 40.88%, for Specimen 2 and 3 it is 27.75% and 29.38%, respectively. The value of  $\varepsilon_B$  for Specimen 1, which was dynamically loaded, increased by 263.6% compared with the average value measured in the static test.  $\varepsilon_B$  was the highest for Specimen 2 and 3 at 40.88%, for Specimen 2 and 3 it was 27.75% and 29.38%,

respectively. The values of the specific strains  $\varepsilon_B$  and  $\varepsilon_C$  for the dynamic test of Specimen 2 and 3 are comparable to the average values of the specific strains at maximum force ( $\varepsilon_{Fmax}$ ) and at rupture ( $\varepsilon_{Break}$ ) measured in the static test. Again, the comparison of the specific strains of the Specimens subjected to higher temperature loading shows that the deformation capacity is reduced [20]. The comparison of the breaking forces shows that the breaking force in the dynamic test is reduced rigorously for Specimen 1 compared with the static tensile test. The breaking force for Specimen 1 in the dynamic test is 37.96% lower than the average value of the breaking force in the static test. This value is reduced by 11.08% for Specimen 2 and by 22.51% for Specimen 3. The behaviour of the PVC-P roof membrane Specimens in dynamic tension is not comparable to the results of the static tensile test. For all three Specimens it was observed that the Specimen breaks brittlely after the dynamic tensile test, only Specimen 2 shows a neck-narrowing phenomenon in the fracture area. There is a colour change on Specimens 1 and 2 exposed to UV radiation—see Figure 6.

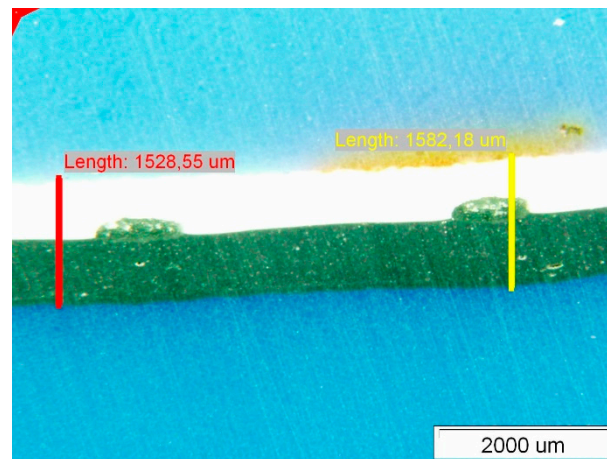
Figure 7 shows the surface of Specimen 1. On both the upper and lower surfaces, we observed degradations which are fistula-like formations. These degradations always occur at the crossing points of the curing phase—the fibres of the polyester mesh. The characteristic area of the degraded site on the upper side exposed to insolation is about  $1,800,000 \mu\text{m}^2$ . The thickness of the Specimen was measured at two characteristic locations along the fibre mesh and in the cross-section of the composite with the polyester mesh fibres—see Figure 8.

**Figure 8.** Membrane thickness measurements.

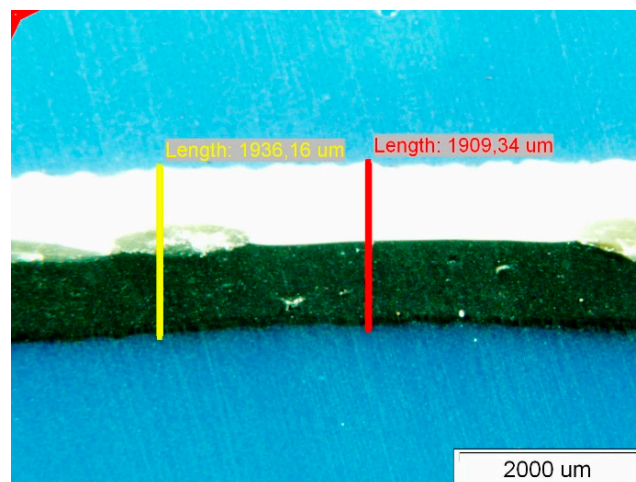
Figure 9 shows the surface of Specimen 2; interestingly, the surface of this Specimen is more diffuse on the upper side than that of Specimen 1. The surface of this Specimen also shows no noticeable degradation similar to the fistula-like formations already mentioned for Specimen 1. The thickness measurement of Specimen 2 is given in Figure 10. It can be seen that the thinning of the thickness of this Specimen is much less than that of Specimen 1, and the variation in thickness at the different measurement points is not noticeable.

**Figure 10.** Membrane thickness measurements.

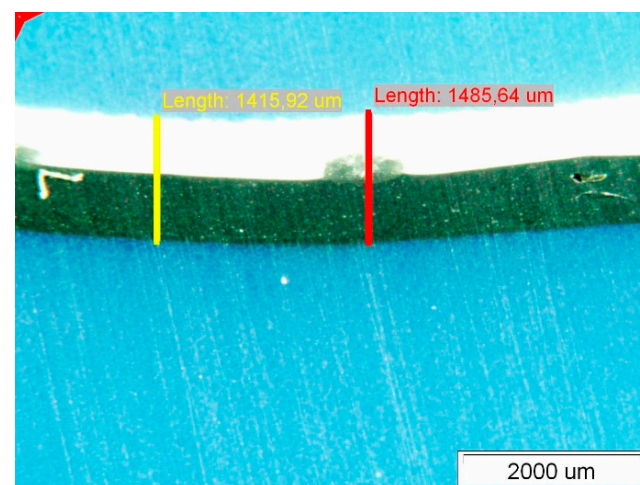
Figure 11 shows the degraded surface of Specimen 3. This surface also shows degradation similar to that of Specimen 1. The spherical degraded areas appearing at the intersections of the polyester mesh filaments are very visible on the upper side, see Figure 11a, while they are barely visible on the lower side, see Figure 11b. The areas of spherical degradation on the upper side of the membrane are different and vary between  $700,000 \mu\text{m}^2$  and  $1,200,000 \mu\text{m}^2$ , they are significantly smaller than those observed for Specimen 1. Additionally, when measuring the thickness of this Specimen, we measured the thinning of the Specimen—the measurements are shown in Figure 12.

Figure 12. Membrane thickness measurements.

The thicknesses of the Specimens measured with the optical microscope are given in Table 3. The optical microscopy performed on the PVC-P roof membrane Specimens showed that the thickness thinned the most on Specimen 1 and 3 and the least on Specimen 2.

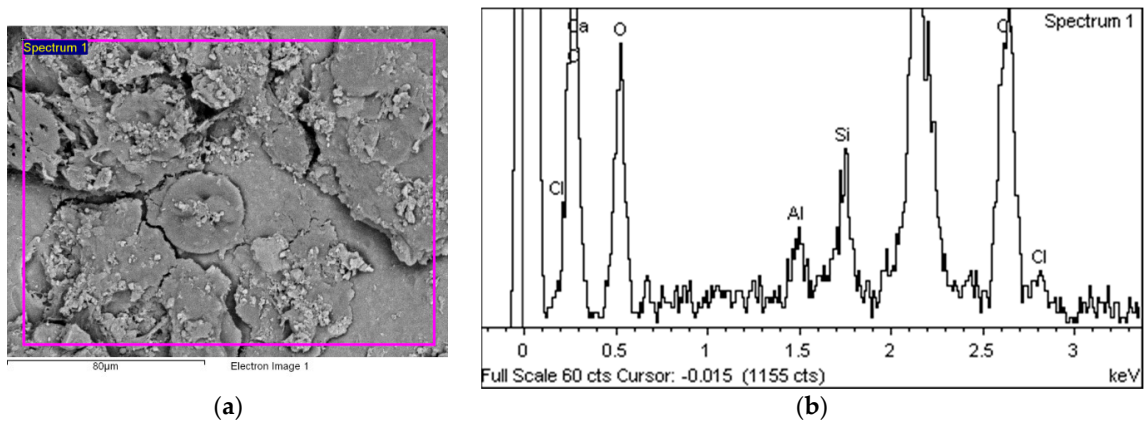
Figure 14 shows the area over which the EDS plot analysis was performed (a) and the EDS spectrum (b).

Figure 14. EDS analysis area (a) and EDS spectrum (b).

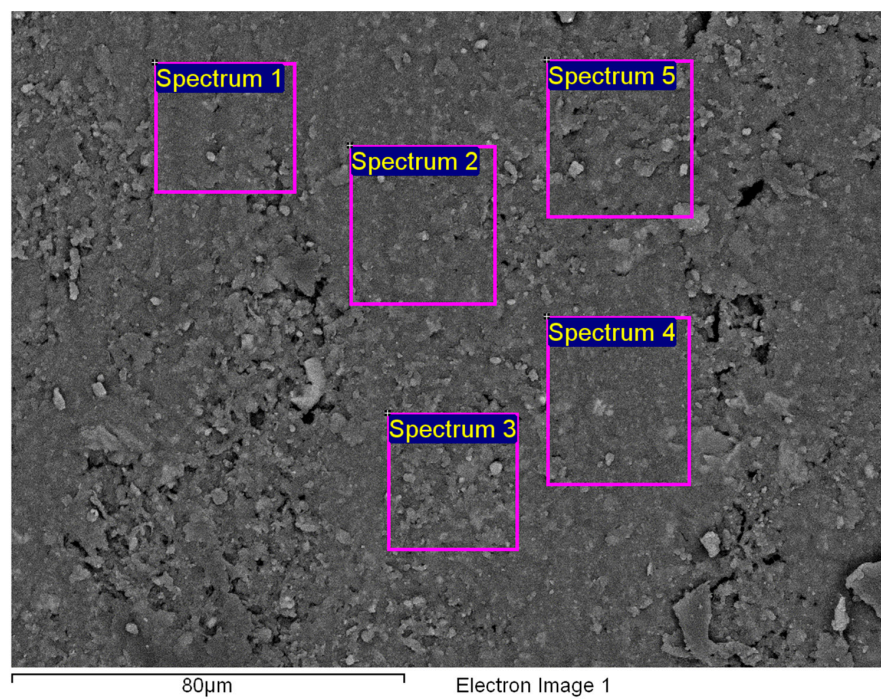
Figure 15a shows an area with a pronounced degradation of the PVC top layer, to the extent that the polyester mesh is no longer completely covered by PVC. The left-hand side (b) shows a typical EDS spectrum of this area. Figure 16 shows the 5 areas where the EDS analysis was carried out. Table 4 summarises the EDS analysis results for Specimen 1.

Figure 16. Five areas where the EDS analysis was carried out.

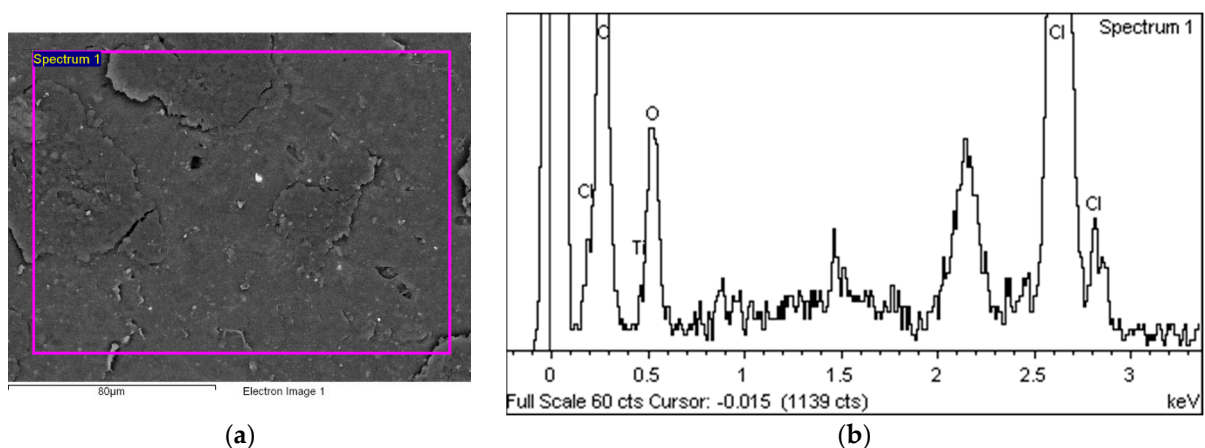
Figure 18a shows the EDS analysis area covering a typical area interspersed with microcracks, on the right (b) is the EDS spectrum of this area.

**Figure 18.** EDS analysis area (a) and EDS spectrum (b).

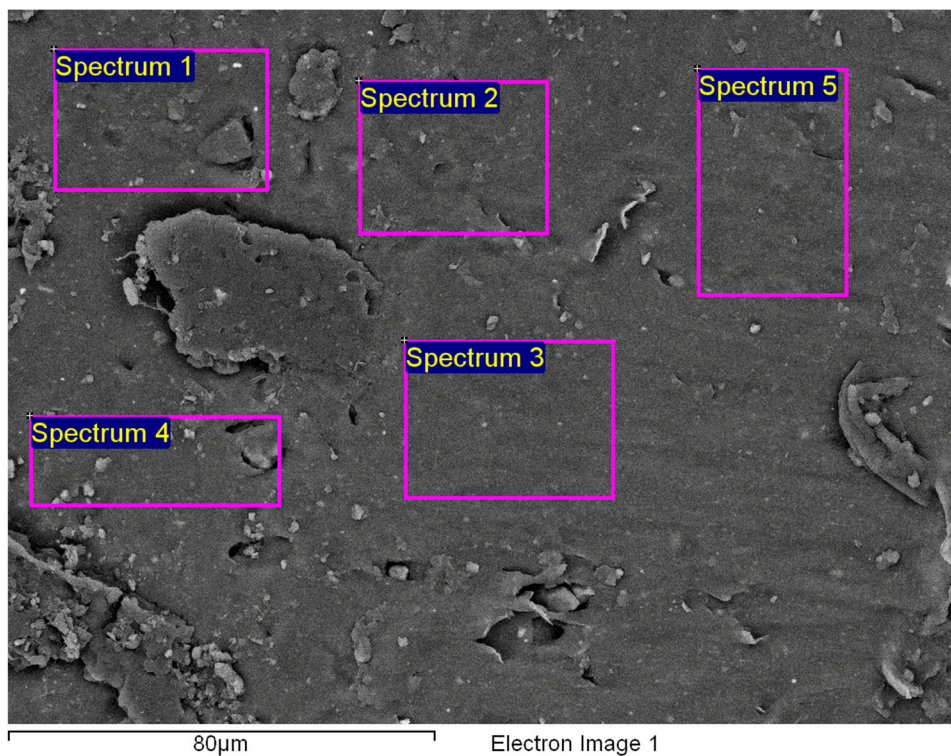
Figure 20 shows the characteristic area of the upper side of Specimen 2 with the location of the five EDS analysis areas. Table 5 summarises the EDS analysis results for Specimen 2.

Figure 20. Five areas where the EDS analysis was carried out.

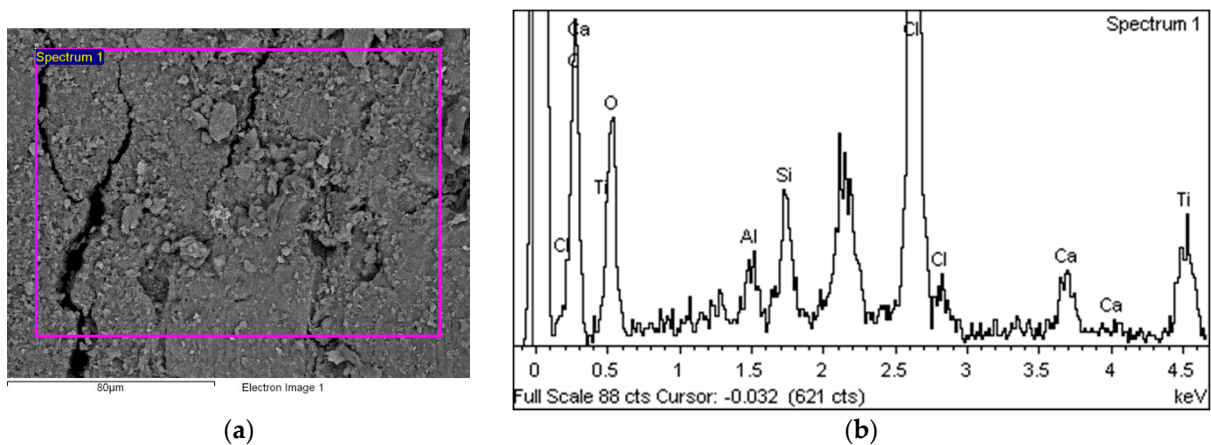
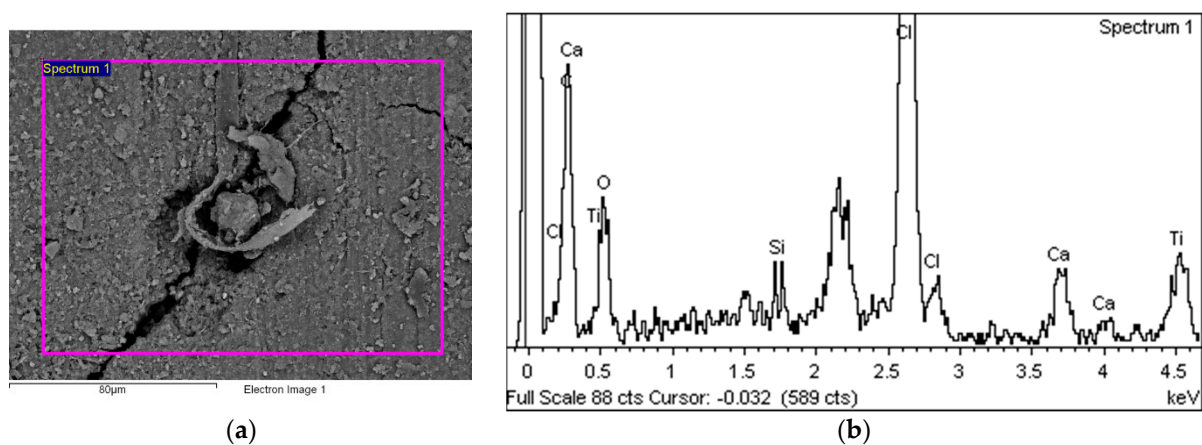
The characteristic microstructure of the upper surface of Specimen 3 is given in Figure 21. This surface is also highly degraded behind many microcracks (yellow arrow) and gaps appearing at the crossing points of the polyester mesh (red arrow). Figures 22 and 23 show such a structure with the area of the EDS spectrum marked (a) and the EDS spectral analysis plot (b). Figure 24 shows the area of the five surfaces on which EDS analysis was performed and Table 6 gives a summary of the spectral analysis results for Specimen 3.

Figure 22. EDS analysis area (a) and EDS spectrum (b).

Figure 23. EDS analysis area (a) and EDS spectrum (b).

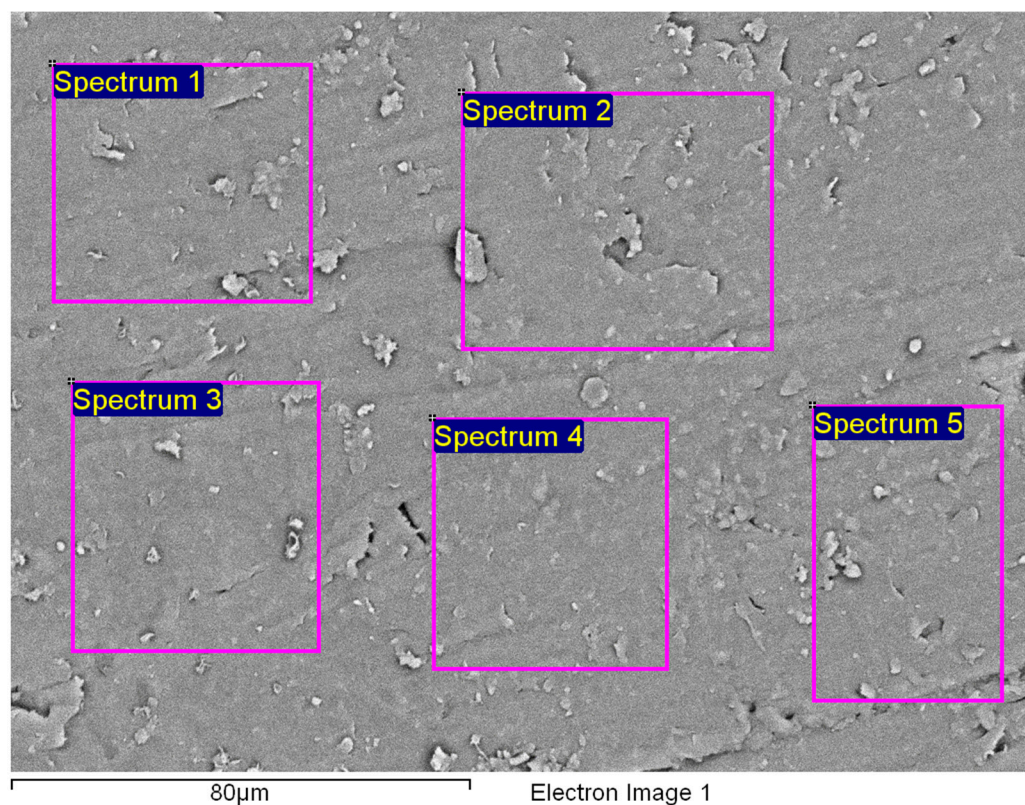
**Figure 24.** Five areas where the EDS analysis was carried out.

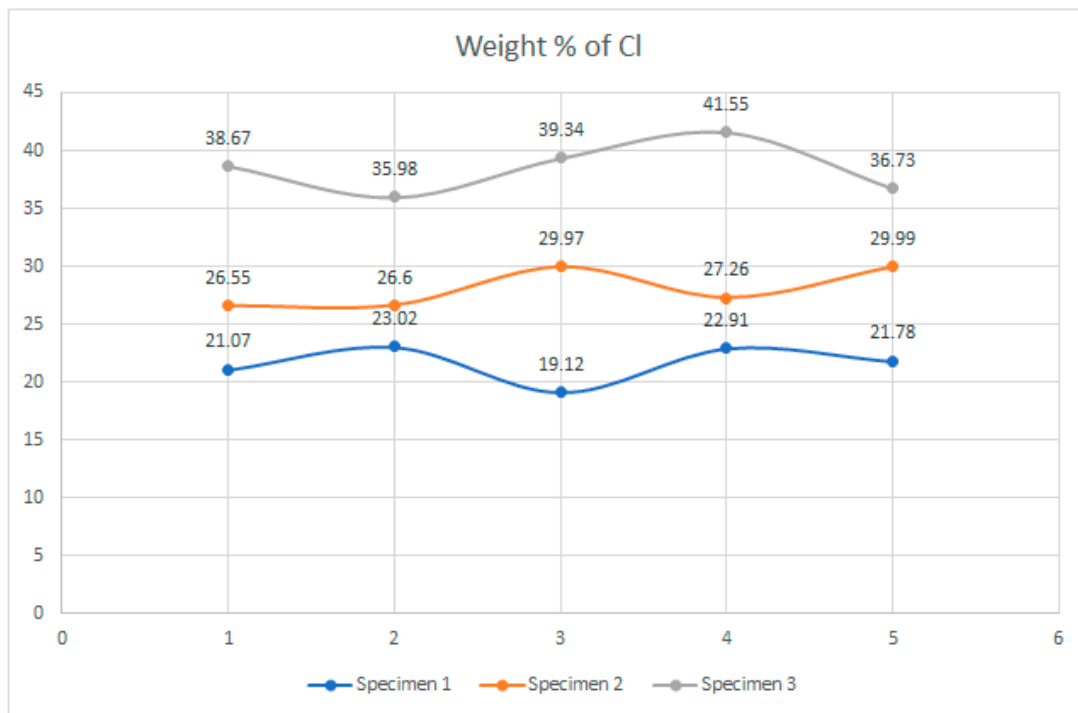
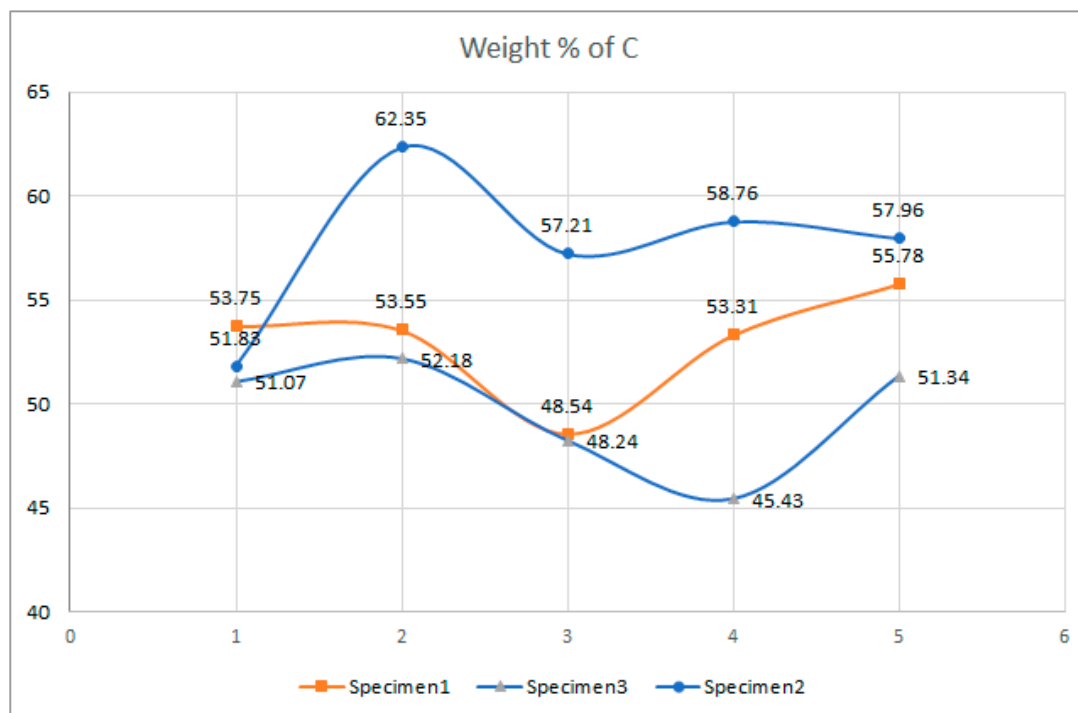
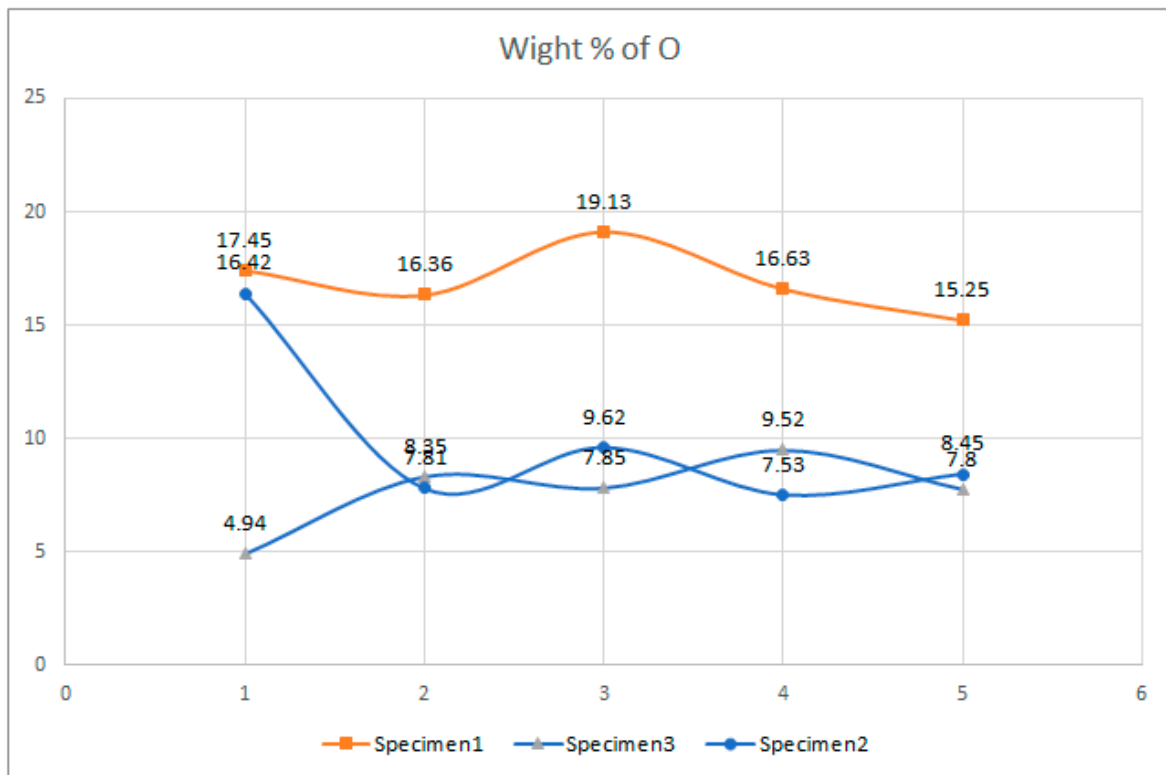
Examination of the microstructure by electron microscopy showed that the most surface degraded Specimen was Specimen 1, which was directly exposed to UV irradiation and high temperatures. Specimens 1 and 2 were not adequately separated from the EPS thermal insulation by polyester felt. The effect of interaction with the EPS and exposure to weathering in PVC-P results in, among other things, a significant mass reduction in chlorine and carbon. From the attached results of the EDS analysis, which are shown graphically in Figures 25–27 as shown in Figures 16, 20 and 24, the average chlorine value as a result of the EDS analysis over the five surface area spectra is lowest in Specimen 1, averaging 21.58% by mass, and is highest in Specimen 3, averaging 38.45% by mass. Specimen 3, which was protected from direct weathering by a layer of polyester felt and gravel, has the least degradation due to dehydrochlorination, Specimen 1 has the most. A typical sign of oxidative degeneration of PVC-P is an increased oxygen level. It can be seen from Figure 28 that the average value of the oxygen element detected by spectral analysis at the five surface measurement points on Specimen 1 is the highest, averaging 16.96% by mass, which is significantly higher than that measured on Specimen 3, where the average value is 7.96% by mass. Oxidative degeneration is highest on Specimens exposed to direct weathering. The carbon element content is approximately the same in all Specimens, with a minimum of 49.65% by weight in Specimen 3 and a maximum in Specimen 2 and 3, where it averages 57.62 and 52.99% by weight, respectively. The individual results of the EDS analyses for all the chemical elements tested and for all the Specimens are given in Figures 28–30.

Figure 25. Result of EDS analysis, presence of an element, Cl, in mass percentage.

Figure 26. Result of EDS analysis, presence of an element, C, in mass percentage.

Figure 27. Result of EDS analysis, presence of an element, O, in mass percentage.

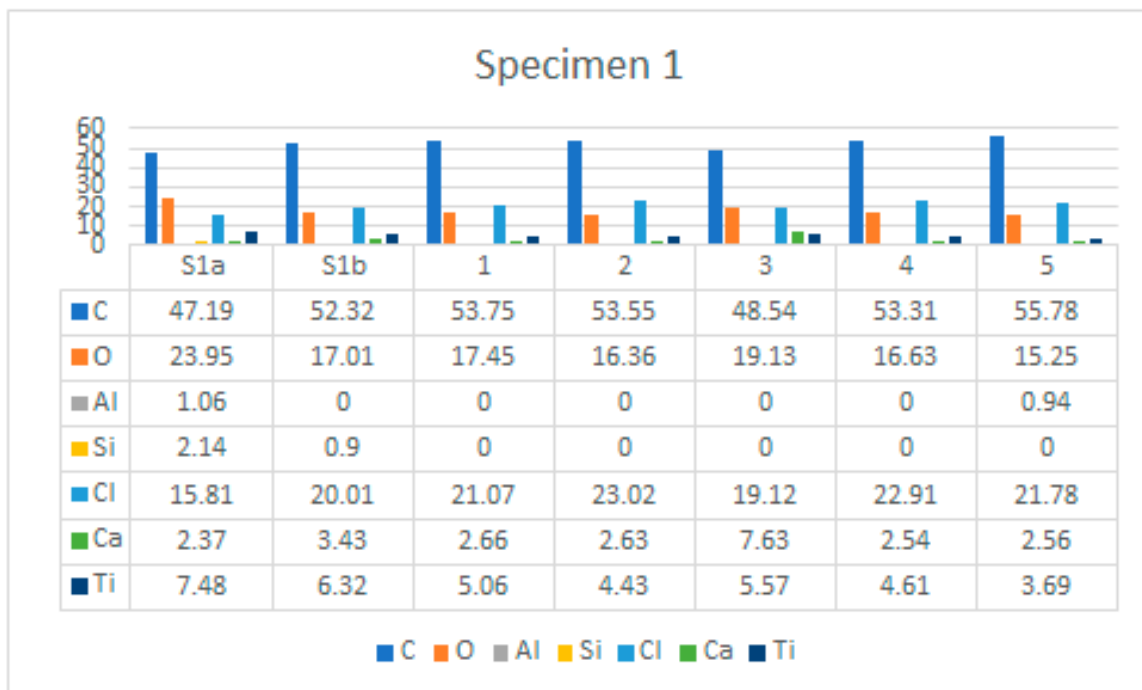
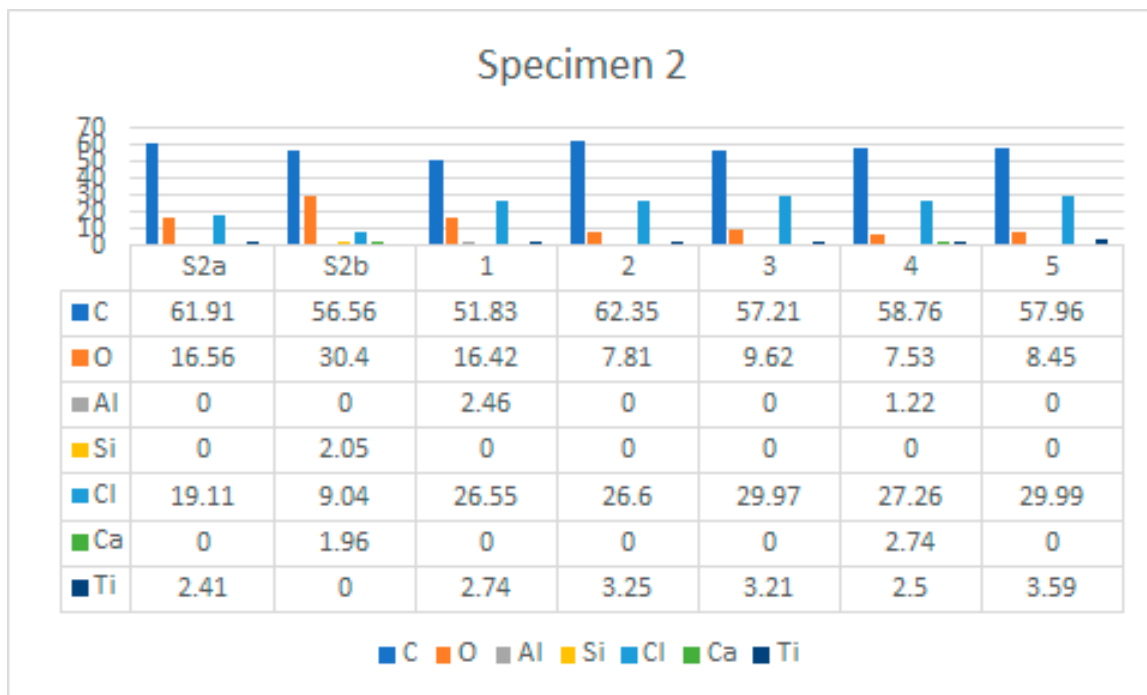
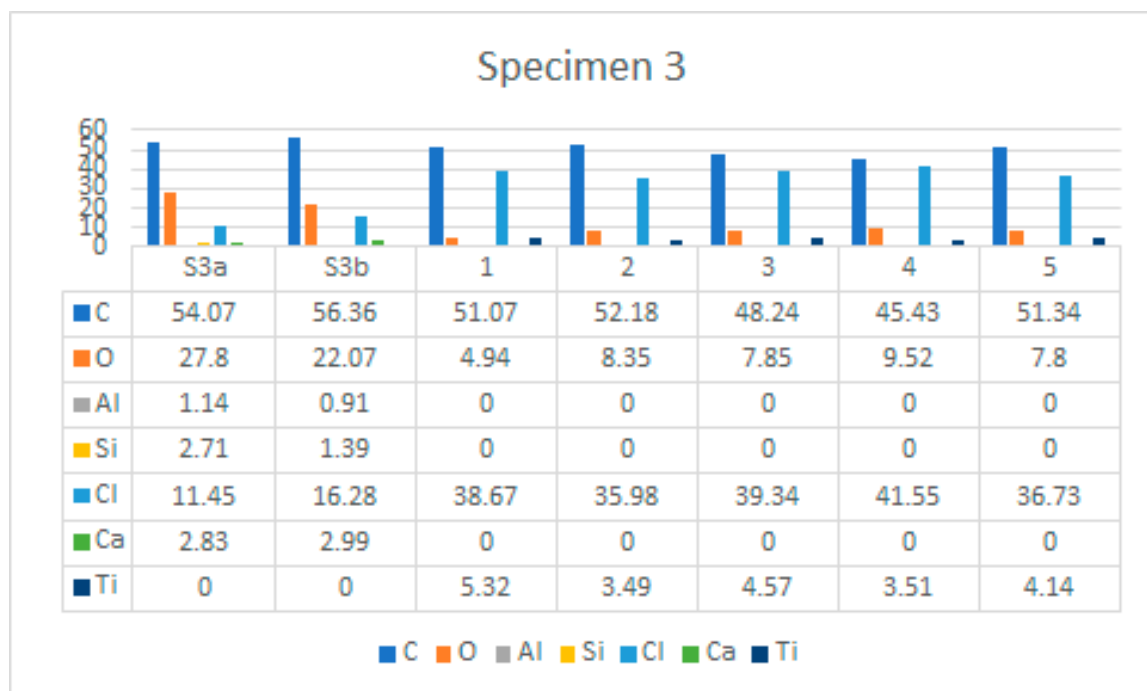
Figure 28. EDS analysis results for Specimen 1, for all areas analysed.

Figure 29. EDS analysis results for Specimen 2, for all areas analysed.

Figure 30. EDS analysis results for Specimen 3, for all areas analysed.
