Case report

Bead debonding from a modern cementless total hip femoral component with concomitant taper corrosion

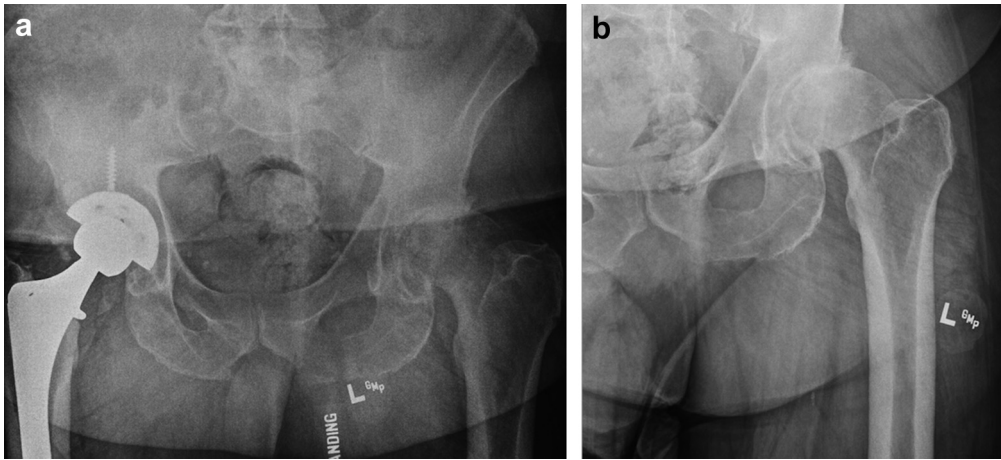
Figure 1. Preoperative (a) anteroposterior (AP) pelvis and (b) AP hip radiographs demonstrate severe degenerative changes at the left hip.
