Analysis of the Root Causes of Damage to the Edges of Tank Manholes on the Main Deck of Handy-Size Bulk Carriers

Abstract: This study analyzes the root causes of cracks in the deck plating around tank manholes. Four handy-size bulk carriers built in one shipyard were analyzed. In all cases, deck cracks were found near manholes, and the average time from the commencement of operation until the occurrence of cracks was 1356 days. Due to this short wear-life of the vessel's structural material, the authors believed that it was unlikely to be caused by corrosion fatigue. The authors hypothesized that main decks cracked around manholes because of very poor-quality welded joints and poor-quality steel (large amounts of non-metallic impurities) used to make the manholes. In order to verify this hypothesis, on each of the vessels, material samples were collected from near the cracks and then examined thoroughly. Each sample was subjected to the macroscopic examination of the natural surfaces of cracks and their vicinity, microscopic examination of the material, mechanical property tests, and scanning electron microscope fractography for samples obtained after impact tests. The examination

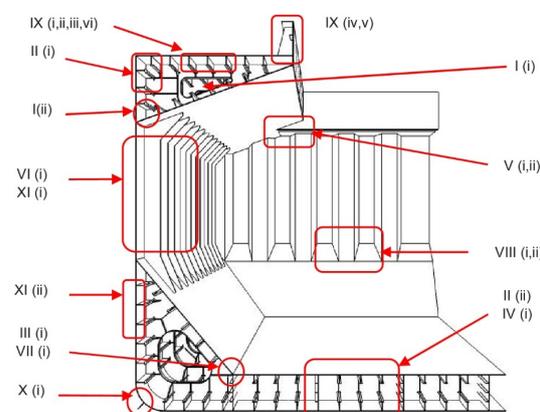
The bulk carrier structural elements most prone to cracks are shown in Figure 1. According to the classification of the US Ship Structure Committee, these elements are located in area IX (ii)—“Fractures in deck plating around access manholes.” These cracks are the subject of the analysis in this article. Detailed information about all areas presented in the figure is provided in the US Coast Guard document [37].

Figure 1. Structural areas prone to fractures in bulk carriers [37].

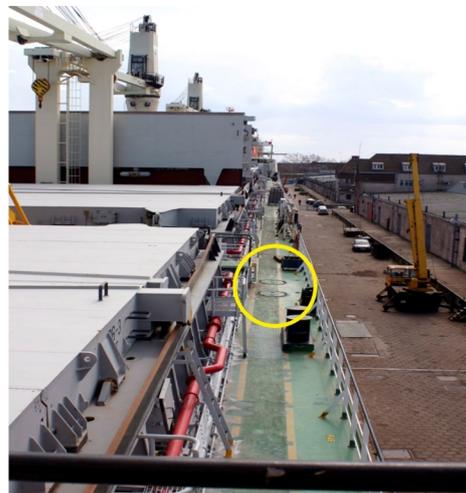
Figure 2. The main deck and tank inspection manhole covers for ballast tanks.

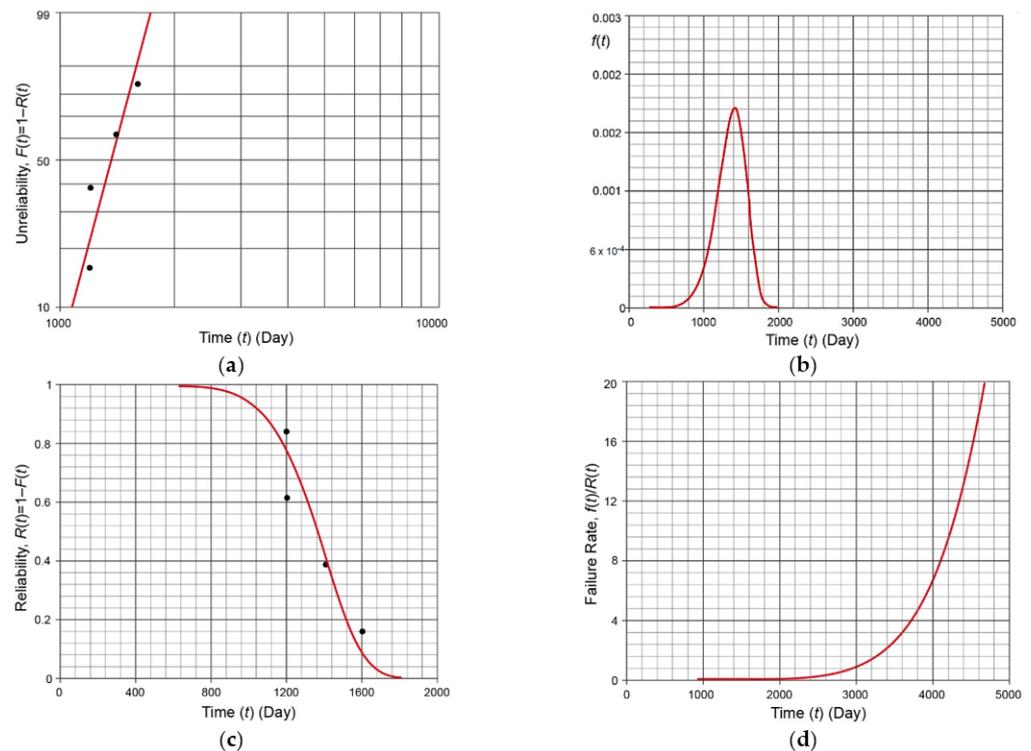
The analysis carried out with Weibull++ 9.0 (ReliaSoft Synthesis, HBM Prensca, Tucson, AZ, USA) enabled us to plot the most important reliability characteristics [54,55], shown in Figure 3. For the analyzed population data, the scale parameter was 1429.74 days, and the shape parameter was 7.91.

Figure 3. Reliability analysis of observed failures: (a) Weibull diagram of the unreliability of the analyzed damage population; (b) probability density function of the analyzed damage population; (c) the graph of the function of the reliability of the analyzed manholes; and (d) the graph of the function of the failure rate for the analyzed manholes.

Preliminary reliability analysis showed that for the analyzed manholes, a crack formed 2000 days after the commencement of the ship operation. The expected lifetime of a ship is usually between about a dozen years and a few decades [56], so if cracks occurred so early into a ship's operation, the cause must be investigated.

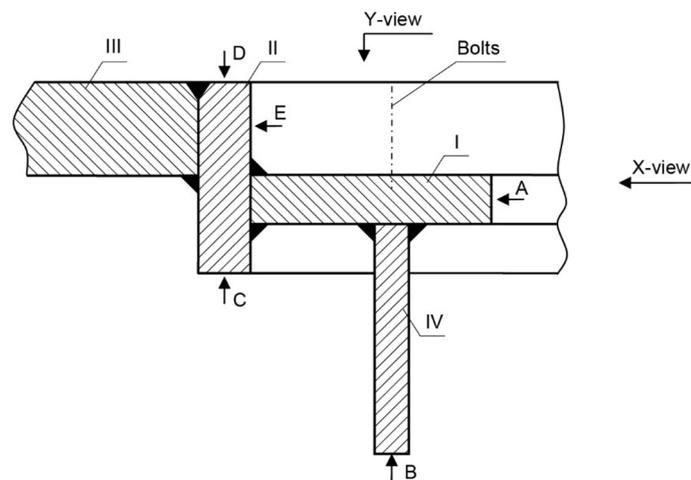
The manhole structure with the marking of components and their surfaces are shown in the enclosed sketches in Figures 11 and 12. Part I is a component with bolts installed in it, as shown in Figure 1. Part II is a combination of part I with element III, which is the deck named in Figure 10. Part IV is not visible in Figure 10.

Figure 10 shows two cracks, also numbered 1 and 2 in Figure 12a,b. Crack 1 probably originates on edge A of element I and runs next to the bolt toward element II. Crack 2 originates on edge C of element II (Figure 11). To analyze crack 1, a bar of the plate (12 mm in size, perpendicular to parts I and II) that contained crack 1 was cut out. Figure 13a shows the sample obtained after cutting off a large part of the cracked element I.

Figure 11. The indication of individual manhole parts from the handy-size bulk carrier 30206 DWT.

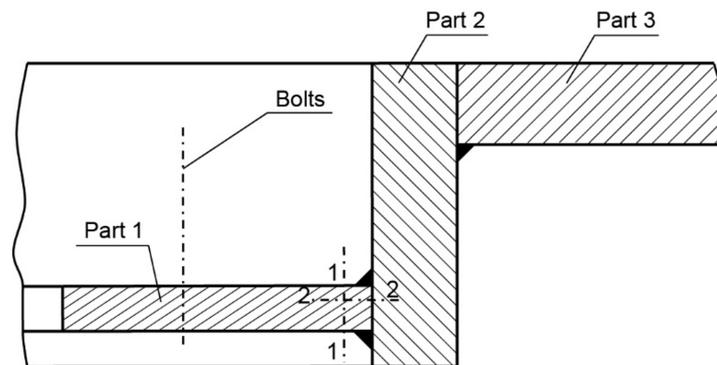
Figure 35 shows a cross-section of the manhole structure with the individual parts marked. Part 2 is a combination of part 1 (the screws fitted in it are visible in Figure 34, and part 3 is part of the deck.

Figure 35. Cross-section diagram of the manhole structure (handy-size bulk carrier 30185 DWT).

Part 1 was cut 25 mm off the part's edge (Figure 35, cut 1-1) so that the cracked part of the bar was separated, and the fracture surface was exposed (Figure 36c).

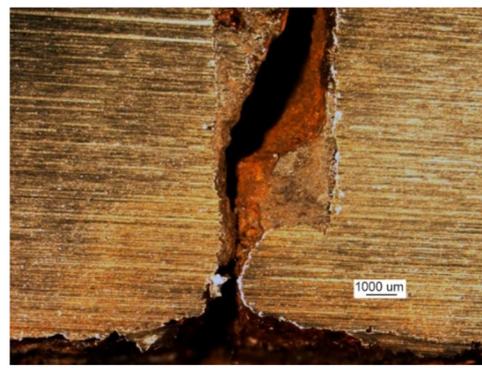
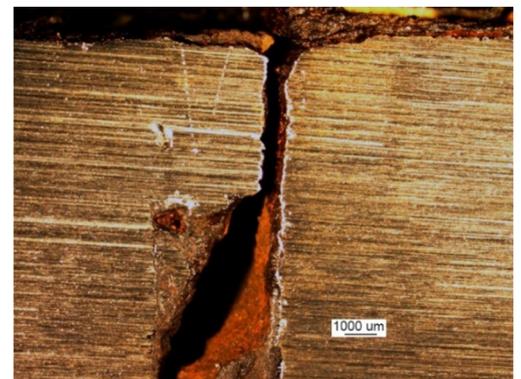
Figure 42 shows where the cracks merged, which is a special point because it can have one of two natures. It can be either a rolled, large, non-metallic inclusion (as its shape indicates), or a very large number of products of intensive corrosion caused by stress at the crack face.

Figure 42. (a,b) Part of the location where the cracks merged (handy-size bulk carrier 30185 DWT). Stereoscopic optical microscopy.

The first case confirms the poor quality of the steel used, and the second case proves the effect of stress on the expansion of cracks and the synergistic effect of stress and corrosion. Cut 2-2 (Figure 35) revealed the route of the crack until it reached part 2, where it branched and severe corrosion occurred (Figure 43a). At this point, the crack did not enter part 2 because there is no connection between the parts, but it expanded and penetrated the joint on the surface of both parts (Figure 43b).

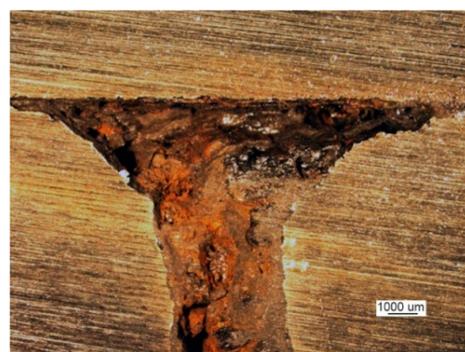
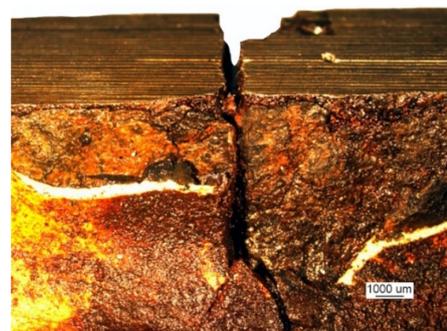
Figure 43. Stereoscopic optical microscopy views (handy-size bulk carrier 30185 DWT): (a) crack reaches part 2 and (b) crack transition from part 1 (upper part of the figure) to the joint.
