Case report

Gross trunnion failure after a metal-on-polyethylene total hip arthroplasty leading to dissociation at the femoral head-trunnion interface

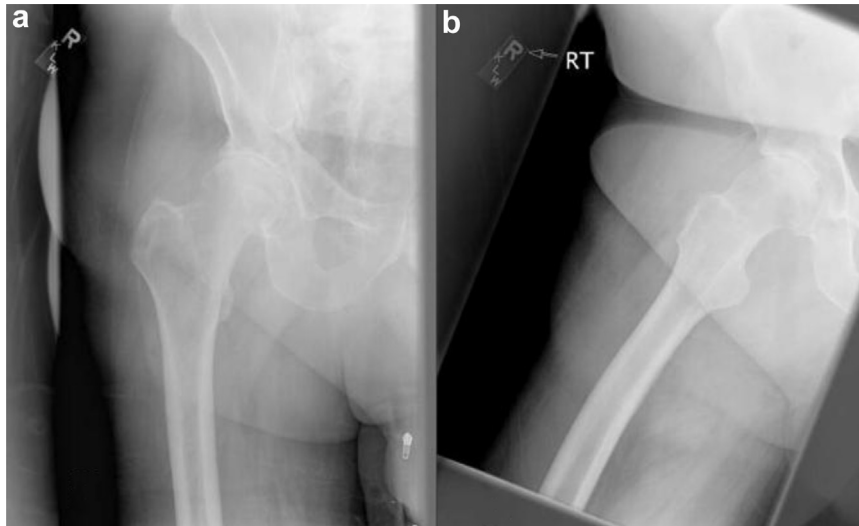
Figure 1. Preoperative anteroposterior (a) and frog leg lateral (b) radiographs of the right hip from September 2008 demonstrating severe osteoarthritis of the right hip.

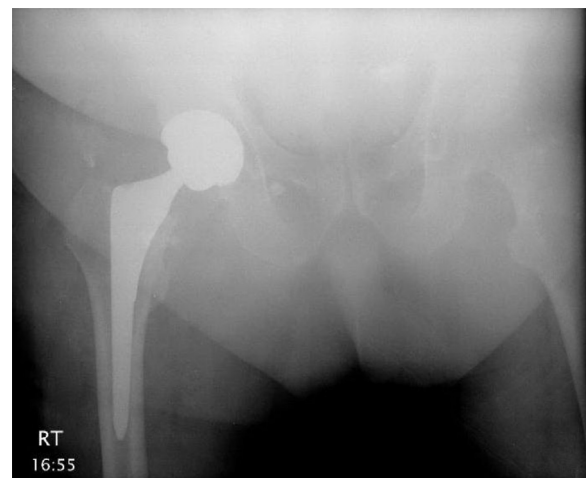
Figure 2. Postoperative anteroposterior pelvis radiograph from September 2008 after right total hip arthroplasty.
