Are asymmetric metal markings on the cone surface of ceramic femoral heads an indication of entrapped debris?

Sebastian Valet^{1*}, Bernhard Weisse¹, Jakob Kuebler², Martin Zimmermann³, Christian Affolter¹ and Giovanni Pietro Terrasi¹

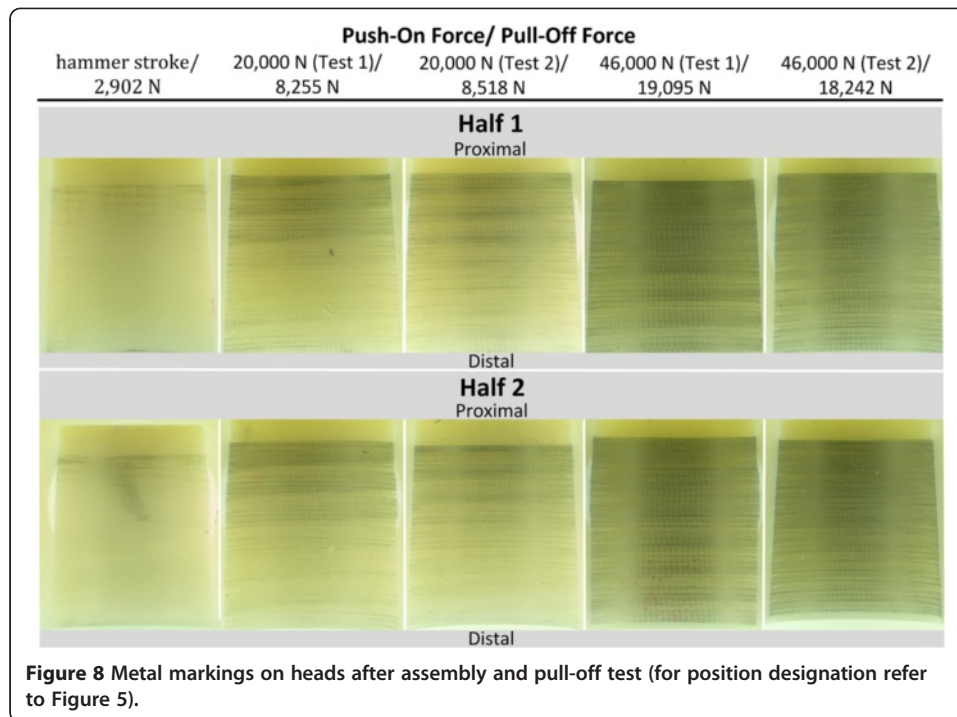
The analysis of the images allowed the following observations to be made:

- **Metal marking characteristics:** The metal marking appeared in a pattern of lines that resulted from manufacturing ridges on the surface of the titanium-taper.

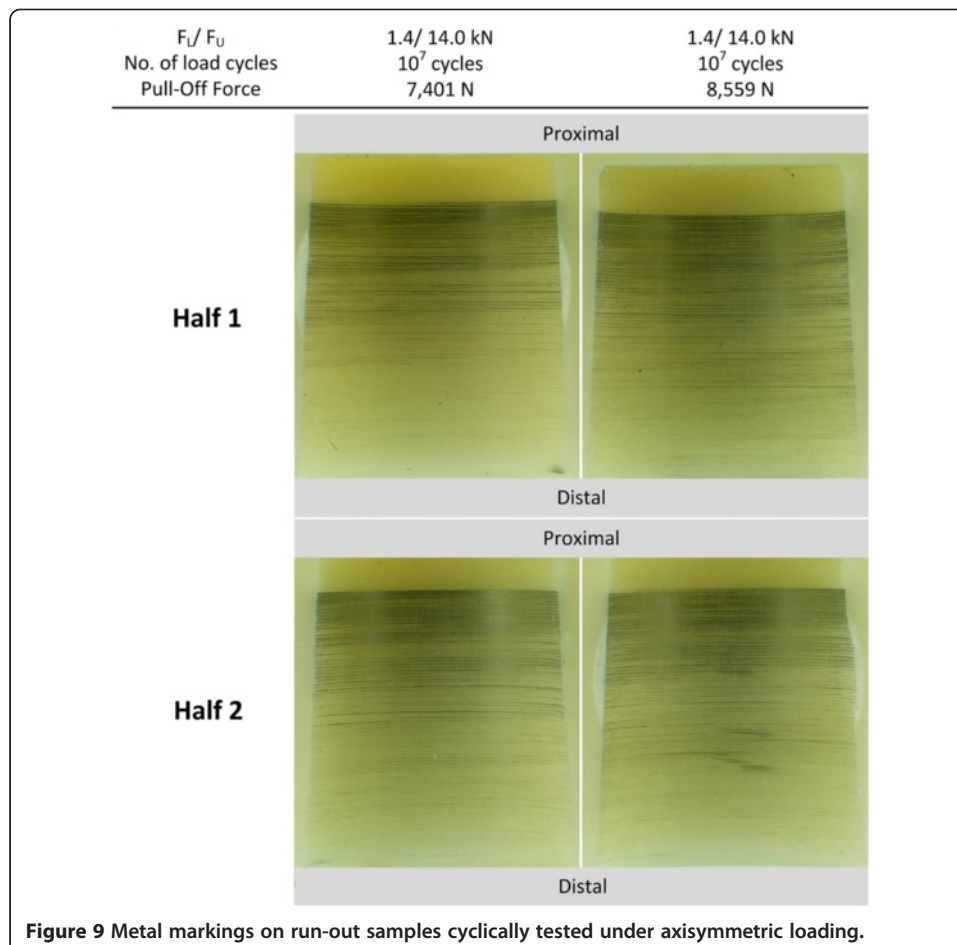
Both tested ball heads passed the cyclic test at an upper compressive load F_U of 14 kN without fracture. No signs of failure were visible on the outside of the head. Both samples were pulled off of the titanium-alloy cone in order to quantify the remaining taper fit stability. A mean pull-off force of 8,215 N was required to pull off the heads after the end of the cyclic tests. This represents a ratio between pull-off and maximum push-on load of 0.35 ($n = 2$, range: 0.02), which is slightly less than the ratio measured in static assembly tests. The remaining metal markings on the tested ball heads are shown in Figure 9. The measured distance d_{GAP} was in a range of 2.4-2.5 mm.

- Distribution of metal marking:** an axisymmetric distribution of metallic marking (TiAl6V4) is present along the circumferential direction for both cyclically tested samples. A clear gradient of metal marking is present in the direction of the taper axis. Most metal markings appeared in the proximal area of the cone, whereas slight metal markings are visible at the distal part of the bore hole. The conical surface exhibited similar distribution of metal marking when compared to the samples that had been statically tested.
