Images in Cardiology

Air Bubble Trapped in the Left Atrial Appendage After Occluder Delivery

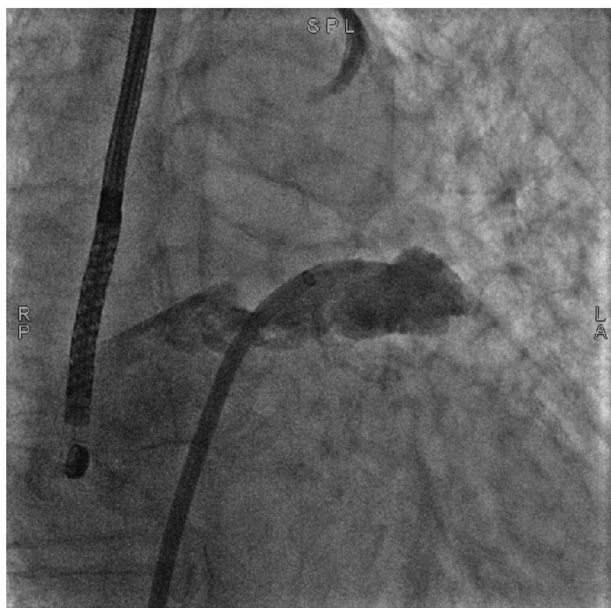
Transseptal access was achieved, guided by transesophageal echocardiography. We then introduced the occluder delivery system into the left atrium, without difficulty. The system was perfused with saline with an autopump. Contrast was injected into the LAA (Fig. 1). After delivery of the device, contrast was injected again. Just after, we clearly visualized an air bubble trapped in the LAA (Fig. 2). We provide a video showing the bubble moving into the LAA (Video 1

view video online). We immediately examined the delivery system and noted that the valve was unclipped from the delivery sheath. We had to push strongly to correctly reclip it. The transesophageal echocardiography did not show any flow from the LAA after device placement.

We finished the procedure and tried to once again unclip the valve, which proved to be impossible. We conclude that the system had a manufacturing defect.

Figure 1. Angiographic image of the left atrial appendage.
