Rupture of an Industrial GFRP Composite Mitered Elbow Pipe

Abstract: This paper examines the immature rupture of glass fiber reinforced plastic composite (GFRP) mitered elbow pipes. The GFRP composite mitered elbow pipe's lifespan was twenty-five years; however, the pipes in question experienced immature failures, resulting in the reduction of their lifetimes to seven, nine, and ten years, respectively. The GFRP cooling water mitered elbow pipe's service conditions operate at a pressure of up to 7 bar and temperatures between 15–36 °C. The root cause of failure was determined using visual inspection, analytical, microstructural, mechanical characterizations, and chemical analysis. The initial visualization inspection revealed an improper joint between the composite overwrapped and the straight pipe sections. Mechanical properties along the axial, hoop and 45° from the axial direction were obtained. The results from the analytical analysis indicated that the elbow might withstand the operating pressure depending on the quality factor, which was confirmed to be low due to the elbow joint's improper fabrication process. As evidence of this, the numerical analyses' results indicated t

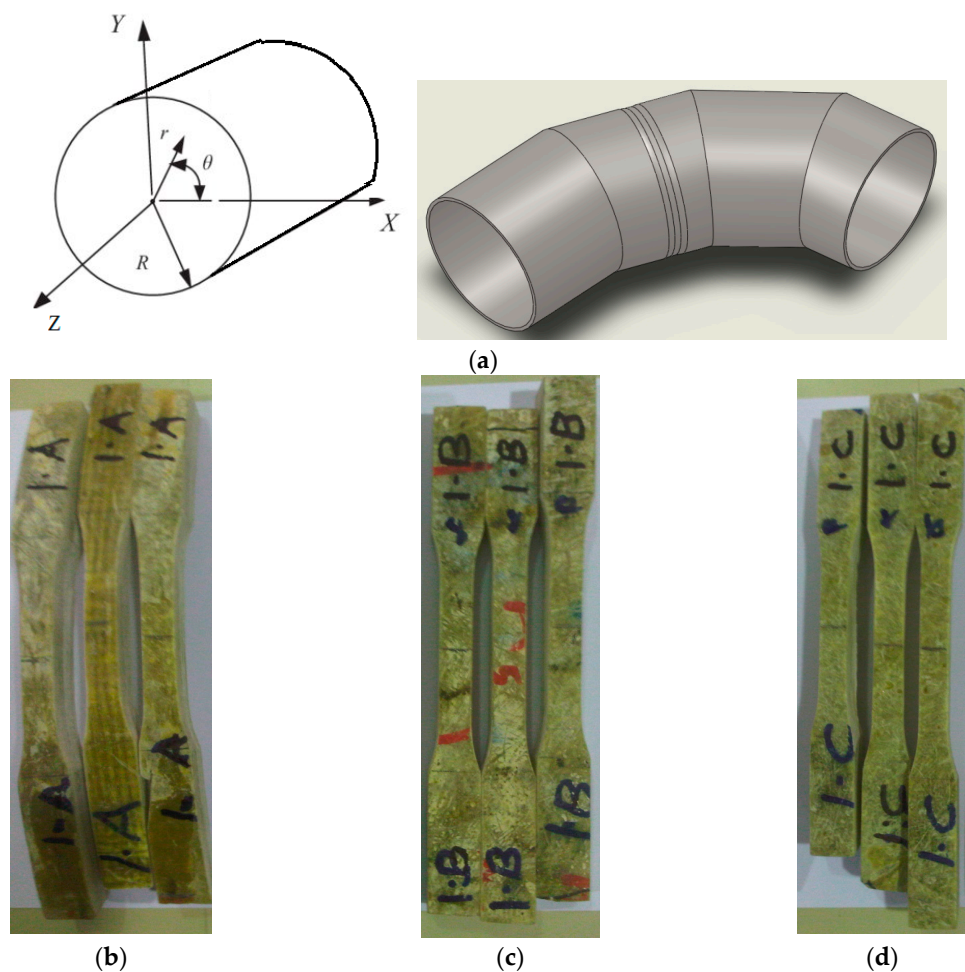
Figure 7. (a) The pipe section shows the coordinate system (r, θ, z); (b) Hoop specimens (along θ direction); (c) Axial specimens (along the z-direction); (d) 45° direction specimens.

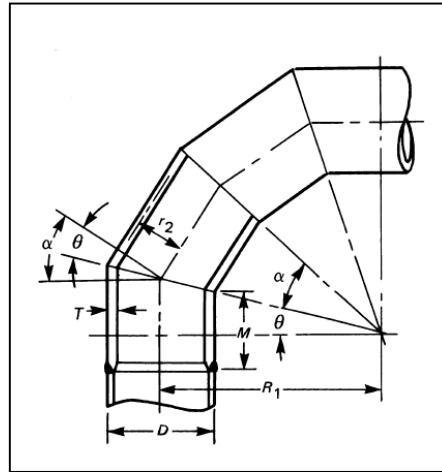
ASME code B31.3-2006 “Process Piping” includes the analytical formulae that can be used to determine the maximum operating pressure allowable for a miter bend. Figure 12 was extracted from ASME B31.3, and details the nomenclature for miter bends recommended by ASME. According to ASME B31.3, the maximum allowable internal pressure shall be the lesser value calculated from the following equations.

Figure 12. Mitered bend nomenclature as per ASME B31.3.

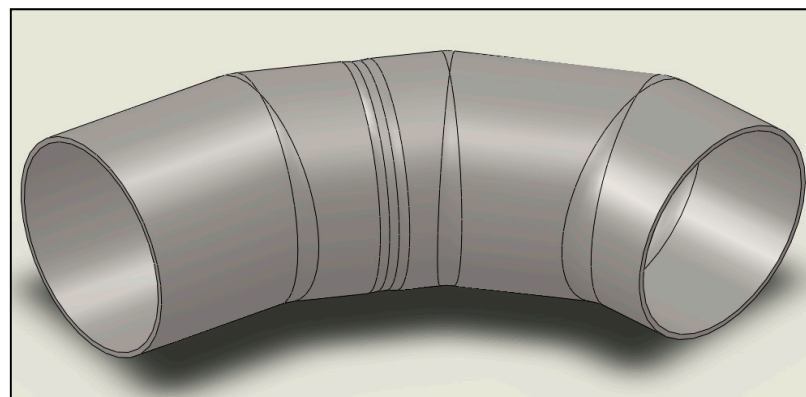
To ensure that the flow is fully developed in the area of interest when analyzed using CFD, 1-m long straight pipe sections were added at the bend's inlet and outlet. Finally, the pipe's fluid area was modeled as a solid body for meshing purposes. The developed model is shown in Figure 16a. After the geometric model was completed, it was imported into ANSYS Workbench. The geometry was checked using the ANSYS design modeling tool to ensure that it was appropriately imported and that no errors had occurred. The geometry was then transferred to the meshing tool to mesh. The primary area of interest was the fluid-solid contact area in the elbow. The aim was to refine the mesh in this area to obtain

Figure 16. Geometrical modeling.

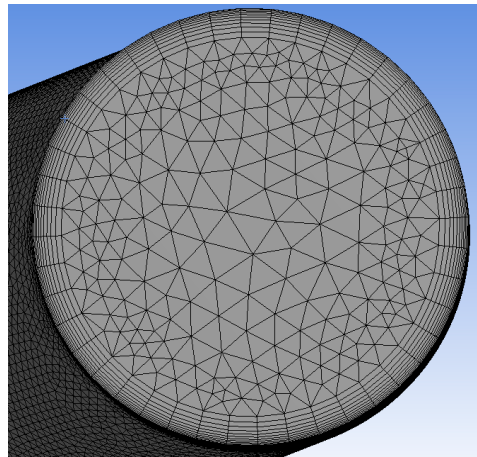
Figure 17. Mesh of fluid zone. Notice the refined mesh near the boundary.
