# The Effect of Tropical Environment on Fatigue Failure in Royal Malaysian Airforce (RMAF) Aircraft Structure and Operational Readiness

**Abstract:** The environmental condition in which the Royal Malaysian Airforce is currently operating its aircraft is prone to corrosion. This is due to the high relative humidity and temperature. With most of its aircraft being in the legacy aircraft era, the aircraft's main construction consists of the aluminium 2024 material. However, this material is prone to corrosion, thus reducing fatigue life and leading to fatigue failure. Using the concept of either Safe Life or Damage Tolerance as its fatigue design philosophy, the RMAF adopts the Aircraft Structure Integrity Program (ASIP) to monitor its structural integrity. With the current problem of not having the structural limitation on corrosion-damaged structure, the RMAF has embarked on its fatigue testing method. Finite Element (FE) studies and flight tests were conducted, and the outcome is summarized. The conclusion is that the longeron tested on the aircraft can withstand the operational load, and its yield strength is below the ultimate yield strength of the material. These research outc

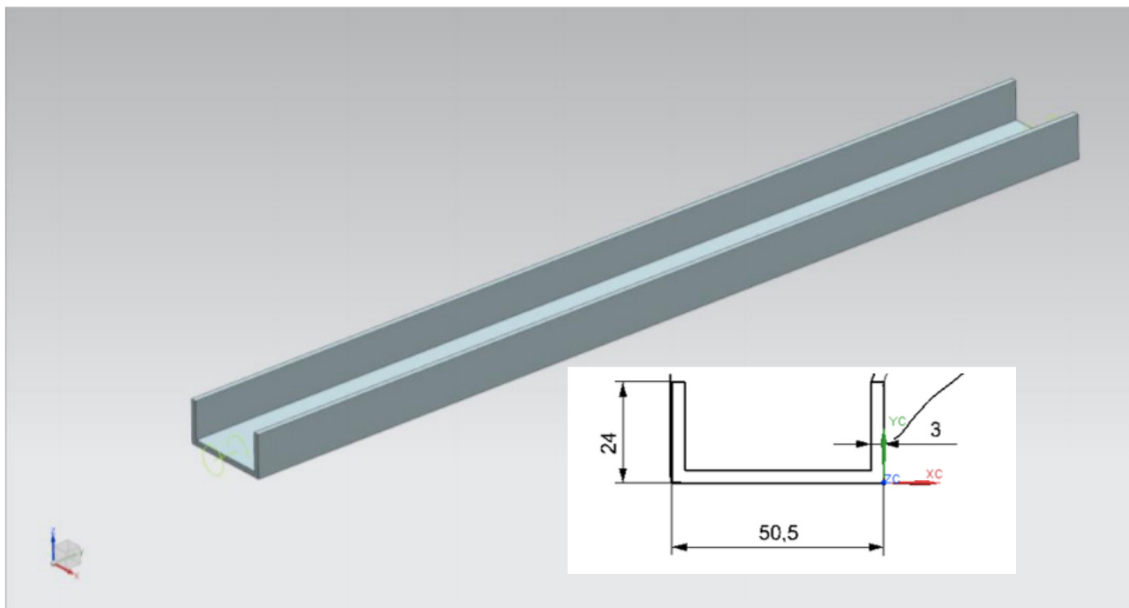
**Figure 12.** CAD model of the C-section of the longeron.

In this analysis, the FEA will be performed on the upper longeron structure modelled as a C-beam structure model. A 3D scanning was conducted on the actual longeron of the aircraft. This was followed by a CAD modelling of the C-sections of the longeron beam structure as shown in Figure 12. An FEA meshing and its boundary conditions were designated on the longeron 3D model. Finally, the strength reduction analysis against the thickness reduction of the longeron was carried out. The input parameters for the upper longeron design are shown in Table 1.

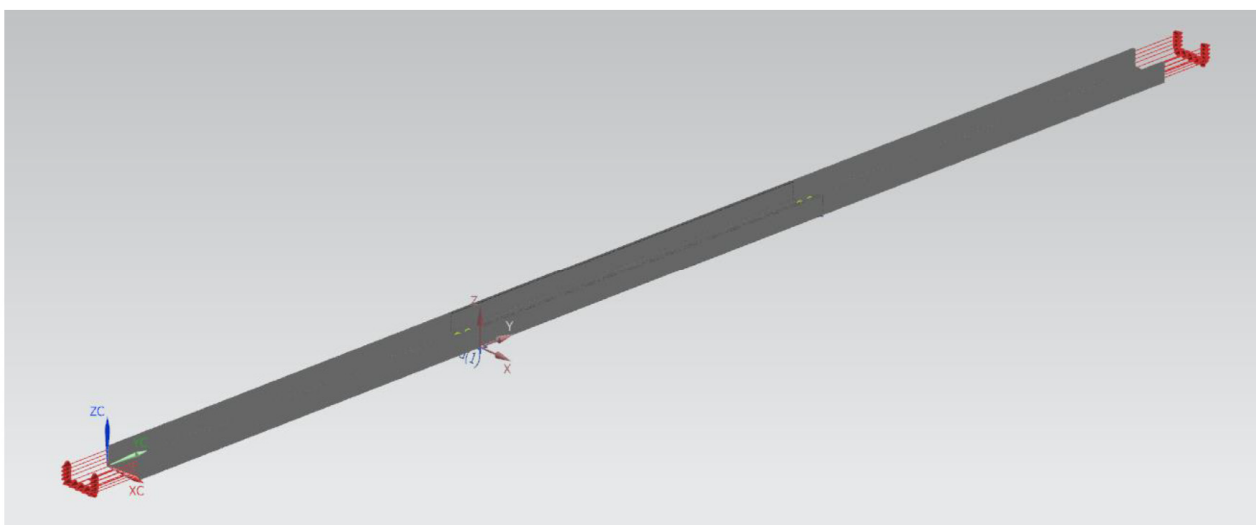
**Figure 13.** Load applied at the longeron.

An applied loading was placed on both ends of the longeron, as shown in Figure 13. Loading was altered by varying its value until the stress experienced by the longeron approaching its yield stress. The yield strength value of aluminium alloy Al2024 is 289.579 Mpa.

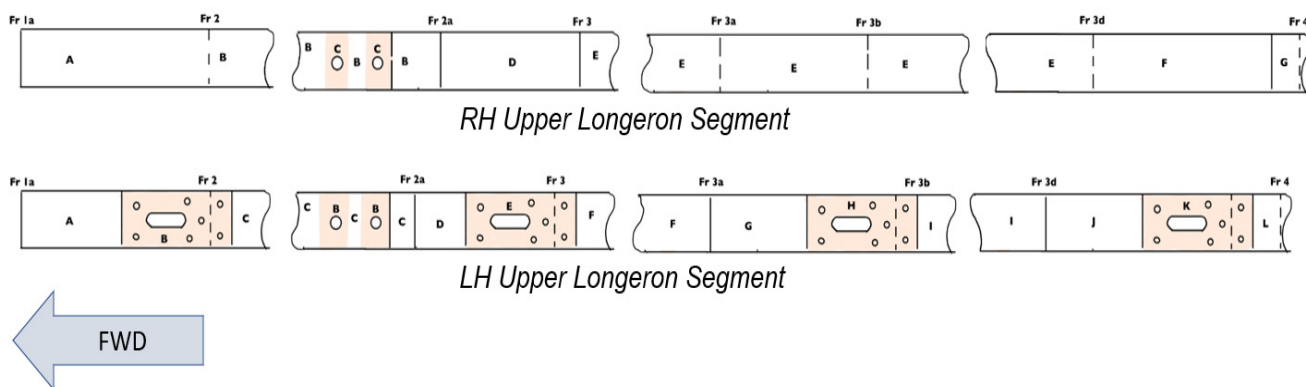
Figure 14. Segments on the longeron for inspection.

The left-hand (LH) and right-hand (RH) longeron were segmented based on Figure 14 for corrosion inspection. Upon blend of the corrosion, a strain gauge was installed at Section C on the RH longeron and Section B on the LH longeron as shown in Figure 15.

There were a few corrosion spots on the LH and RH longeron. Corrosion treatment work was carried out, which in return reduced the thickness of the longeron. The longeron has a thickness of  $2.7 \pm 0.2$  mm. Considering that the longeron's initial thickness (datum) is 2.7 mm, the structural area was treated and segmentized. Based on Table 2 and Figure 16, there was a thickness loss of 0.36 mm on the LH longeron. It is located between the two-lifting point. The detailed inspection and treatment result is depicted in Table 2.

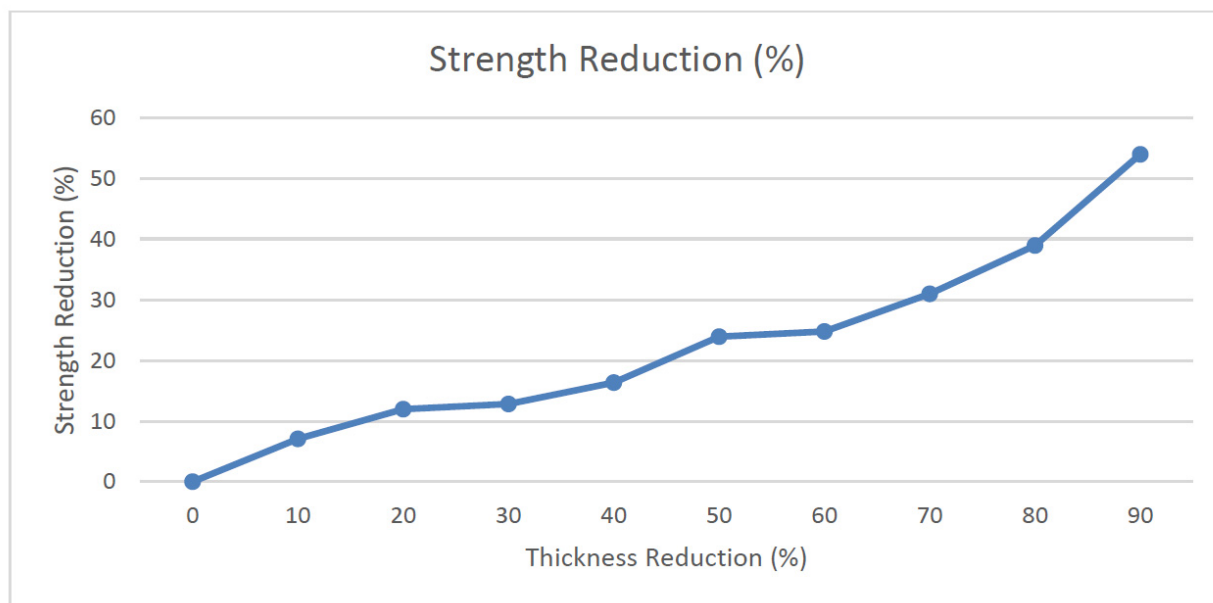
Figure 18. Strength reduction vs. Thickness reduction for upper longeron

Figure 18 below depicts the graph of strength reduction in percentage versus thickness reduction with an increment of 0.3 mm. Table 3 shows the details of the strength reduction of the upper longeron.

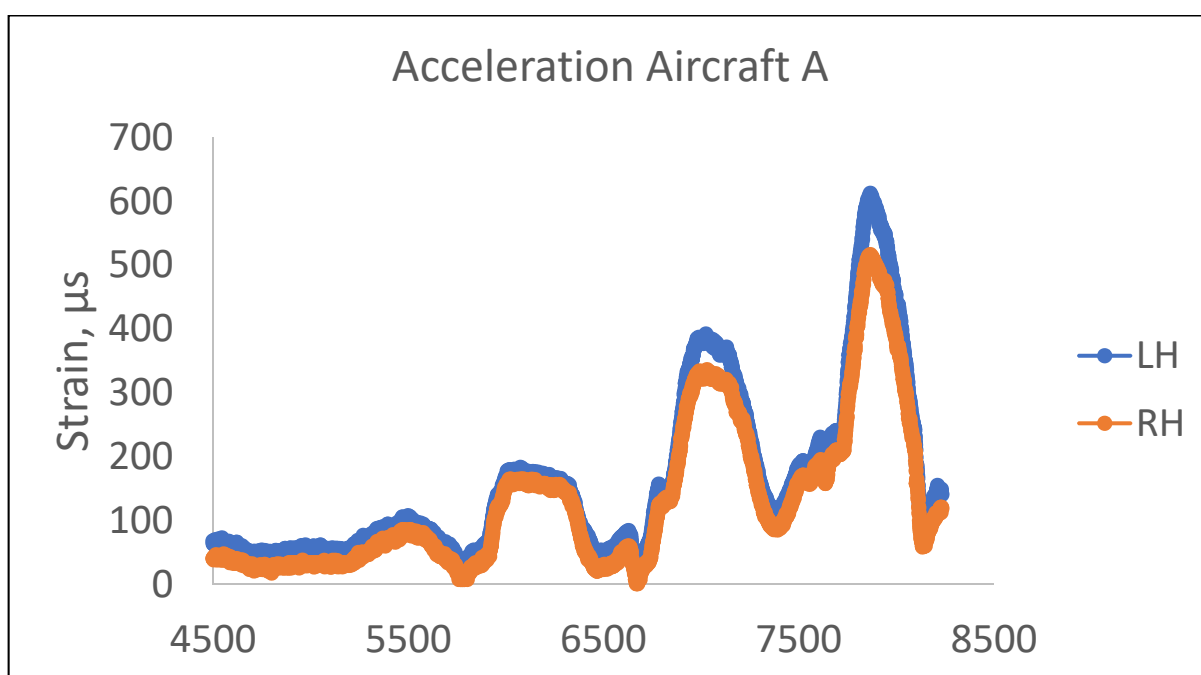
Figure 19. Acceleration data from aircraft flight test.

Based on Figure 19 and Table 4, there is a variation of strain recorded on either side of the longeron. The LH longeron has the highest strain recorded during the 6g acceleration, approximately around 612.5  $\mu\epsilon$  (44.1 MPa). Based on the corrosion severity data in Table 2, the LH longeron recorded the lowest remaining thickness, which contributed to the stress concentration point and recorded the highest strain. This also most likely shows that the location is subjected to a reduction in fatigue strength.
