Novel Method for Failure Modes Detection in UV-Cured Clear Coated Polymer for Automotive Interior Mechatronic Devices

Abstract: Plastic parts used in automotive interior are difficult to coat, due to their low surface energies as well as their sensitivity to temperature and solvents, rendering the development of coating systems for such substrates challenging. Automotive customer requirements are explicit and clear, mainly focused on functional and surface defects. A new failure modes detection methodology of UV clear coated polymers for automotive interior, obtained by a multi-step manufacturing process, is proposed. The polymer complex parts analyzed in this paper are manufactured in various steps as follows: two components plastic injection molding, primer coating, laser engraving, and UV-cured clear coating. The failure modes detection methodology of the parts within each process step is investigated using different tests and analyses as follows: surface tension test, painting adhesion test, optical 3D measuring, energy dispersive X-ray analysis (EDX), and microscopy. A design of the experiments (DoE) based on the Taguchi technique with the aim to detect the influence of the m

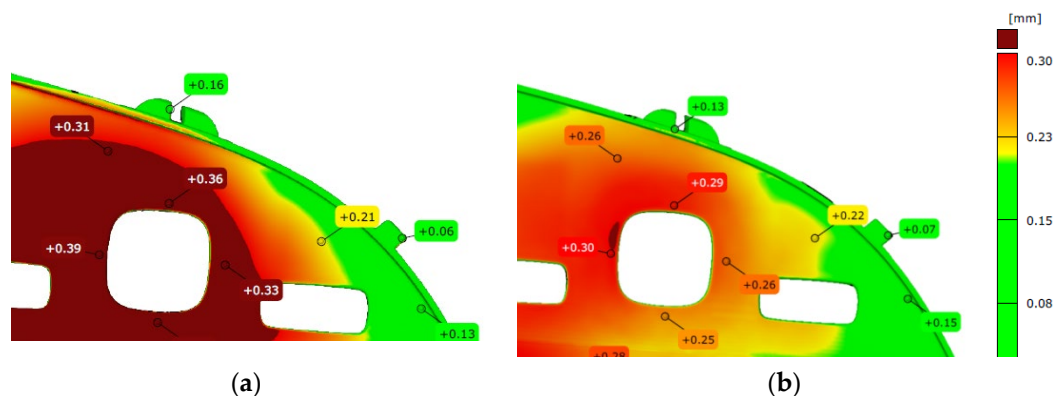
The parts produced in the eight different cavities of the mold were optical 3D measured to investigate their 3D shape. This factor was taken into analysis, supposing that the surface energy will be influenced by the 3D shape. A sample of three parts has been measured by optical ATOS Scan Box machine. The measurement results show that the parts out from the cavities 3, 4, 5, and 6, from the eight cavities of the mold, were detected with bigger deformations compared with the ones from the cavities 1, 2, 7, and 8 (Figure 6). These results do not lead to a clear link with the possible failure mode of fish-eye defects occurrence.

Figure 6. The results of optical measurements of: (a) a part out from the cavities 3, 4, 5, and 6; (b) a part out from the cavities the cavities 1, 2, 7, and 8.

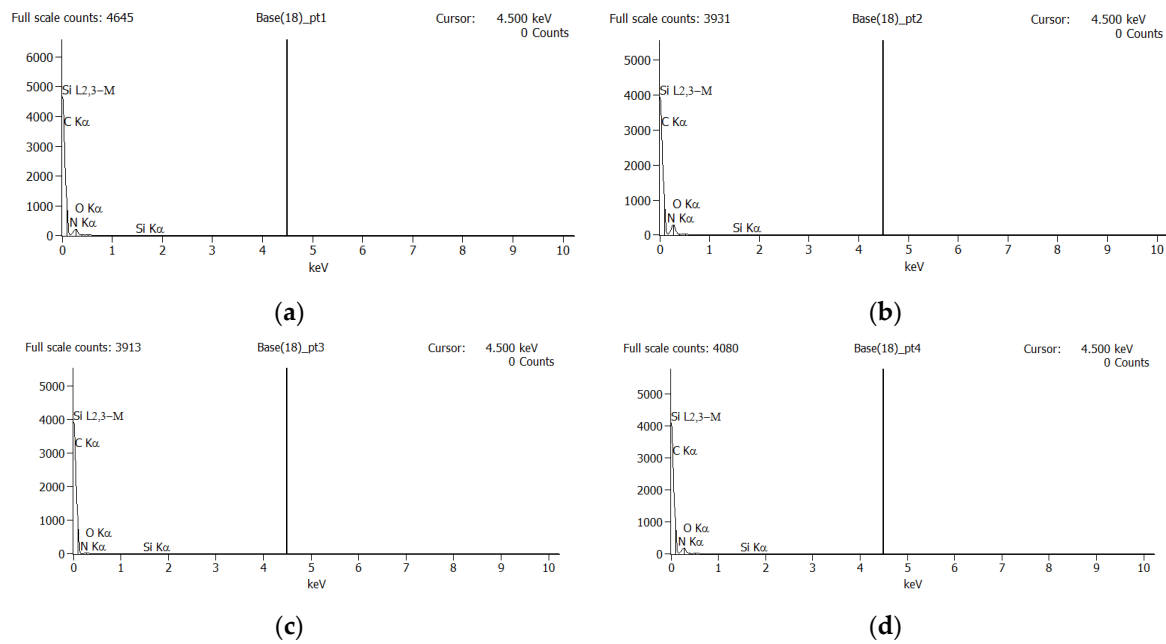
A number of three EDX analyses were performed within different areas which contain defects of the part, as shown in Figure 9. Four points were chosen for the first EDX analysis on the SEM image (Figure 9). Based on the results shown in Figure 10, only two EDX points are relevant (Point 1 and 2) for the following analysis. The results of the EDX analysis for the first area are presented in the Table 3. Similar EDX results, within only two points, were obtained for the other two interested areas from Figure 9. A possible contamination with a material such as oil or demolding spray during the injection process of the plastic part was checked by EDX analysis, and the results are shown in Figure 10.

The EDX analysis did not reveal any clear element that should not be present, because in the plastic substrate mainly hydrocarbons are present [16], and the base layer is also a hydrocarbon, so that the presumption of oil or release agent contamination was maintained.

Figure 10. EDX analysis for the four points within the case (a) from Figure 9: (a) Point 1; (b) Point 2; (c) Point 3; (d) Point 4.

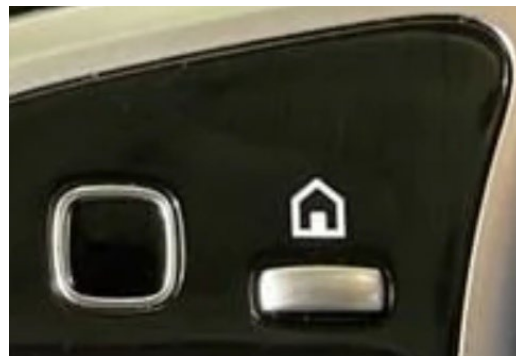
Laser-engraved parts after the black primer coating process are visually inspected to check that the paint has been completely removed. Microscopic analysis and measurements are performed to inspect the symbol line sizes as well as possible laser-etched edge defects (Figure 11). There were no defects detected from visual and the microscopic analysis, the process being optimized [36].

Figure 11. Laser engraving of the parts.

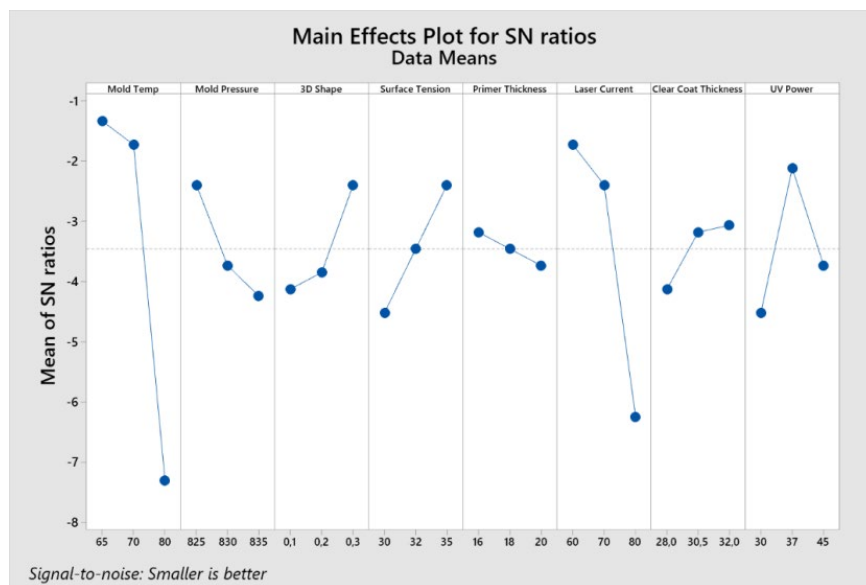
As can be seen, based on the ranking from the Table 4, but also in Figure 13, two factors have the most influence in fish-eyes defect occurrence: the mold temperature and the laser engraving current. In third and fourth places, the UV power and the surface tension could be selected as medium influence.

Figure 13. Main effects plot for Signal to Noise Ratios.

Therefore, based on the selected parameters and their levels, the DoE shows the optimal parameters combination to achieve the minimum quantities of the “fish-eye” defects as following: Mold Temp level 1, Mold pressure level 1, 3D Shape level 3, Surface Tension level 3, Primer thickness level 1, Laser current level 1, Clear Coat thickness level 3, and UV Power level 2. It must be underlined that the surface defects will be reduced by using the optimal combination, but not eliminated at all.
