Field Investigation of Clay Balls in Full-Depth Asphalt Pavement

The \$19.6 million interchange improvements and roadway reconstruction at the intersection of US-31 (two lanes in both directions) and SR 38 in Hamilton County, Indiana, were built in summer 2012. The amount of hot mix asphalt (HMA) was 63,818 tons for mainline, shoulders and ramps. The Average Daily Truck Traffic (AADT) was recorded as 24,814 in 2011.

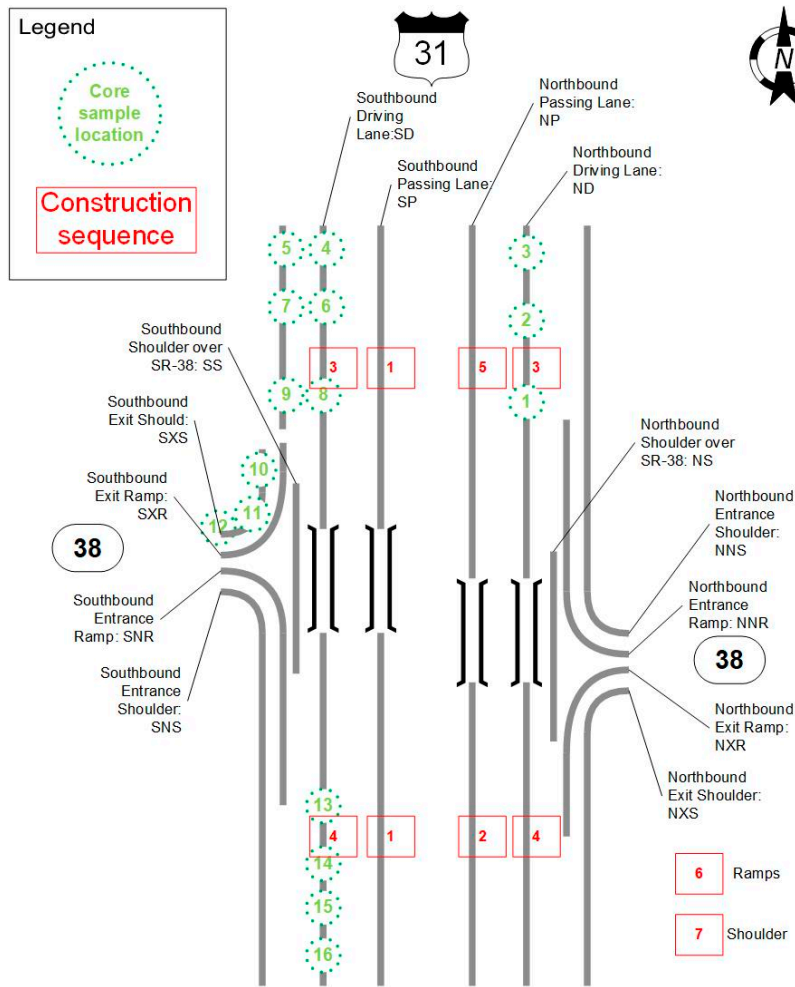
Two types of cores were taken: cores with clay balls and cores without clay ball from good and bad sections based on visual observation. Popouts were only observed at pavement surface, and thus the coring depth was 2 inches, which covered the entire surface course depth. These cores were drilled on 12 August 2013 and were delivered back to the laboratory for detailed inspection. Figure 2 presents a schematic plot that shows the project layout with core location and construction sequence. As shown, the cores were taken from paving sections with low frequencies of clay balls, such as core sample locations 4, 6, 8, and 13 to 16, as well as from paving sections with high frequencies of clay balls, such as core sample locations 5, 7, 9, 10, and 11. Cores were taken from driving lane, passing lane, shoulder, and ramp. Note that a couple of samples were taken within each core location, and a total of 633 cores were obtained.

Figure 2. Schematic of US-31 and SR-38 with core location and construction sequence.

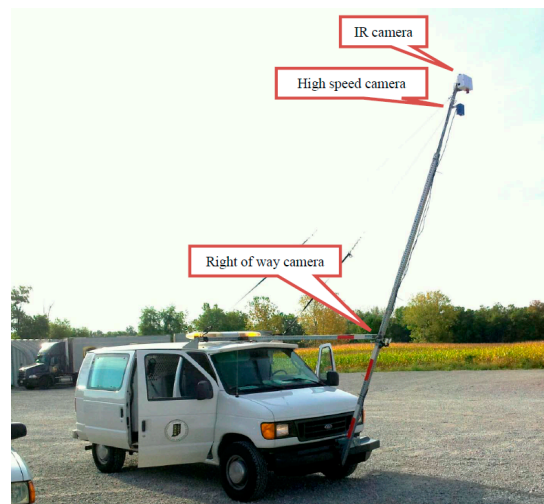
The detection of clay balls can be achieved by measuring the density or texture of asphalt pavement. Pavement sections with observed clay balls are usually characterized with extreme high in-place air voids or very non-uniform texture distribution [14,15]. In this study, in order to rapidly detect clay balls, pavement surface images were collected and analyzed using the INDOT pavement infrared image collection system integrated with an infrared (IR) camera, a gray scale high-speed camera and a right of way camera (iPhone 4S) as shown in Figure 3. The system consists of a van, three cameras that were fixed to a bar, and a computer to acquire image data. As shown, the IR camera was placed at the very top of the bar and took photos that were perpendicular to the pavement in vertical direction. The gray scale high-speed camera was set in the middle. The right of way camera was put close to pavement surface which was used to capture clay ball. A distance measuring instrument (DMI) system was used to measure the distance the van drove. The IR camera was triggered at a fixed distance based on DMI data. The right of way camera embedded an iPhone 4S cell phone to take photos and used GPS to determine location. Both cameras covered the width of one entire traffic lane. The operation speed ranged between 5 and 10 mph. The image collection was conducted from 9:30 to 15:30 on 17 September 2013. Two replicates were conducted in the morning and in the afternoon, respectively to avoid any potential test error.

Figure 3. Infrared image collection system.

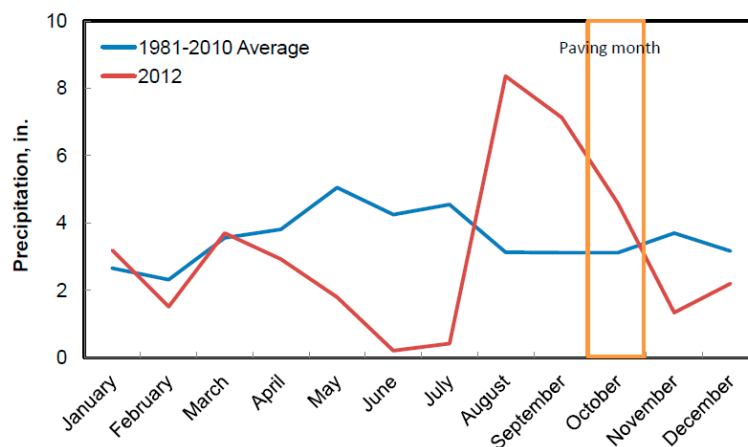
During paving, there were seven raining days, and no construction was conducted on those days. Figure 8 shows precipitation distribution within each month in 2012, as well as the average monthly precipitation based on years from 1981 to 2010. It is shown in the figure that precipitations in October 2012 were much high compared to its companion averaged from 1981 to 2010.

Figure 8. Comparison of monthly precipitations.
