# Repair of Block Masonry Panels with CFRP Sheets

**Abstract:** In the 1980s, block masonry started to be widely used for new constructions in Italy's earthquake prone areas. However, recent seismic events demonstrated that block masonry buildings may need to be repaired after earthquakes due to cracking. Construction defects are the main cause for cracking of block work masonry. Carbon fiber reinforced polymer (CFRP) sheets have been used as a local repair method for non-defective and defective wall panels. An experimental program was formulated to investigate the shear behavior of block masonry walls repaired with CFRP sheets. A total of six wall panels were constructed in the laboratory and tested in shear (in-plane lateral loading). It was found that, although the control (non-defective) wall panels had a high ultimate load capacity, the use of CFRPs reduces the effects of construction defects and restores the lateral load capacity in non-defective walls. Overall, this research suggests that the use of epoxy-bonded CFRP sheets could be used for local repair of cracked wall panels.

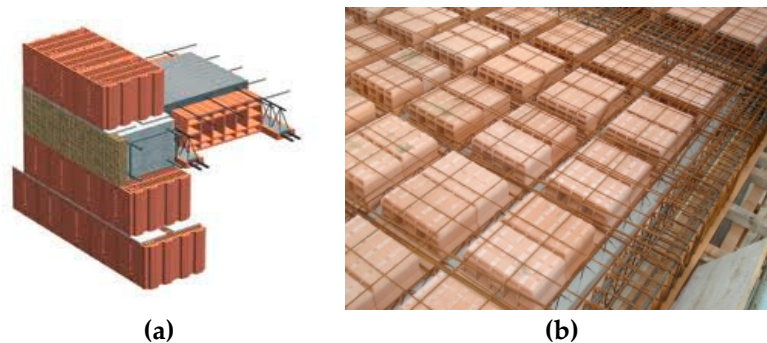
The typical construction method of hollow clay block masonry in Italy consists in the use of 25–40 cm thick blocks, to form a single-wythe wall, and a cement mortar. In order to reciprocally connect the walls, and prevent out-of-plane collapse mechanisms, the Italian Building Code requires the construction of ring beams at each floor level and at the eaves level. These are typically made of a reinforced concrete (RC) [31]. The horizontal and roof diaphragms are usually made of 1-way steel-reinforced concrete joists, tile hollow blocks and a 4–5 cm-thick slab reinforced with steel-wire mesh. The joists are fixed to the ring beams and both the ring beam and the slab are cast simultaneously (Figure 4). This construction method was very common in Umbria in the area struck by the 2016 earthquake.

**Figure 4.** (a) Detail of the area near the RC ring-beam, (b) a horizontal diaphragm and ring beams ready for casting.

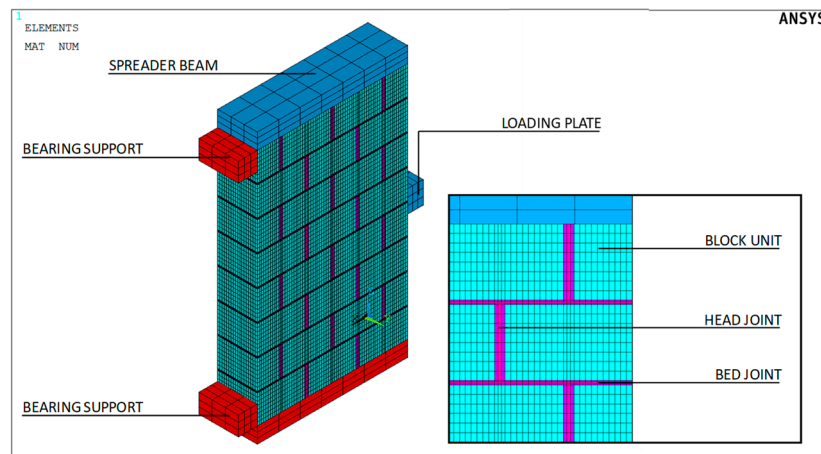
Figure 7. FE model with mesh discretization.

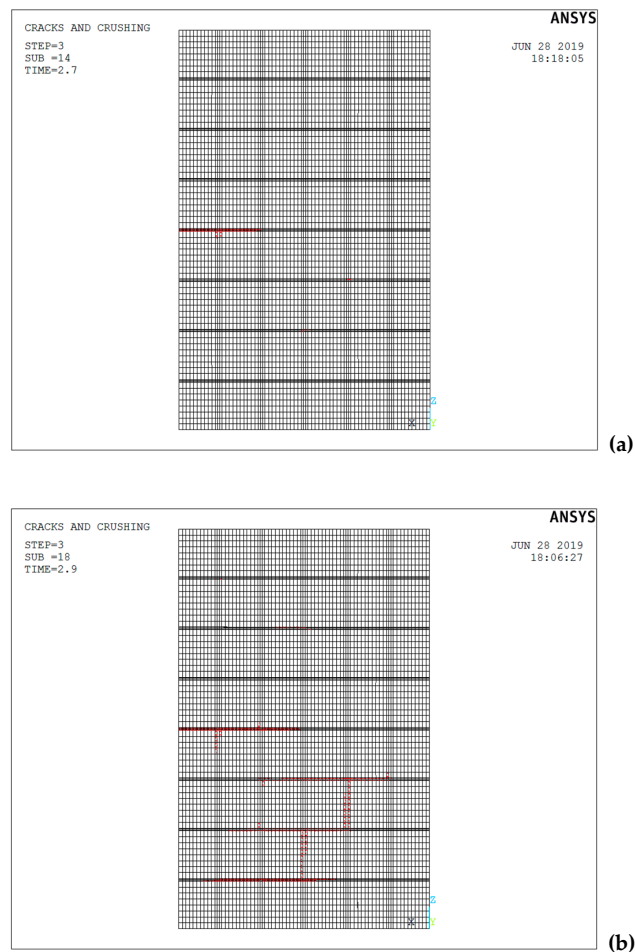
A numerical analysis was thus performed, in which the FE model was firstly subjected to both self-weight and a distributed pressure load, followed by a ramped 10 kN horizontal load. Figure 8 shows the failure progression sequence observed during the FE analysis on the block masonry panel. Cracking is not present on the whole specimen, but mainly on its lower half. In detail, following the opening of a predominant horizontal crack at the panel mid-height (Figure 8a), stepped diagonal cracks developed (through bed and head joints) along the compressed diagonals (Figure 8b), when the interface bond strength was attained.

**Figure 8.** FEM crack pattern: (a) opening of the horizontal crack; (b) stepped diagonal cracks.

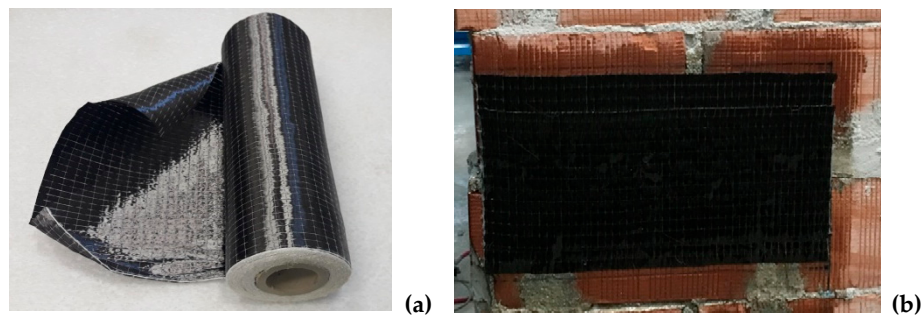
**Figure 11.** (a) Uni-directional CFRP sheet, used for local repair, (b) detail of a repaired wall panel.

To repair the wall panels, only one type of CFRP composite was used: this was made from carbon fibers embedded in an epoxy resin matrix to form a unidirectional CFRP sheet, as shown in Figure 11. The 0.165 mm thick CFRP sheet had a tensile strength of 3,324 MPa with a tensile modulus of 312.2 GPa (Table 2). The rupture strain was 1.07%. The same epoxy resin employed to cure the carbon fibers was also used to apply the fibers to the wall's surface. The epoxy resin is produced by Kimia, under the brand name Kimitech-ep-in: this is a low-viscosity, transparent, bi-component product. The manufacturer declares in the data sheet a compressive strength of 65 MPa, and a tensile strength of 30.4 MPa. The weight density of the epoxy resin is 1.08 g/cm<sup>3</sup>. The surface of the wall panels was not treated to improve the bond performance: the CFRP was directly glued to the tile blocks.

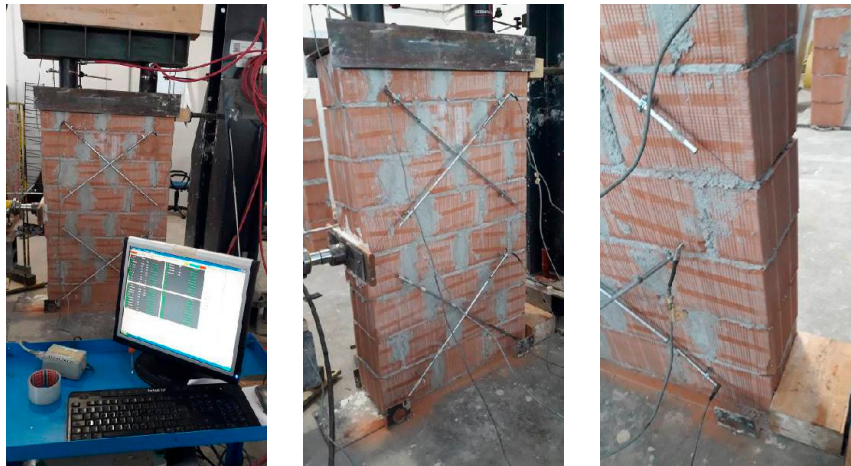
Following the initial application of the vertical load, up to the limit of 45 or 67.5 kN (corresponding to a compressive stress of 0.2 or 0.3 MPa, respectively), the shear horizontal load was applied in cycles of increased magnitude, up to failure (Figure 14). The overall structural response of the walls was very satisfactory, with high lateral load capacities varying between 150.55 and 182.98 kN, corresponding to a shear strength of 0.2493–0.3187 MPa. If these values are compared with the shear strength of other types of masonry (solid bricks, stonework, etc.), the hollow block masonry results are much stronger [39,40]. As soon as the principal tensile stress reaches the tensile strength of the cement mortar, a crack forms and failure occurs.

Figure 14. Non-defective wall panels.

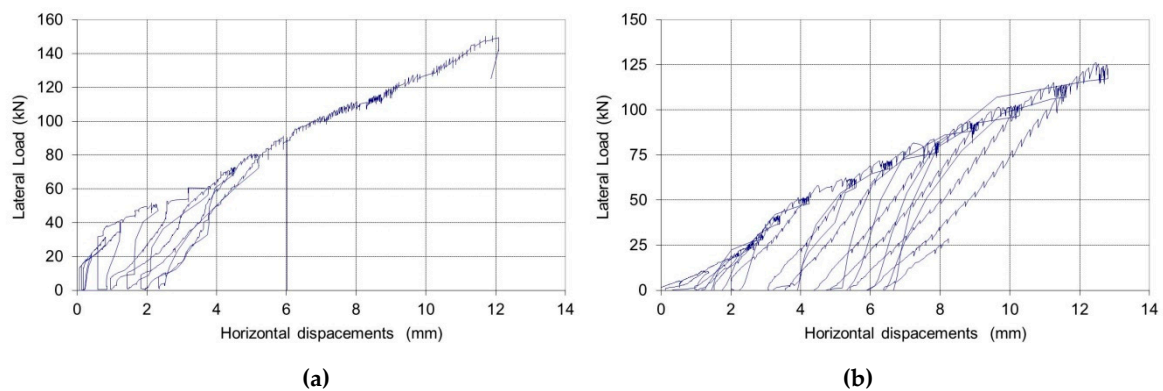
The panels’ response in terms of deformations (horizontal displacements of the LVDT D5 along the panel’s line of symmetry, exhibited a linear lateral load-horizontal displacement relationship for low horizontal loads, turning un-linear near the failure load. Figure 17a shows the lateral load vs. horizontal displacement for the non-defective (P1-ND-30).

**Figure 17.** (a) Lateral load vs. horizontal displacement for non-defective (P1-ND-30), and (b) for the defective panel (P5-DE-20).

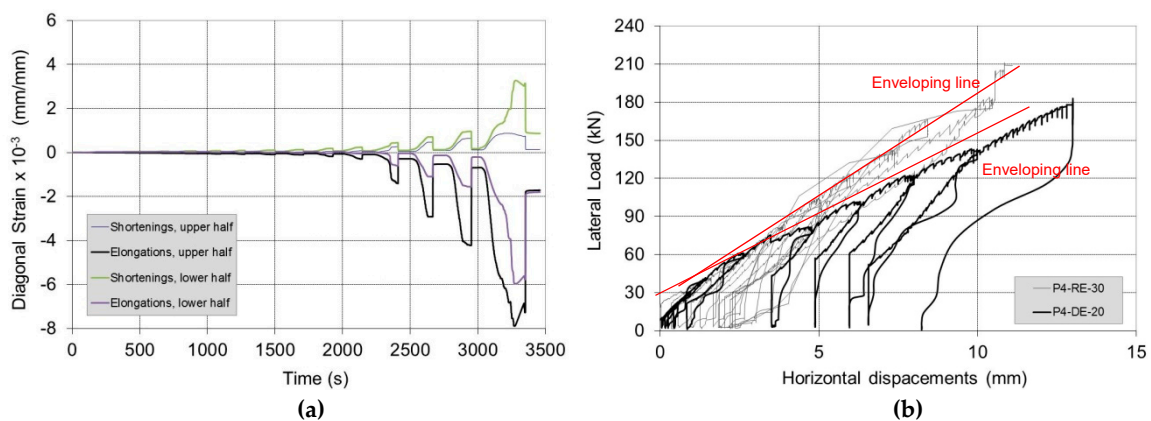
**Figure 20.** (a) Diagonal strains for Test No. P4-RE-30, (b) Panel No. 4, before (up to horizontal cracking) and after repair: lateral load vs. horizontal displacements.

Figure 20b compares the structural response of Panel No. 4 before and after repair. It can be noted how the application of the CFRP sheet caused an increase in the lateral capacity (although the vertical compressive stress was 0.2 MPa for the P4-DE-20 test and 0.3 MPa for the P4-RE-30 test). In terms of lateral stiffness, it is worth noting that the slopes of the enveloping lines of the curves are very similar. The CFRP repair did not change the shear stiffness of the panel, but only acted to prevent the re-opening of the bending horizontal crack.
