Case Report

Fracture of the Femoral Component Caused by Insufficient Crimping after Modern Unicompartmental Knee Arthroplasty

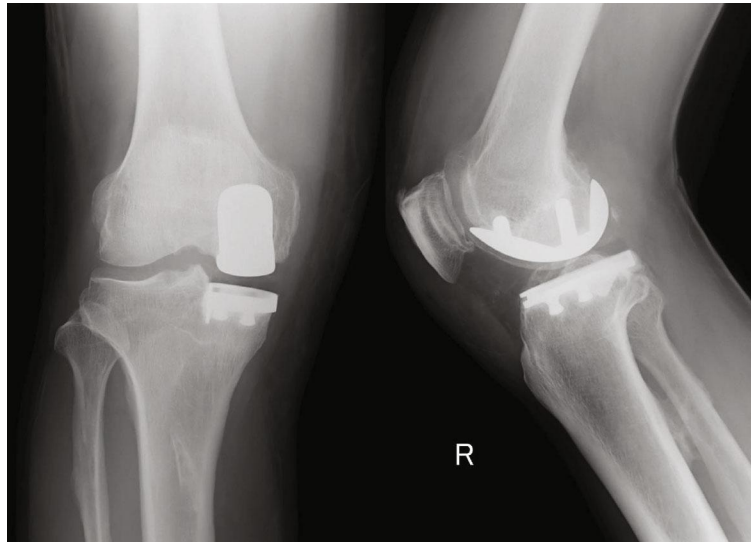
FIGURE 1: Immediate postoperative radiography demonstrating good implant position and alignment.

during the perioperative period. The postoperative knee range of motion was 0° – 140° , and no knee instabilities were noted. No abnormalities and problems with the positioning of the component were noted on the postoperative radiograph (Figure 1).
