Erosion and Corrosion Resistance Performance of Laser Metal Deposited High-Entropy Alloy Coatings at Hellisheidi Geothermal Site

Andri Isak Thorhallsson ^{1,*}, Francesco Fanicchia ², Emily Davison ², Shiladitya Paul ²

Abstract: Geothermal process equipment and accessories are usually manufactured from low-alloy steels which offer affordability but increase the susceptibility of the materials to corrosion. Applying erosion-corrosion-resistant coatings to these components could represent an economical solution to the problem. In this work, testing of two newly developed laser metal deposited high-entropy alloy (LMD-HEA) coatings—CoCrFeNiMo_{0.85} and Al_{0.5}CoCrFeNi, applied to carbon and stainless steels—was carried out at the Hellisheidi geothermal power plant. Tests in three different geothermal environments were performed at the Hellisheidi site: wellhead test at 194 °C and 14 bar, erosion test at 198 °C and 15 bar, and aerated test at 90 °C and 1 bar. Post-test microstructural characterization was performed via Scanning Electron Microscope (SEM), Back-Scattered Electrons analysis (BSE), Energy Dispersive X-ray Spectroscopy (EDS), optical microscopy, and optical profilometry

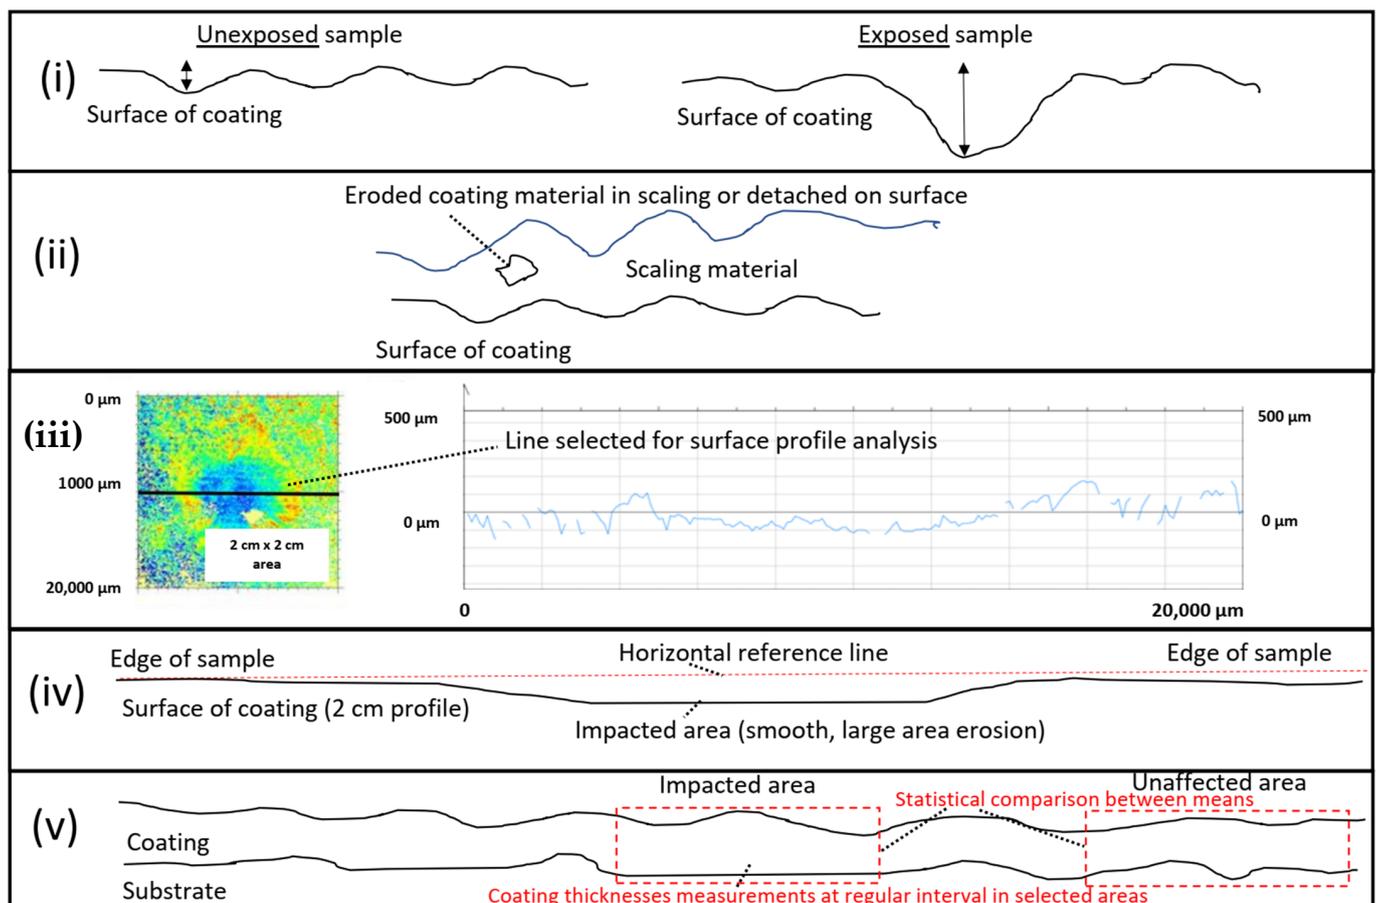
Figure 1. Methods for erosion assessment in our study: (i) erosion pit and shape comparison with an unexposed sample, (ii) coating material detached from the surface or within scaling, (iii) roughness measurements with optical profilometry, (iv) analysis with horizontal line adjacent to 20 mm length surface by image splining, and (v) statistical analysis of coating thicknesses in impacted area vs. unaffected area.

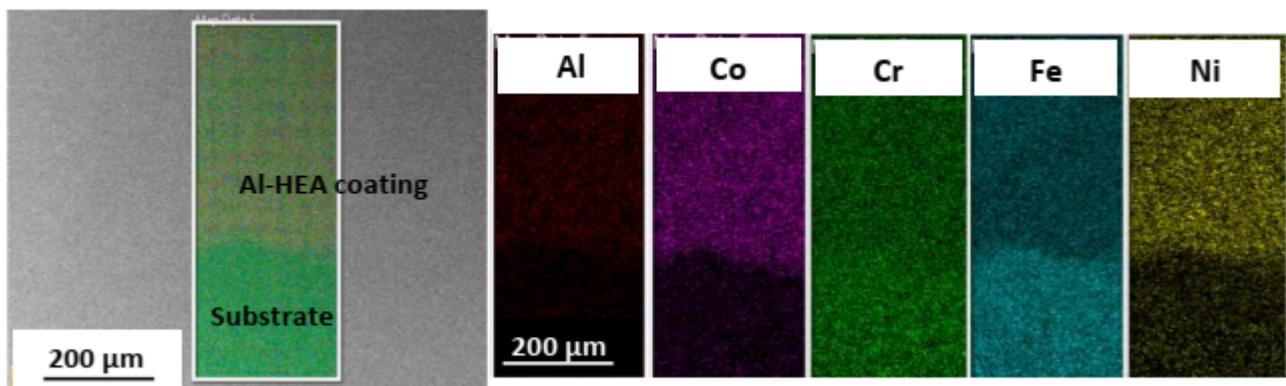
The Al-HEA coating in sample Al-HEA-304L contains Al but not Mo as in the Mo-Coating. In the comparison of Al-HEA coating with the Mo-HEA coating, a more homogeneous microstructure can be observed in the Al-HEA coating material, with the appearance of a more single-phase matrix as seen in Figure 7.

Figure 7. Elemental mapping of the boundary between Al-HEA coating and the 304L substrate.
