Defibrillation threshold testing: What is all that noise?

KEYWORDS Defibrillation threshold testing; Device explantation; High-voltage shock; Implantable cardioverter-defibrillator; Noise (Heart Rhythm Case Reports 2019;5:457–460)

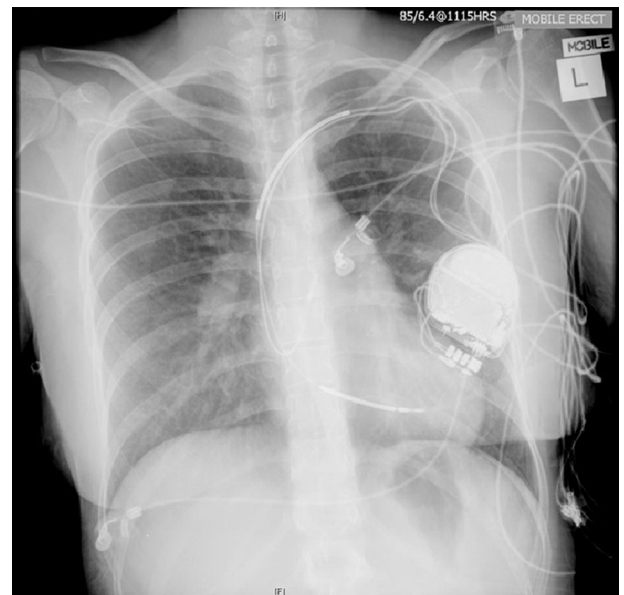
Figure 1 Chest radiograph showing submammary position of implantable cardioverter-defibrillator generator, dual-coil right ventricular shock lead, and right atrial lead.
