# Optical Properties of Thomson Scattering Diagnostics Lower Window Glass under Laser Irradiation

**Citation:** Zhou, J.; Zang, Q.; Zhao, J.; Xiao, S.; Che, Y.; Ren, M. Optical Properties of Thomson Scattering Diagnostics Lower Window Glass under Laser Irradiation. *Materials* **2021**, *14*, 2702. <https://doi.org/10.3390/ma14112702>

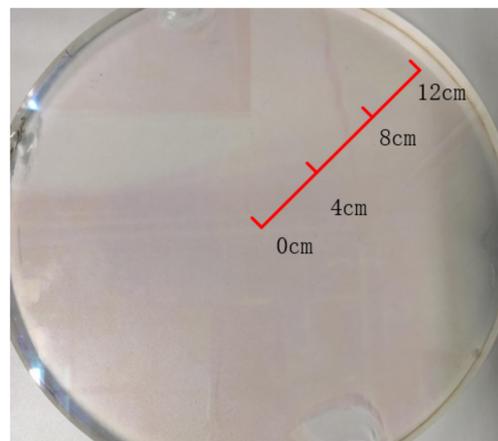
Figure 2. Window glass under Thomson scattering diagnosis, 28 cm in diameter and 2 cm in thickness.

After a round of experiments, three positions were randomly selected: the center position ( $R = 0$  cm) and two other positions ( $R = 4$  cm and  $R = 12$  cm), as shown in Figure 2. The transmittance was measured and compared based on the sample position on the glass, as shown in Figure 3a,b.

After the experiment, the surface coating was observed and analyzed by a high-power microscope and XPS. We re-polished the glass with the same parameters as before the glass coating. The transmittance was measured with a spectrophotometer at different positions before and after the coating was polished, and the polished glass was analyzed by Raman scattering and EPR. Its B class of Stripe degrees, Level 2 of optical uniformity, Level 3–4 of surface roughness and plane consistency of PV value.
