Cause Analysis of the Large-Scale LPG Explosion Accident Based on Key Investigation Technology: A Case Study

ABSTRACT: Blending dimethyl ether (DME) into liquefied petroleum gas (LPG) has become a common phenomenon. On December 3, 2019, an LPG/DME explosion occurred in Beijing, resulting in 4 deaths and 10 injuries. To deeply investigate the cause and explosion process of the explosion accident, the accident investigation method combining on-site inspection, material evidence analysis, experimental verification, and logical reasoning was used. In addition, the location of the ignition point, the explosive substances, the cause of the gas leakage, the process and the distribution characteristics of the gas leakage, and the ignition process were successively reasoned and analyzed in detail. The results show that the LPG/DME-blended gas can effectively corrode silicone flange gaskets, forming laminar fractures and radial cracks on the gasket. As a result, the tensile strength of the gasket decreased. Under the action of the gas pressure inside the pipeline, the gasket was torn and a leakage hole was formed. The leaked combustible gas formed at least 305 m³ of the explosive gas mixtur

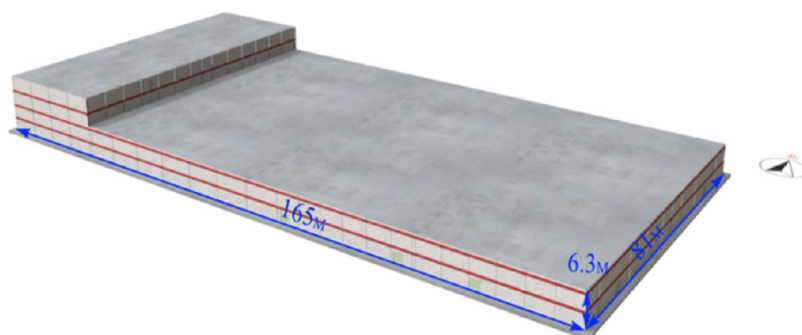
**Figure 1.** Overview of the production workshop where the explosion occurred.

At around 2:43 a.m. on December 3, 2019, an explosion occurred in the first-stage production workshop of Kyo-Nichi Todai Foods Co., Ltd. in Niulanshan Town, Shunyi District, Beijing, resulting in 4 deaths and 10 injuries, serious workshop damage, and direct economic losses of 2.02 million dollars. The production workshop where the explosion occurred is a brick and concrete structure building with one floor above ground and part of two floors above ground. It is 165 m long from east to west, 81 m wide from north to south, and 6.3 m high, as shown in Figure 1. Figure 2 shows the relative location

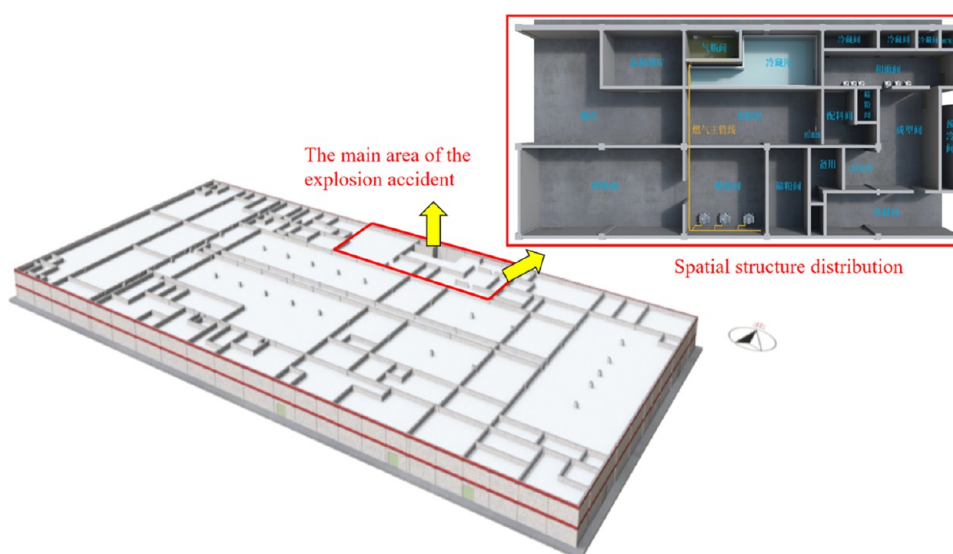
**Figure 2.** Relative location and the three-dimensional spatial structure distribution of the main explosion accident area.

and the three-dimensional spatial structure distribution of the main explosion accident area.

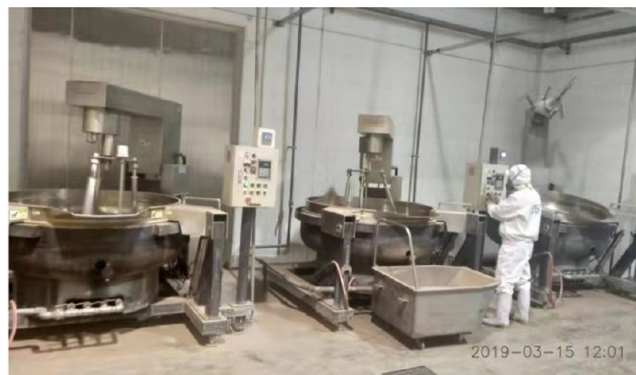
Figure 7. LPG stir-frying machines before the explosion.

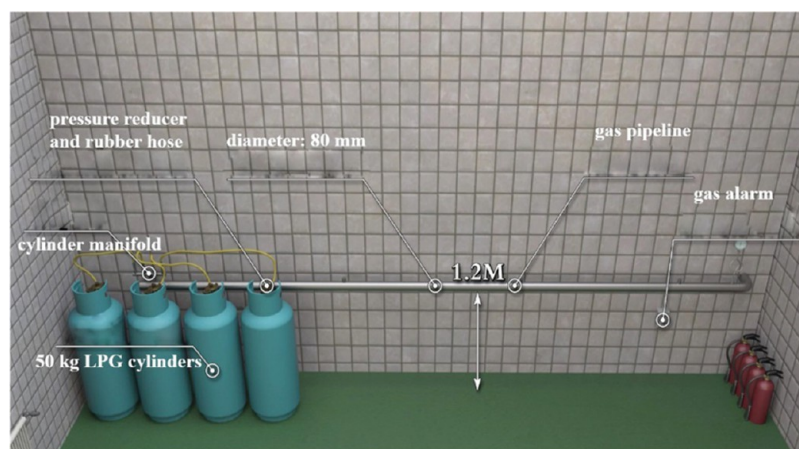
Figure 8. Connection condition of gas cylinders and the gas pipeline in the gas cylinder room.

2.3.1. Conditions of the Gas Pipeline Connection. On the northwest side of the workshop, a gas cylinder room with a width of 5.76 m and a depth of 2.7 m was partitioned by 240 mm thick perforated lightweight bricks. The partition wall extended up to the ceiling and was about 5.5 m high. The ceiling of the gas cylinder room was 3 m high, and the door was directly opened to the outside. Before the accident, there were four 50 kg LPG cylinders in the southeast corner of the gas cylinder room, which were connected to a gas pipeline with a diameter of 80 mm through the cylinder manifold. Forced ventilation facilities were located in the northeast corner to vent outside the roof. The main layout is shown in Figure 8.

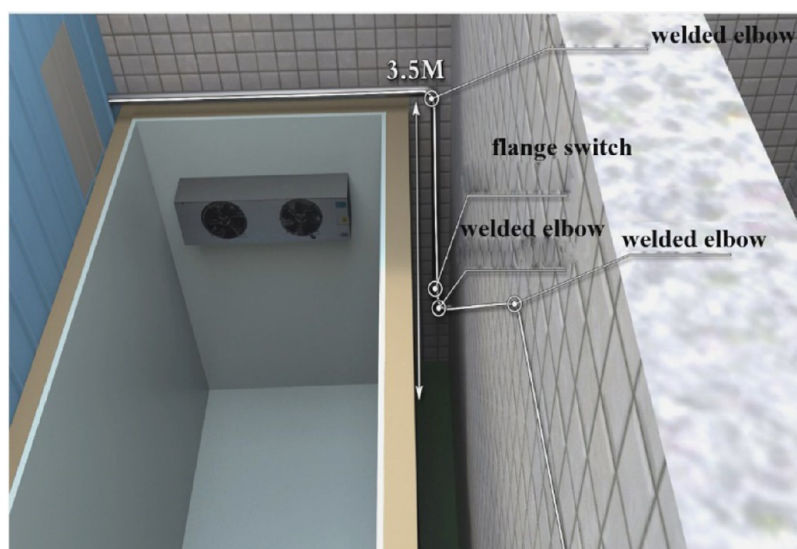
Figure 9. Connection condition and locations of the ball valve and the flanges.

ball valve was about 10 cm upward from the bend). The inlet and outlet of the ball valve were connected to the pipeline using flanges. An access hole was set on the partition wall of the refrigerated storage corresponding to the location of the ball valve, as shown in Figure 9. Then, the pipeline bent to the south at a height of about 3.5 m above the ground, crossed the roof of the refrigerated storage along the west wall of the building, passed through the partition wall on the south of the refrigerated storage and the south wall of the raw material storage, extended to the south wall of the stir-frying powder room, extended to about 30 cm from the ground through three vertical pipes, and finally, connected to three LPG stir-frying machines using hoses. The connection condition of the entire gas pipeline is shown in Figure 10.

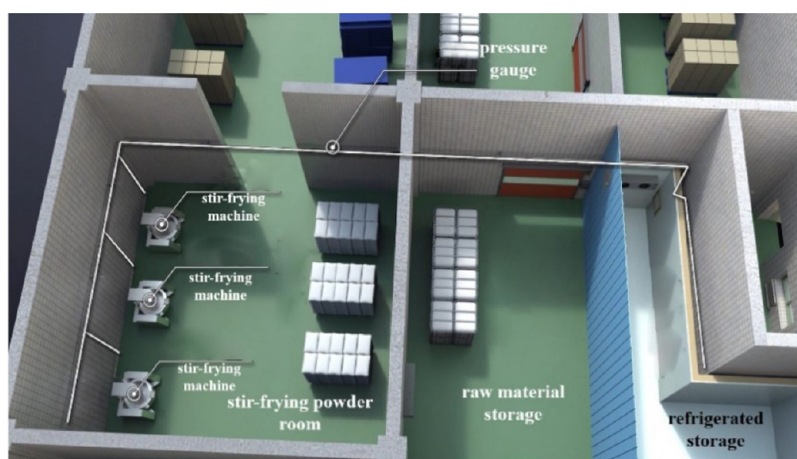
Figure 10. Connection conditions of the entire gas pipeline.

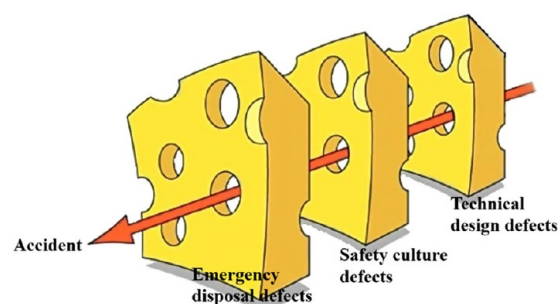
Figure 14. Three defects in the process of accident preparation based on the cheese principle.

there are defects in the three links and, under specific conditions, the defects match, the light passes, leading to the explosion. The process of the explosion is shown in Figure 14.
