Research Article

Failure of Polyethylene Inlays in Cementless Total Hip Arthroplasty: A Retrieval Analysis

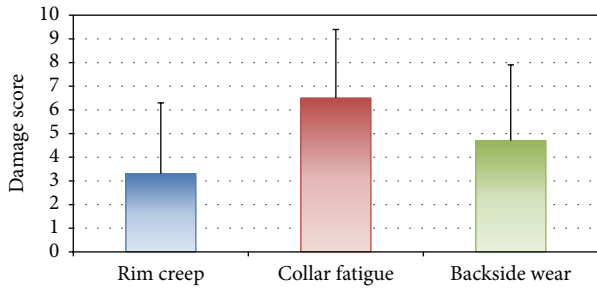
3.2. Damage Scores. Rim creep was present in 38% of the polyethylene inlays, whereas backside wear was seen in 90% of the inlays and collar fatigue occurred in 68% of the cases. The total damage score ranged from 1 to 27 (14.5 ± 7.2). Examples for a severe damaged inlay (damage score = 26.5) and an inlay with low damage (damage score = 1) are shown in Figure 4. The assessed damage scores for each type of damage are given in Figure 5.

FIGURE 5: The scores are given for each type of damage. The mean and the standard deviation are shown.

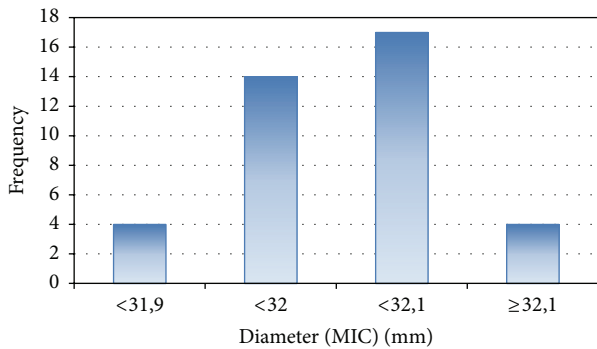
Depending on the analytical approach the diameters varied between $31.997 \pm 0.127 \text{ mm}$ (MIC), $32.166 \pm 0.163 \text{ mm}$ (LSC), and $32.334 \pm 0.253 \text{ mm}$ (MCC). Regarding the MIC diameter, 35 of the 39 inlays (90%) had a diameter of 32.1 mm or less, and 18 inlays (46%) had a diameter less than 32 mm (Figure 6).

FIGURE 6: Distribution of the cup opening diameter of the 39 inlays.

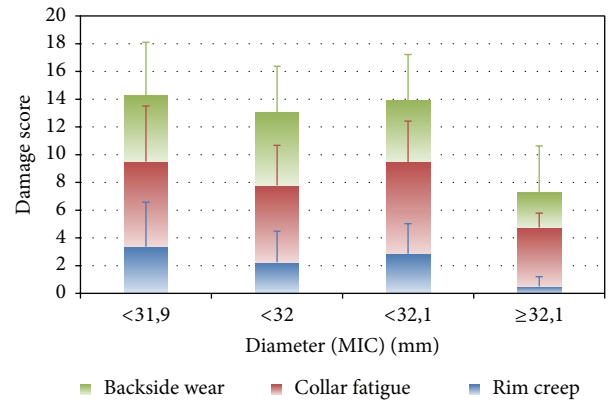
In Figure 7 the damage scores are compared depending on the cup opening diameter. Lower damage scores are obvious if the cup opening is equal to or greater than 32.1 mm. For rim creep this difference was statistically significant ($p = 0.008$).

FIGURE 7: Comparison of the damage scores depending on the cup opening diameter. The total height of the bars corresponds to the total damage score. The mean values and the standard deviations are shown.

This assumption is supported by the observation that the damage scores were smaller if the cup opening diameter was above 32.1 mm (Figure 7).
