Effects of Starter Defect on Energy Release Rate of Three-Point End-Notch Flexure Tested Unidirectional Carbon Fiber Reinforced Polymer Composite

Abstract: The mechanics of damage and fracture process in unidirectional carbon fiber reinforced polymer (CFRP) composites subjected to shear loading (Mode II) were examined using the experimental method of the three-point end-notch flexure (3ENF) test. The CFRP composite consists of $[0^{\circ}]_{16}$ with an insert film in the middle plane for a starter defect. A 3ENF test sample with a span of 50 mm and interface delamination crack length of 12.5 mm was tested to yield the load vs. deformation response. A sudden load drop observed at maximum force value indicates the onset of delamination crack propagation. The results are used to extract the energy release rate, G_{IIC} , of the laminates with an insert film starter defect. The effect of the starter defect on the magnitude of G_{IIC} was examined using the CFRP composite sample with a Mode II delamination pre-crack. The higher magnitude of G_{IIC} for the sample with insert film starter defect was attributed to the initial straight geometry of the notch/interface crack and the toughn

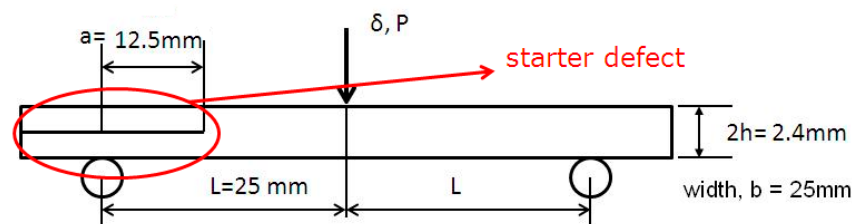
Figure 1. End-notched flexure test set up with sample having starter defect.

The three-point end-notch flexure test was carried out according to the ASTM D790 and ESIS 3ENF test protocols. The 3ENF test sample was 25 mm wide, 70 mm total length, and the initial crack length was 12.5 mm. The ratio of the length of the starter defect to the half span was fixed at 0.5. The 3ENF tests were carried on an Instron 8501 universal testing machine using a 5 kN load-cell, with 1 mm/min crosshead displacement, and with load applied at the mid-point (Figure 1).

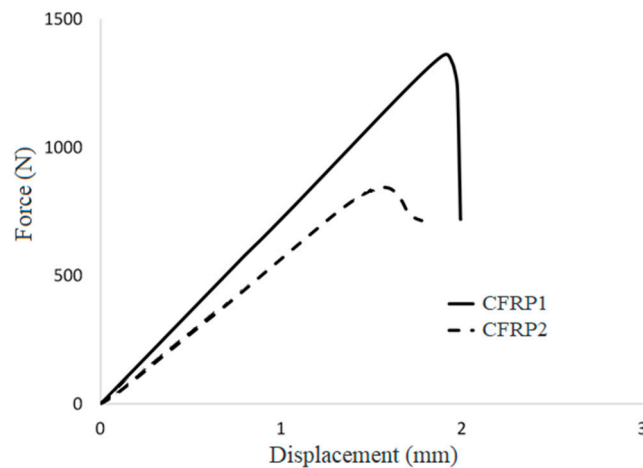
Figure 2. Typical load vs. displacement curves of the carbon fiber reinforced polymer (CFRP) composites under three-point end-notch flexure (3ENF) test.

Typical load vs. displacement curves resulted from the 3ENF test on the particular unidirectional CFRP composites with two types of starter defects are depicted in Figure 2. The CFRP composite with insert film as starter defect (CFRP1) showed that force increases linearly, reaches a peak value, and experiences a sudden load drop. This brittle failure response, in which sudden drop occurred after the composite reached its fracture point, is typical for CFRP composites under flexural loading [13–15]. CFRP composites may at times exhibit stiffness degradation (decreasing slope of the curve) just before failure [15]. However, this particular composite seemed to not show such a phenomenon. For CFRP composite with mode II pre-crack as starter defect (CFRP2), the force linearly increases, followed by a nonlinear increase to reach the peak value, and declines nonlinearly within short displacement range after reaching peak value, then finally drops. The CFRP2 samples seem to exhibit degradation of stiffness just before failure [15].

In terms of point of failure, CFRP1 failed at a higher peak load and at a higher elongation at break than CFRP2. The former's slope was also higher than that of the latter. There are some possible reasons for CFRP1 (sample with insert film as starter defect), showing both higher stiffness and strength compared to its Mode II pre-cracked counterparts (CFRP2). First, there are resin bags adjacent to the thin film in CFRP1 (Figure 3), while there is none in CFRP2. This resin bag is vested in CFRP1, considering the fabrication method, in which the thin film used to make the end-notch region was actually slotted within stacks of pre-pregs [16,17]. The consequence of these resin bags is the occurrence of sites with lower fiber fraction ratio (higher matrix content). Hence, the higher elongation at break shown by CFRP1. The second reason for the higher stiffness, strength, and elongation at break of CFRP1, compared to those of CFRP2, is that the interface adhesion between the matrix and carbon fiber in the former was higher than it was in the latter. The cause for this difference in interfacial adhesion might be in part from the subpar performance of the CFRP2. If the first reason is true, in which there are sites with lower fiber volume fractions in CFRP1, then CFRP2 which contains no such site should exhibit higher stress and strain. Causes for this include the induced microcracks at the fiber-matrix interface and more areas of shear stress concentration, both of which may possibly occur if the crack front is wider than when the starter crack was a thin film. In other words, the crack front is curved or nonlinear, as opposed to its linear initial condition, similar to the crack front feature in previous reports [16,18].

Another trial was made on the CFRP2 sample by subjecting it to another round of 3ENF test, herein termed CFRP2' for convenience. The load vs. displacement curve of CFRP2' is similar to that of CFRP2, including the nonlinear decrease after the peak point (i.e., stiffness degradation). In terms of critical energy release rate under Mode II fracture, the G_{IIC} of CFRP2' was similar to CFRP2. A possible explanation for this similar Young's modulus, strength, elongation at break, and G_{IIC} is the crack front of CFRP2' resembled that of CFRP2, which is curved. This similarity was a preferred indication of reproducibility, when mode II pre-crack was used as starter defect for 3ENF test of unidirectional CFRP composite.

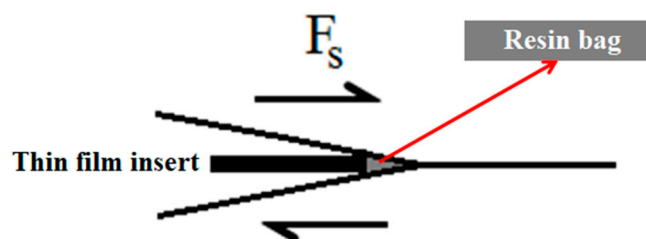
Figure 3. Resin bag supposed to feature in sample with thin film insert as starter defect.

Presence of resin bags in CFRP1, as mentioned above, might be the cause [17]. Resin bag's fiber volume fraction is low, which means it has a higher matrix content. The higher G_{IIC} of CFRP1 might be reflected from this corresponding higher matrix content at the resin rich crack tip. Additionally, crack front condition of the CFRP2 might be influential as well. As mentioned above, there is possibility that the crack front of CFRP2 might be curved, which means the crack front is longer than the initially linear crack tip. Damage zone developed at the crack tip dissipates some portion of the total external energy the sample was subjected to (by shear loading), before macroscopic propagation [16]. The longer the crack tip, as in CFRP2's supposedly curved crack front, the more strain energy dissipated prematurely and did not reflect in the bulk composite's force-displacement curve. Hence, the lower G_{IIC} of CFRP2.

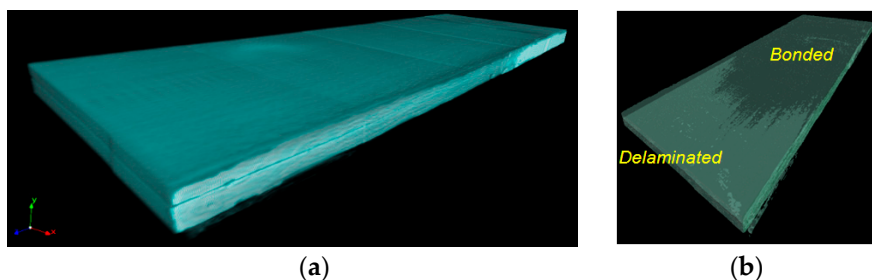
Figure 4. Isometric views of (a) the 3ENF tested unidirectional CFRP composite with thin film as starter defect (CFRP1) and (b) with its crack front profile visible.

From the available 3D image (one representation is in Figure 4), the cracked CFRP1 features the curved crack front. This micro CT image of curved crack front profile, as the result of 3ENF test on unidirectional CFRP composite, is currently the first one ever reported. A previous report [16] had indirect analysis that crack front of 3ENF tested CFRP was curved, but no image was shown as evidence, and attempts to verify this by sectioning and acoustic emission were unsuccessful.

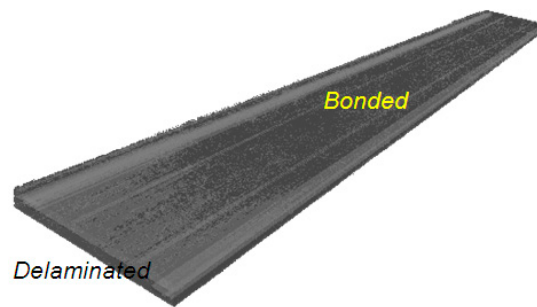
Figure 5. Isometric view of the 3ENF tested unidirectional CFRP composite with Mode II pre-crack as starter defect (CFRP2), with crack front profile shown.

As for 3ENF tested CFRP composites with mode II precrack as starter defect (CFRP2), its crack front also shows a similar curved profile (Figure 5). This finding supports the analysis about the less performing CFRP2, which was perceived due to its curved (which means longer than initially linear) crack front. It should be noted that the shown crack front was obtained after the 3ENF test. The initial crack front is the one obtained after the 3ENF test of CFRP1, thus it corresponds to the curved crack front profile of CFRP1. This means there actually was no apparent change in the length of the crack front for CFRP2, since it started with a curved crack front and ended also with a curved crack front (the length was even slightly reduced). Chances are that the CFRP2 did not show subpar properties, as observed in previous section (judging from load vs. deformation curve alone). It readily showed consistent behavior in terms of G_{IIC} . Similar G_{IIC} of CFRP2' (when CFRP2 was subjected to another round of 3ENF test) from that of CFRP2 verified this. This finding is in line with the current recommendation to use G_{IIC} obtained from 3ENF tests on unidirectional CFRP composites for design consideration for showing conservative and consistent values.

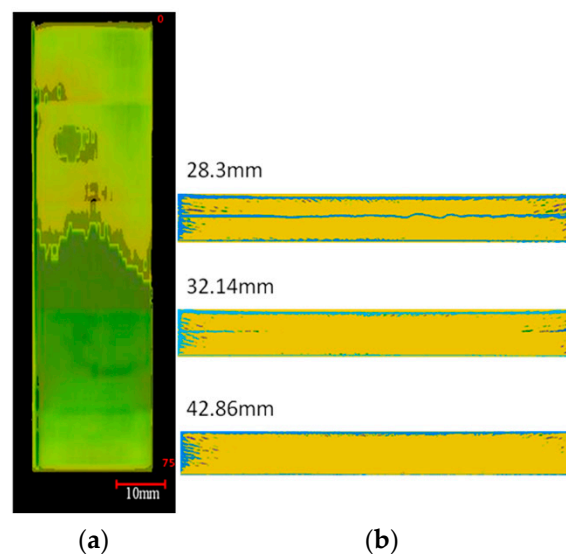
Figure 6. (a) Top and (b) front views of the 3ENF tested CFRP2 sample [Note: the numbers indicate the distance from the front end].

Clearer view on the damage zone of the CFRP2 sample can be seen from Figure 6 where the top and front views are presented. Wavy crack front when seen from front view is apparent. The insert film used to make the end-notch (starter defect) for the composites was expected to produce flat crack front. However, since the rigidity of thin PTFE film is low, the thin film could not resist the tendency for ply waviness during fabrication [14,15,20]. Seen from the top and front views, it is obvious that the crack front of CFRP2 was curvy, with propagation more towards both edges and less in the center region. The curved crack front was opposite to that observed by Davies et al. [16], who reported that the crack propagation at the specimen center was up to 2 mm longer than on the edges.

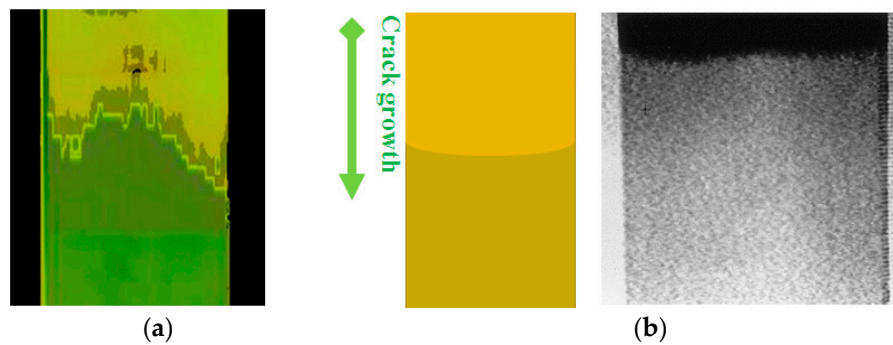
Figure 7. Internal crack profiles of (a) Mode II fracture in this study and (b) Mode I fracture [19].

Comparing the crack front profile between that obtained from mode II fracture test found in this study and mode I fracture test performed previously [19], the orientation of the curve was the opposite (Figure 7). The propagation pattern that eventually becomes the final crack front profile might be governed by the location of the site of initial crack. Considering the crack front profiles of CFRP1 and CFRP2 reported here, it seems crack initiation started from the edges. The microcracks might initiate from sites with less matrix content (higher fiber volume fraction) at the edges, created when the specimen was sectioned. This observation that the crack initiated at the edges puts a doubt to analysis in Section 3.1, where the cracks initiated due to fiber breakage like what happened to flexure tested CFRP composites [13].

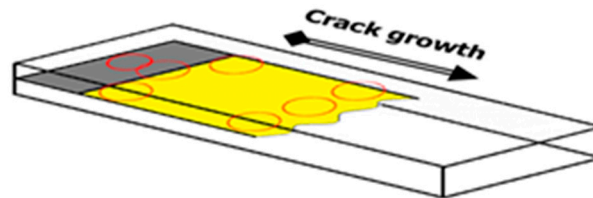
Figure 8. Schematic drawing of the location of the SEM observation on CFRP2 sample.

Fractography analysis on 3ENF tested CFRP composites was done using scanning electron microscope (SEM). It was intended to complement the analysis on damage mechanisms on the unidirectional CFRP composites. Another intention was to verify the findings from micro CT scans, since the rendered images resolution of the scanned object was not so high. The 3ENF tested samples were opened to reveal the paths of crack propagation. The analysis was done only on the CFRP2 sample, since it featured both the traces of crack front from 3ENF tested CFRP1 and the final crack front of CFRP2 itself. Considering the small area coverage of SEM, the images should be captured from multiple sites of interest within the sample. A schematic drawing showing the locations of the SEM observation taken on the sample is depicted in Figure 8. To help clarify the location, top view of the sample showing the location of SEM observation was also presented (Figure 8). What to observe in Figure 9a is the trace of a crack front left behind by 3ENF tested CFRP1. Four locations were observed for this purpose. Point 1 was at the pre-cracked area (initial) where it included the insert film’s image.

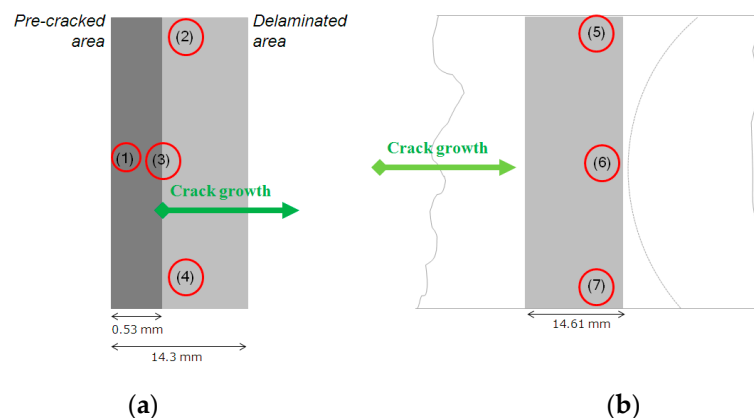
Figure 9. Schematics of top view of the CFRP2 sample showing the locations of SEM observation: (a) initial condition and (b) after 3ENF test.

Points 2 and 4 show the delaminated area at the edges, while point 3 is at the center. Figure 9b shows the shortest final crack front of the 3ENF tested CFRP2, where points 5 and 7 were at the edges while point 6 was at the center. The longest path of the crack front at edges was not observed due to difficulty in sectioning the sample without forced opening (intended to preserve the crack front).

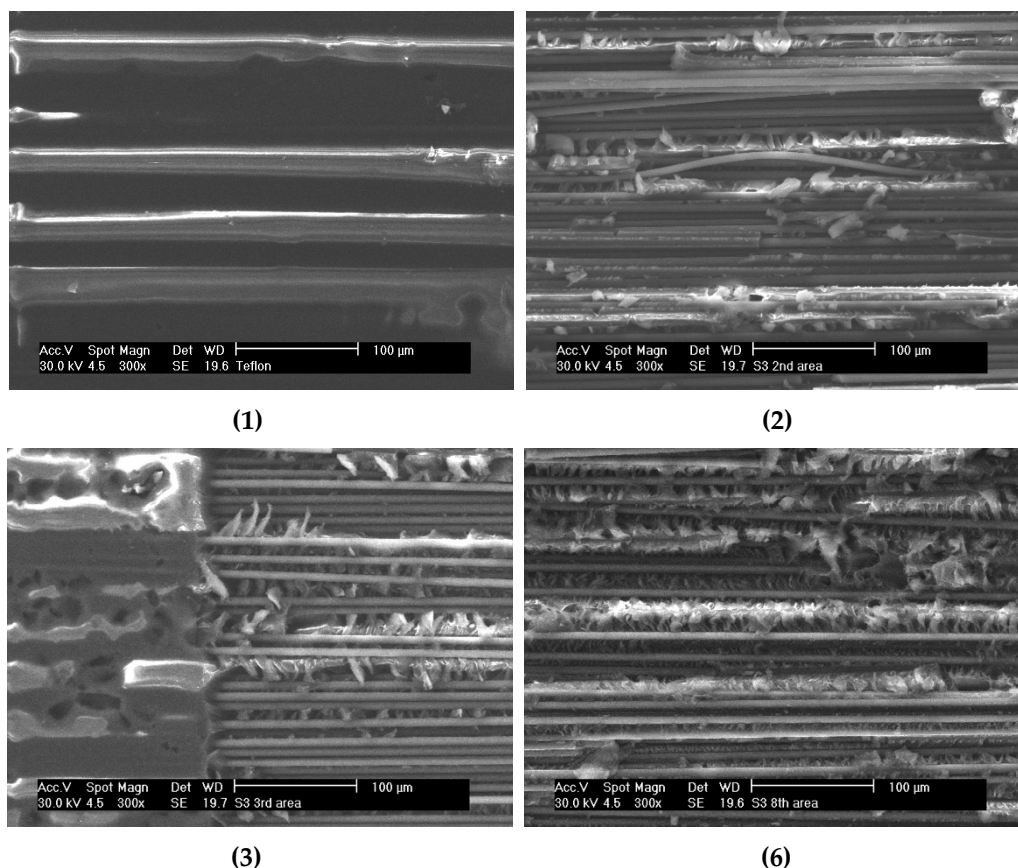
Figure 10. Fractographs of Mode II crack for sample with thin film starter defect. [Note: Number in bracket denotes the location of observation as shown in Figure 9].

Figure 10 shows SEM images of the observed sites within CFRP2. There was no sign of fiber breakage, confirming the analysis that fiber breakage was not the crack initiator. This might indicate that crack initiation started at edges and was initiated by microcracks at the matrix or at matrix-fiber interface. The figures of the damaged zone show that there are hackles formed at the matrix. They are characteristics of Mode II fracture at the matrix [22,23]. There was no sign of shear lip formation, an indicator of ductile matrix [24], thus confirming that the epoxy matrix is of strong and brittle type. Density of hackles is proportional to strain [22]. Figure 10 location 6 showed only slight difference in density of hackles, and a similar trend was found on locations 5 and 7. However, there was the occurrence of pulled fibers at each edge. These evidenced that the applied shear load induced higher strain at the edges than at the center. Indirectly, it can be deduced that the cracks indeed propagated more at the edges than at the center when CFRP1 was 3ENF tested.

At the final crack front of the CFRP2 sample, in particular at the center, it was apparent that hackles at the center were less rotated than those at the edges (Figure 10). This evidenced that the edges were more strained compared to the center. However, it cannot be deduced that for 3ENF tested CFRP2, the cracks propagated more at the center, considering the initial crack front was readily curved.

Overall, the fractographs of the 3ENF tested unidirectional CFRP composite sample supported the finding obtained from the micro CT scan. It was found, albeit through low resolution micro CT images, that the crack front profiles of 3ENF tested CFRP1 and CFRP2 are curved, with more propagation occurred at edges compared to at the center. This fractography analysis complements and confirms the finding from the micro CT scan.
