Study on Low-Velocity Impact Damage and Residual Strength of Reinforced Composite Skin Structure

Abstract: In order to better understand the damage tolerance of reinforced composite plates, the impact damage of the reinforced composite plates was investigated under low-velocity impact test. The experimental results show that the impact of different positions and energies causes different degrees of damage to the specimens, including but not limited to ply fracture, internal delamination of the skin, and debonding of the stiffeners and skin. After impacting, the specimens were tested in an axial compression. The results show that the ultimate bearing capacity of the specimen is also affected by different forms of impact. The impact point has the greatest influence on the specimen while it locates at the intersection of longitudinal and transverse bars. Compared with the intact specimen, the ultimate load carrying capacity was reduced by 16.83% and 44.02%, while the specimen impacted by 15 J and 30 J, respectively. The compression failure mode of the damaged specimen is mainly the breakage of the stiffeners and the delamination of the skin.

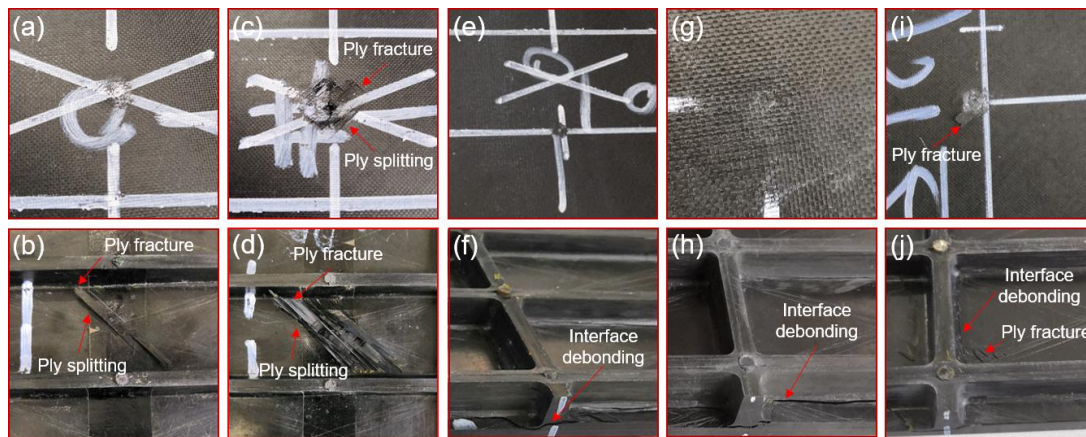
Figure 5. External impact damage of panels: (a,b) Out of plane damage of #2 specimen; (c,d) Out of plane damage of #3 specimen; (e,f) Out of plane damage of #5 specimen; (g,h) Out of plane damage of #6 specimen; (i,j) Out of plane damage of #7 specimen.

Low-velocity impact damage is formed on the surface of the specimen. However, due to the different impact locations and impact energies, the forms of external damage are also different. As shown in Figure 5a,b, there is out of plane damage on the #2 specimen. The hammer forms a pit of about 3 mm in diameter on the upper surface of the specimen. The damage of the lower surface is obvious. The matrix cracks are along the direction of laying layer, and the cracks are limited by the stiffeners, with a length of about 47 mm. The damage of the #3 specimen is depicted in Figure 5c,d. The diameter of the pit on the upper surface is about 8 mm, the ply fracture along the direction of the pavement and the delamination appears at the edge of the pit, the damage on the lower surface of the specimen includes ply fracture and fiber breakage. The crack of the matrix is along the fiber direction. The fracture line formed by the fiber breakage exhibits two states, one is along the 0-degree direction and the other is perpendicular to the fiber direction. This phenomenon is due to the large tensile stress on the back of the specimen during the impact process, which is decomposed into the short axis direction and the fiber direction. The experimental results of the impact point at the lower part without the stiffeners are similar to those of the impact on the laminates. Because of the support of the stiffeners, the impact energy did not reach the damage threshold of the specimen, and there is no obvious damage on the specimen surface. The damage of the #5 specimen is shown in Figure 5e,f. The impact formed a pit with a diameter of about 1 mm on the upper surface of the specimen. In addition, the stiffener/skin debonding could be found on the lower surface of the specimen. Figure 5g,h present the out-of-plane damage of the #6 specimen. There is no obvious damage on the upper surface, but the lower surface skin is debond from the stiffener. As for the #7 specimen, it has a pit with a diameter of 3 mm on the upper surface as shown in Figure 5i, and the plate layer at the edge of the pit cracks along 45°. Same with the #5 and #6 specimens, the impact induces the lower surface to delamination and the stiffener/skin debonding as presented in Figure 5j.

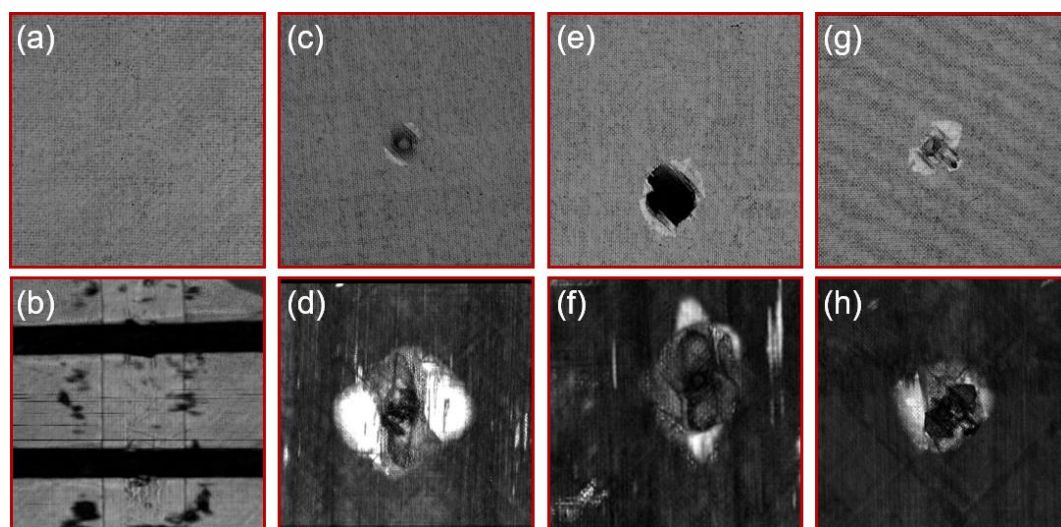
Figure 6. Internal impact damage of panels: (a,b) Specimen without damage before impact; (c,d) Internal damage of #2 specimen; (e,f) Internal damage of #5 specimen; (g,h) Internal damage of #7 specimen.

The internal damage of the specimen was detected by an ultrasonic C-scan system. Figure 6a,b shows the C-scan of the specimen before impact, and there are no defects and damages inside the specimen. Figure 6c shows the impact pit on the upper surface of the #2 specimen, and Figure 6d presents the internal damage of the intermediate layer of the #2 specimen. In addition, the impact damage areas of #2, #5, and #7 specimens from C-scan are illustrated in Table 3. Interestingly, the shape of the damaged areas looks peanut-shaped with the major axis in the longitudinal direction, which was also observed by Wiggeraad and Feng [23,30]. Compared with Figure 5c,d, the interior damage is much serious than the external damages. Moreover, the greater the impact energy is, the greater the internal damage is. Due to the small impact energy and the support of the lower stiffener, no obvious damage was observed in the #4 specimen. The internal damage of the #5 specimen is shown in Figure 6e,f. As the impact point is above the stiffener, the stiffener absorbs part of the energy during the impact. Therefore, the damage in the skin is much less than the damage at position 1. Figure 6g,h show the internal damage diagram of the #7 specimens. It can be seen that the internal damage is approximately elliptical. The damage area is smaller than the damage at position 1.

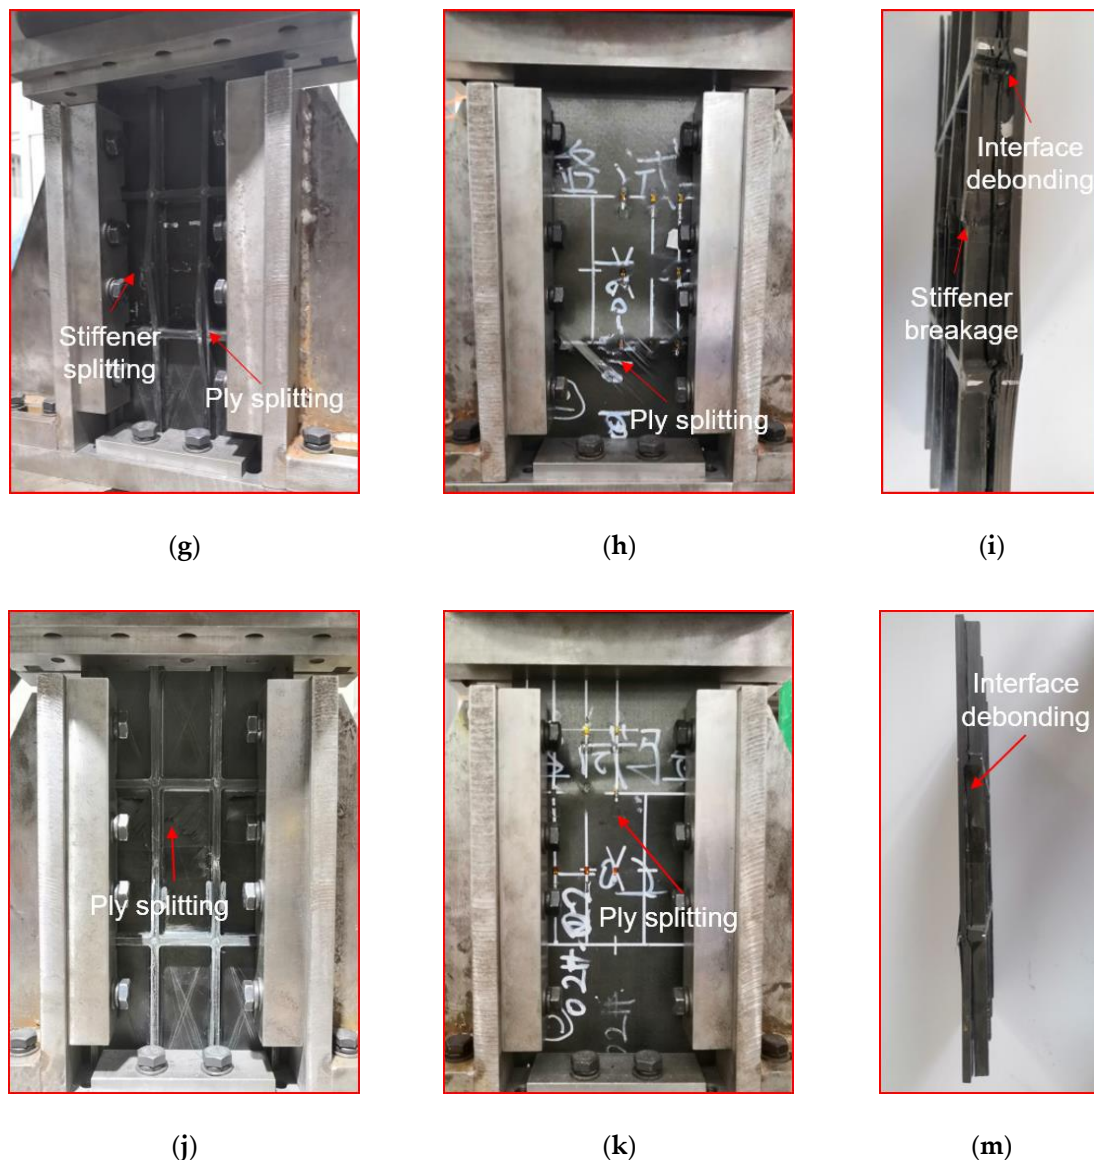
Figure 10. Cont.

Figure 10. Damage diagram of specimen after compression: (a–c) compression damage of #1 specimen; (d–f) compression damage of #3 specimen; (g–i) compression damage of #4 specimen; (j–m) compression damage of #7 specimen.

The typical compression failure of the intact specimen (#1) is shown in Figure 10a–c. Before the failure, the specimen was displaced uniformly under the compressive load. With the increase in compression load, the specimen becomes slightly unstable. When instability occurs, part of the load in the skin will be transferred to the bars and the stiffeners. Therefore, the damage tends to initiate in the interface of skin and stiffeners. Then, the damage of interface expands with the compressive load increasing, which triggers the further decrease of carrying capacity of skin. While the load exceeds the ultimate bearing capacity of the specimen, the stiffened plate will collapse, resulting in the delamination of the skin [23]. As presented in Figure 10a, the stiffener is broken caused by compression and the fracture position is randomly distributed. The stiffener fracture led to serious delamination and ply fracture (shown in Figure 10c). Moreover, the stiffener/skin interface is debonded along almost the entire spanning length. On the other side of the specimen, the skin is broken along the 45° direction, resulting in serious ply fracture and ply splitting.

The compression failure diagrams of the impact point of Position 1 (#3 specimen) are shown in Figure 10d–f. The failure modes of #2 and #3 specimens are similar, which forms on the side of the stiffener including (shown in Figure 10d): stiffener breakage, stiffener delamination, stiffener and skin interface debonding, and severe delamination of skin. As presented in Figure 10e, on the side of the skin, the intermediate section bearing capacity is weak due to the impact. During the compression process, the specimen is broken along the intermediate section, and the skin is arched outward on the same horizontal line. The skin is bent toward the side of the skin, and the failure modes include the ply fracture and the ply splitting. Moreover, Figure 10g–i shows the compression failure diagram of impact point of Position 2 (#4 specimen). The stiffener fracture of the specimen appears before the critical load. The final failure modes of the specimen are the fracture of the stiffeners and the local delamination of the skin caused by the fracture of the stiffeners. Furthermore, the compression failures of impact point of Position 3 (#7 specimen) are presented in Figure 10j–m. Before reaching at the ultimate load, first the stiffener of the specimen breaks. Due to the fracture of the stiffeners, the bearing capacity of the specimen is insufficient, and then the skin is compressed and layered. The impact point

of Position 3 resulted in a large area of debonding between the skin and the stiffeners, leading to a complete separation of the stiffeners and the skin after the compression failure of the specimen. It is a common phenomenon that the damage position of the skin passes through the impact point, which shows that the bearing capacity of this point is very weak after being impacted. Moreover, the impact is causing out of plane deformation of the panel leading to inter-laminar shear failure at stiffener–skin interface. Due to low fracture and mechanical properties of resin, debonding occurs, leading to severe degradation of overall load bearing capacity of the skin panels.
