Mitigation of Galvanic Corrosion in Bolted Joint of AZ31B and Carbon Fiber-Reinforced Composite Using Polymer Insulation

Abstract: The use of polymer insulation to mitigate galvanic corrosion was examined for bolted joints of AZ31B Mg alloy and carbon fiber-reinforced composite. To assess the corrosion behaviors of bolted joints with and without polymer insulation, solution immersion and salt spray exposure (ASTM B117) tests were conducted, and the corrosion depths and volumes were determined for the joint specimens after the tests. The polymer-insulated bolted joints exhibited much lower corrosion depths and volumes, highlighting the effective mitigation of galvanic corrosion. The reductions of joint strength in the post-corrosion joint specimens were relatively small (up to ~10%) in the polymer-insulated group but greater (up to 90%) in the group with no insulation. Cross-sectional characterization of post-corrosion joints with polymer insulation revealed local pits developed on AZ31B under galvanic influence, indicating that limited galvanic attack (that did not decrease the joining integrity significantly) could still occur during a long salt spray exposure (~1264 h) owing to

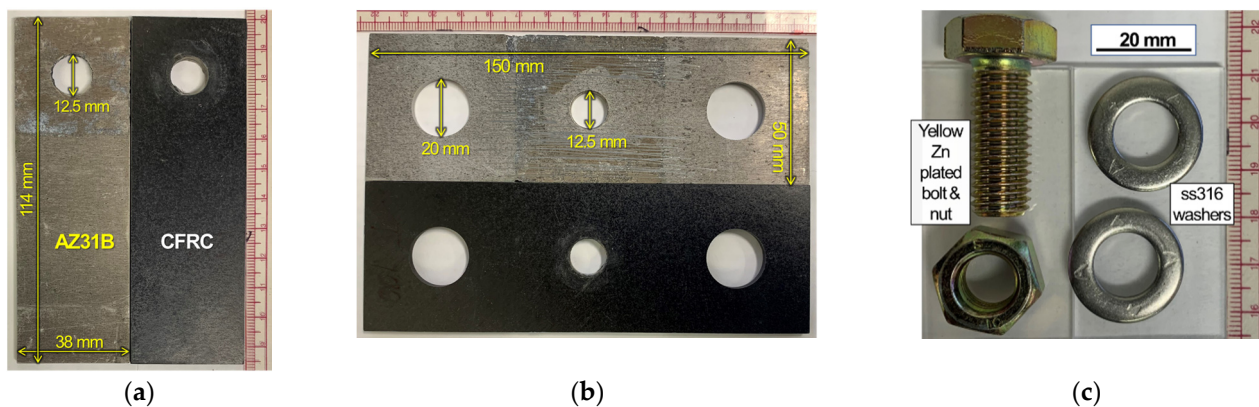
**Figure 1.** Machined AZ31B and CFRC sheets with 12.5 mm pilot holes for (a) lap shear and (b) cross-tension joint specimens. For bolting in a pilot hole, a steel bolt and a nut with yellow Zn plating, as well as two ss316 washers shown in (c) were used.

Both AZ31B and CFRC were machined by waterjet cutting for the assembled parts of lap and cross-tension type joints. The appearance and dimensions of machined AZ31B and CFRC parts are shown in Figure 1a,b. For bolting, commercially available mechanical fasteners, steel bolts and nuts with yellow zinc plating finish, and type 316 stainless steel (ss316) washers were purchased from an external vendor (Mcmaster carr, Elmhurst, IL, USA). A bolt and a nut with two ss316 washers, which were used in this work, are shown in Figure 1c. Two commercial epoxy resins were purchased to prepare the polymer-insulated bolt joints: (1) a clear adhesive type resin (Master Bond EP33CLV) for coating on the AZ31B surface, and (2) a low-viscosity type resin (DAP fast cure epoxy-acrylate) for (a) healing of microcracks that would potentially be produced during a predrilled hole process and (b) for electrical insulation around a pilot hole on CFRC. A thin film PTFE tape was also purchased for the threads on bolts.

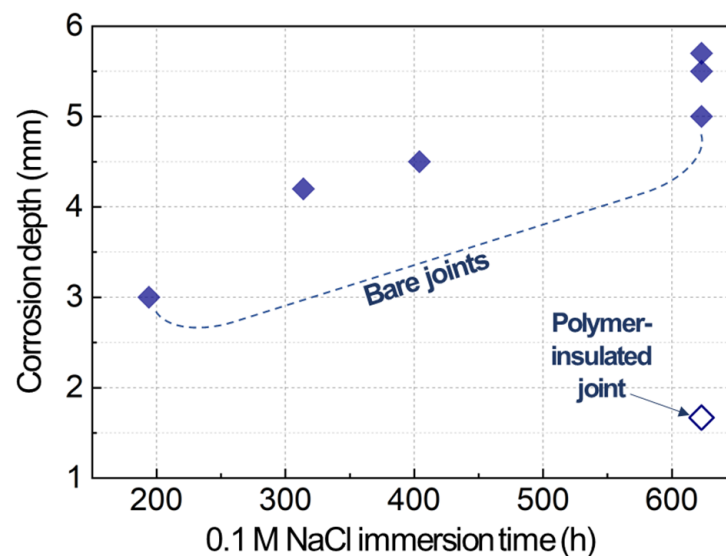
Figure 5. Corrosion depths measured from post-immersion AZ31B shown in Figure 4 as a function of immersion time.

For a quick quantification of Mg galvanic corrosion, the depths of corroded volumes were measured for AZ31B in the bare and polymer-insulated bolted joints, as designated by yellow arrows in Figure 4b. The measured corrosion depths are plotted as a function of immersion time in Figure 5. The depth formed from the bare joints increased with time but seemingly at a slower rate after 314 h. This slow-down is likely associated with the lateral-direction corrosion loss, which was noticed in the samples immersed for 314, 404 and 623 h (see Figure 4). Meanwhile, there was only one polymer-insulated joint sample that developed a measurable corrosion depth after 623 h. The corrosion depth was about 1.7 mm and was much smaller than the depth measured from the bare joints (≥ 5 mm). In light of these results, together with the corrosion potential data, it can be stated with confidence that Mg galvanic corrosion was mitigated by adopting a polymer insulation method.

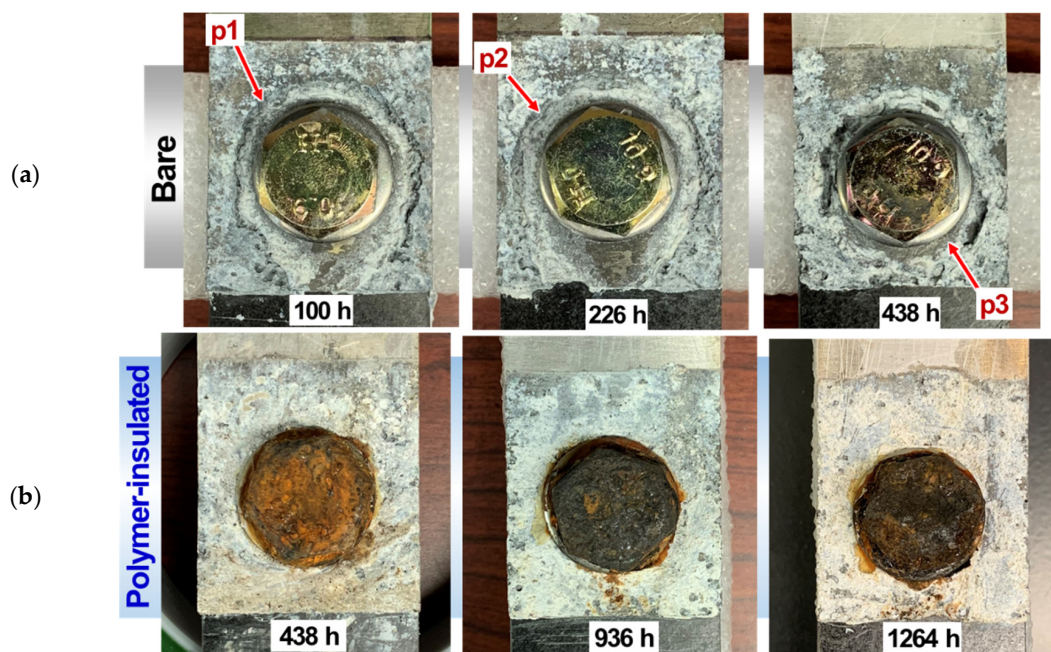
Figure 6. Lap shear bolted joints after salt spray exposure presented for (a) bare and (b) polymer-insulated conditions. The exposure time is designated for each specimen.

The bare and polymer-insulated joints were also exposed to an ASTM B117 salt spray environment with the specific masking applied on both lap and cross-section configurations, as described in the experimental section. The post-corrosion lap shear joints are shown in Figure 6 for the bare and polymer-insulated conditions. The bare joints developed corrosion ditches on Mg (designated as p1-3 in the top row of Figure 6) around the ss316 washers, clearly indicating severe Mg galvanic corrosion proximity to the noble metallic components of the bolting setup (which were galvanically protected, and therefore not corroded). It was visually noted that the corrosion ditch fully penetrated the AZ31B sheet after 438 h exposure. In polymer-insulated joints exposed longer than 438 h, however, no distinct groove attack was found around the ss316 washers, and both the steel bolts and AZ31B corroded in a relatively uniform manner. This observation indicates that the polymer insulation was effective in impeding galvanic coupling so that AZ31B did not suffer from severe corrosion ditch attack, whereas the steel bolt, which was no longer galvanically protected, corroded simultaneously.

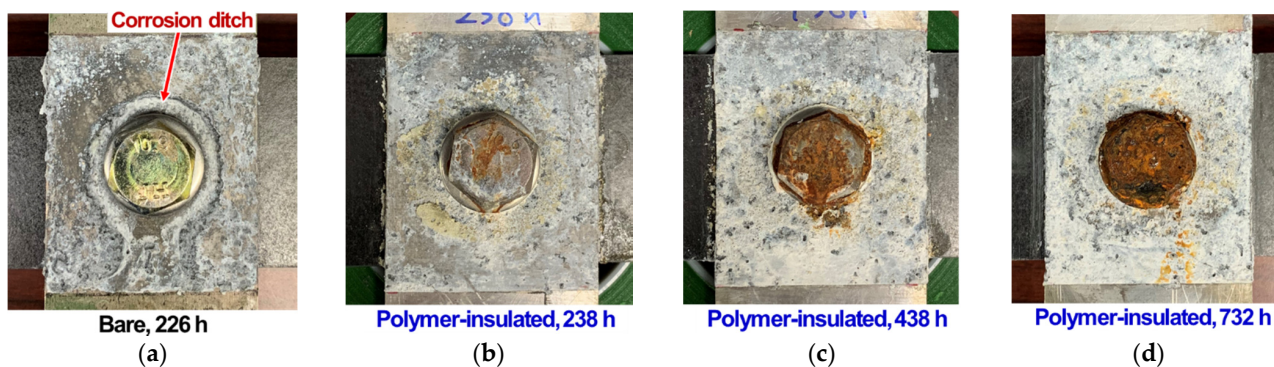
Figure 7. Cross-tension bolted joints after salt spray exposure presented for (a) bare and (b–d) polymer-insulated conditions. The exposure time is designated for each specimen.

Figure 7 shows the cross-tension joints after salt spray exposure for one bare case (238 h) and three polymer-insulated cases (238, 438, 732 h). Again, the formation of a severe corrosion ditch with an uncorroded steel bolt was observed in the bare joint. In the polymer-insulated joints, no corrosion ditch was visually detected, and the steel bolts formed rust layers that covered an increasingly large area over time. Overall, the corrosion attacks and morphologies observed after the salt spray exposure were very similar between the lap and cross-tension joints prepared with the bare and polymer-insulated conditions.

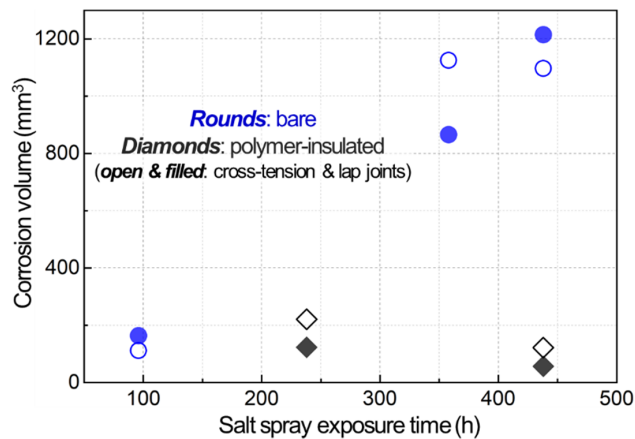
Figure 8. Corrosion volumes of lap and cross-tension joints plotted as a function of salt spray exposure time for the bare and polymer-insulated conditions. The corrosion volumes were determined by optical profilometry, as exemplified in Figure S3.

The corrosion volumes of the bare and polymer-insulated joints were quantitatively analyzed using an optical profilometry technique, with the uncorroded (i.e., tape-masked during the salt spray exposure) AZ31B surface serving as the reference plane. The post-corrosion joints were disassembled, and only the AZ31B plates were used for optical profilometry measurements, as described further in Figure S3 in the Supplementary Materials. The quantified corrosion volumes are plotted as a function of salt spray exposure time in Figure 8. In both the lap and cross-tension joints, the bare condition showed the corrosion volumes increasing with time, with a much greater increase than seen in the polymer-insulated condition due to the prevailing and aggregating corrosion ditch attack. In contrast, the corrosion volumes of polymer-insulated joints were relatively low and did not increase with time, implying that Mg corrosion was saturated without being alleviated by the galvanic impact that was prominent in the bare joints.

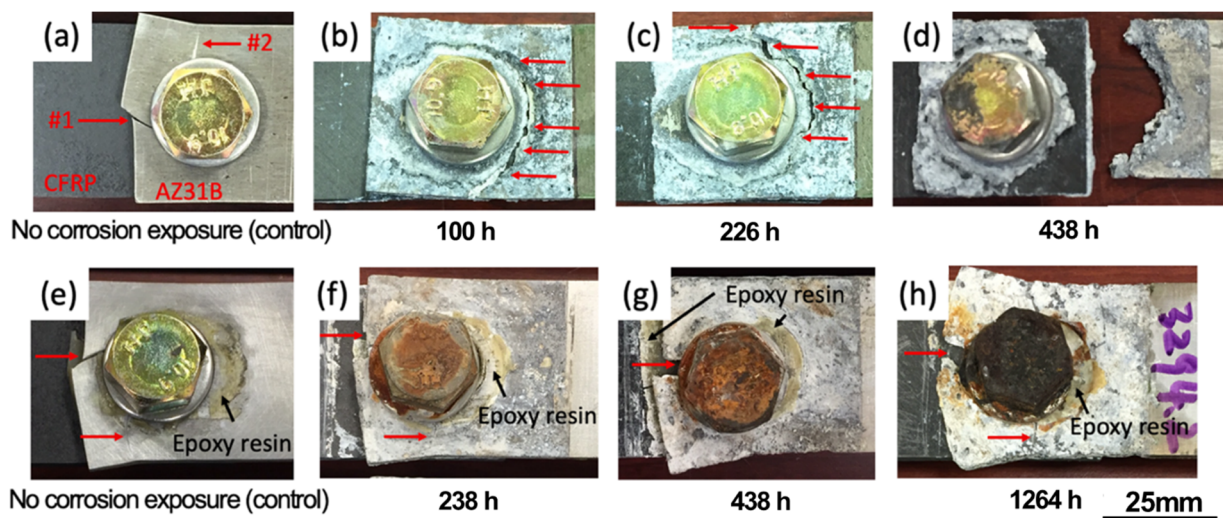
Figure 10. Comparison of fractography from lap shear tensile testing with different ASTM B117 exposure times for (a–d) bare and (e–h) polymer-insulated CFRC-AZ31B bolted joints. Red arrows indicate the failure locations on AZ31B, and black arrows show the epoxy resin overfill layer on the AZ31B surface.

Figure 10 shows fractography for the bare (Figure 10a–d) and polymer-insulated bolted joints (Figure 10e–h) with increasing corrosion exposure times. For the bare case, the failure mode for uncorroded joints was mixed cleavage-tension (red arrow #1) and net-tension (red arrow #2) failures, as shown in Figure 10a. As corrosion exposure time increased, galvanic corrosion of AZ31B formed a corrosion ditch on the periphery of the bolted center, as previously shown in Figure 6. This ditch corrosion attack on AZ31B resulted in the crack initiation, as designated by red arrows in Figure 10b,c, and it subsequently led to final failure during the tensile shear testing. For the polymer-insulated joints, mixed cleavage tension and net tension failure modes were commonly found in uncorroded and salt spray-exposed conditions, indicating that the primary failure mode was not changed due to the mitigation of AZ31B galvanic corrosion.

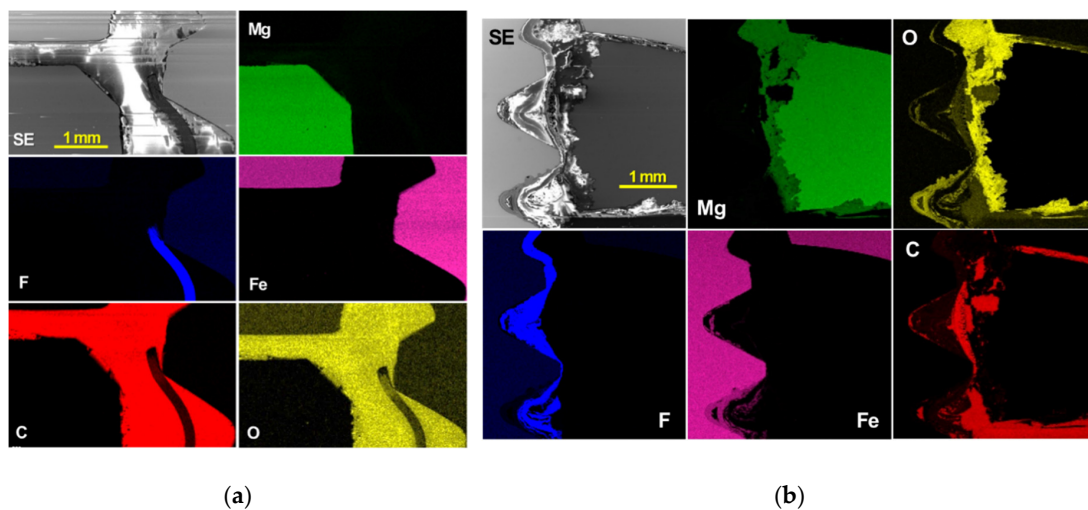
Figure 12. SEM images with corresponding EDS maps for (a) the area designated by B in Figure 11a and (b) the area designated by E in Figure 11b. All EDS elemental maps were recorded using K-alpha characteristic X-ray of each element.

More EDS mapping analyses were conducted for the areas designated by B and E in Figure 11a,b, respectively, as presented in Figure 12. In the uncorroded joint, Fe and Mg did not overlap with O, and a strong F intensity was detected from the PTFE tape (Figure 12a). In contrast, extensive corrosion of AZ31B was indicated by the overlap of Mg and O, as well as corrosion of steel bolt threads (overlap of Fe and O) underneath the PTFE tape as designated by F intensity) (Figure 12b). Despite the corrosion mitigation effect, the application of polymer insulation could not completely stop corrosion of AZ31B and the steel bolt in the inner area of the joint.
