REVIEW ARTICLE

A narrative review of current and emerging MRI safety issues: What every MRI technologist (radiographer) needs to know

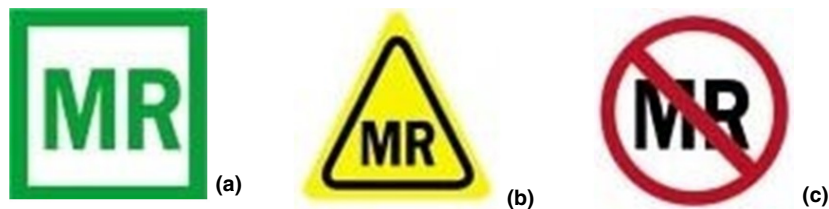
Figure 2. Icons used in the ASTM F2503-20 standard for MR safety category labelling: (A) MR Safe, items that pose no known risk or hazard in the MRI environment; (B) MR Conditional, implants and devices demonstrate no hazard in the MRI environment, but only when prescribed conditions for safe use are adhered to; (C) MR Unsafe, implants and devices should never be brought into the MRI environment.²¹

Despite these risks, it is important that patients with medical implants and devices are not unnecessarily excluded from MRI. Having an accurate understanding of the composition of these objects and their behaviour in the MRI environment can enable such patients to undergo an MRI examination.²⁰ To assist this, the American Society of Testing and Materials (ASTM) International Committee designed a labelling system in 2005 that identifies three MRI safety categories: MR Safe, MR Conditional and MR Unsafe, each with an associated icon (Fig. 2).^{20,21}

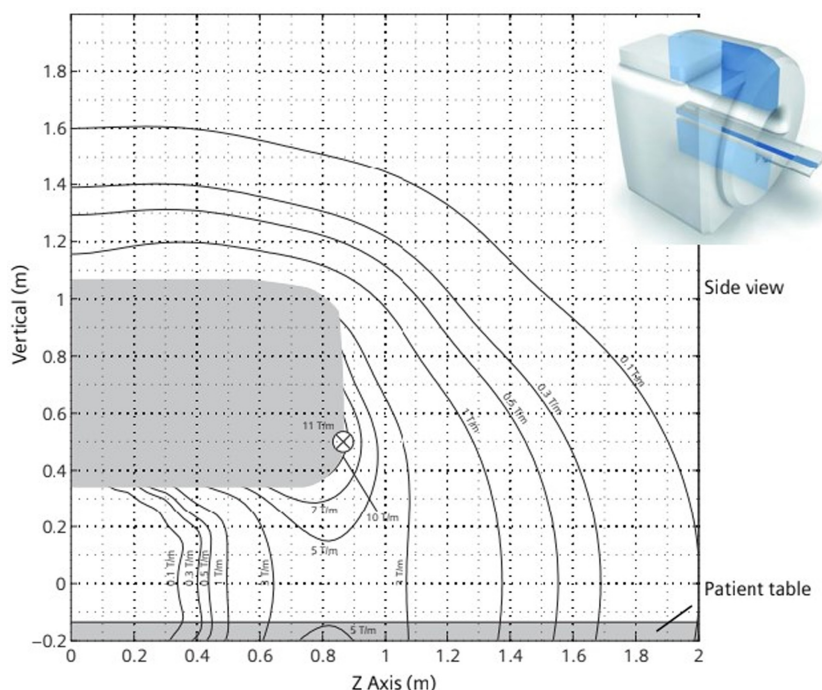
Figure 3. Example of vendor spatial gradient magnetic field map: 3T Skyra scanner. (Courtesy of Siemens Healthineers).

MRI system vendors provide SGMF maps for each scanner, which plot the change of the static magnetic field over distance and demonstrate the point of maximum spatial gradient (Fig. 3). Vendors have their own SGMF maps, and these will differ between scanners, requiring the MRI technologist to be able to interpret different SGMF map formats. MRI technologists must be capable of interpreting these maps to determine implant safety with respect to any defined spatial gradient limitations prior to imaging patients with medical devices.^{20,22}

is the ability to apply these conditions to a specific scanner in the workplace by understanding the vendor SGMF maps.

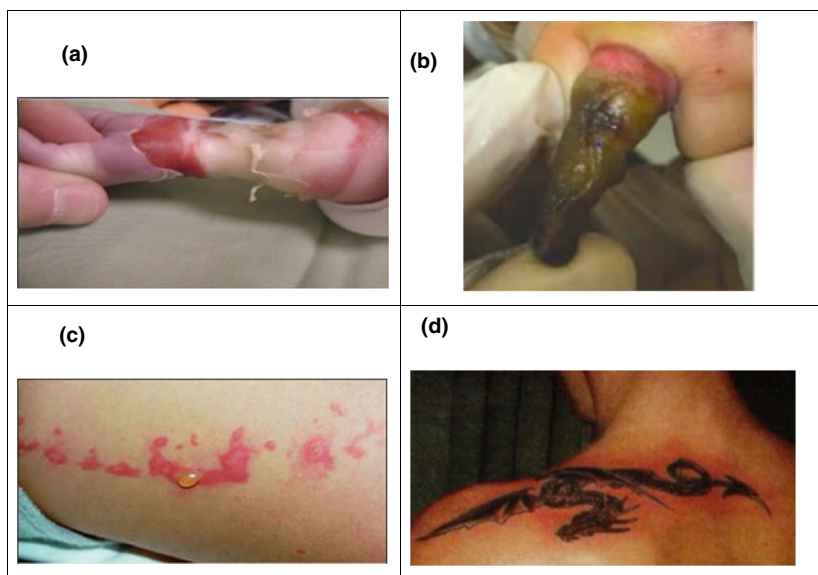
Figure 4. Examples of RF induced burns: (A) fourth-degree burn immediately after MRI examination on a 5-week-old baby, caused by an MR Unsafe pulse monitor. This resulted in amputation of the forearm⁵⁸ (B) burn resulting from an MR Unsafe pulse oximeter on the finger, post-escharotomy (C) second-degree burn after MRI examination from invisible metallic microfibres in clothing (D) first-degree burn around a tattoo after MRI. (Images courtesy of, and reprinted with permission from, Frank G. Shellock, Ph.D., www.MRIsafety.com).

If equipment comprised of conductive materials such as physiological monitors and electronically controlled devices remain in the magnet bore with the patient, it is possible for localised heating and burns to occur where they are in direct contact with the skin.² Two recent case studies reported by Abdel-Rehim, Bagirathan *et al.*³⁴ demonstrated that placement along the patients' abdomens of insulated electrocardiograph (ECG) monitor cables (described by the authors as 'MRI compatible') created full-thickness burn lines. Both patients were reported as having a high body mass index and had been subjected to a lengthy MRI examination, whereby the possibility for the lack of thermal regulatory ability and the formation of conductive loops of the cable could have been responsible for the burn. Figure 4A and B further demonstrates the consequences of using MR Unsafe equipment during the MRI examination.

Novel MRI burn hazards are also being created with technological advances in other industries, as in the athletic clothing manufactured with invisible silver-embedded microfibres. This conductive material can produce electromagnetic eddy currents, and there have been multiple reports of second-degree burns to patients when scanned while wearing such clothing^{31,37} (Fig. 4C). This highlights the importance of changing all patients into facility-provided gowns.

Tattoos and permanent cosmetic products that contain metallic components can also pose a risk. In 1996, discussion regarding the risk of permanent cosmetics began after a patient with tattooed eyeliner underwent an MRI examination. The reaction of the iron oxide pigments to the RF magnetic field was thought to have caused painless oedema for 48 hours after the MRI.⁴¹ Ross et al.⁴² reported a case study in 2011 where a potential electric current was produced in metallic tattoo pigments on bilateral thigh tattoos, producing a cutaneous burn at each tattoo site. Figure 4D demonstrates a first-degree burn on a shoulder tattoo after MRI.¹⁹

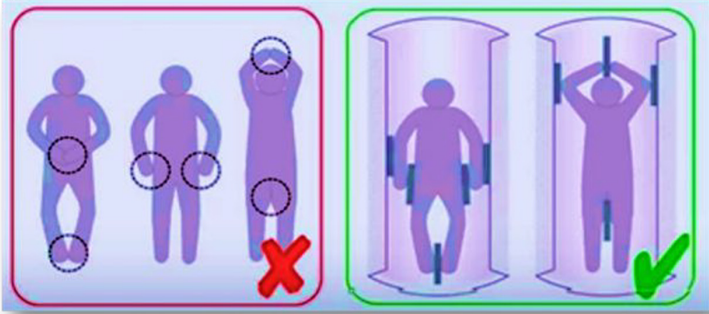
Preventative measure
Physiologic monitors, leads and cables	Leads or cables should not directly contact the patient; place pads at least 1cm in thickness (not a sheet) between the patient and lead/cable. All equipment within the scanner room must be MR Conditional. ⁴¹
Skin-to-skin contact	Place pads at least 1cm in thickness (not a sheet) between places where there may be skin-to-skin contact within the RF field, for example between the thighs or where the thumb may touch the side of the body. To avoid a conductive loop, the legs and arms should not be crossed. ⁴¹

(Image courtesy of Siemens Healthineers)	
Skin-to-magnet bore contact or skin-to-transmit RF coil contact	Ensure pads at least 1cm in thickness (not a sheet) are placed between the patient and the side of the bore, or the patient and RF transmit coil if contact is possible. ⁴¹
Metallic microfibre clothing	Change all patients out of street clothes into MRI safe gown or scrubs. ⁶
