## Advanced Mitigation Process (AMP) for Improving Laser Damage Threshold of Fused Silica Optics

The laser damage precursors in subsurface of fused silica (e.g. photosensitive impurities, scratches and redeposited silica compounds) were mitigated by mineral acid leaching and HF etching with multi-frequency ultrasonic agitation, respectively. The comparison of scratches morphology after static etching and high-frequency ultrasonic agitation etching was devoted in our case. And comparison of laser induce damage resistance of scratched and non-scratched fused silica surfaces after HF etching with high-frequency ultrasonic agitation were also investigated in this study. The global laser induce damage resistance was increased significantly after the laser damage precursors were mitigated in this case. The redeposition of reaction produce was avoided by involving multi-frequency ultrasonic and chemical leaching process. These methods made the increase of laser damage threshold more stable. In addition, there is no scratch related damage initiations found on the samples which were treated by Advanced Mitigation Process.

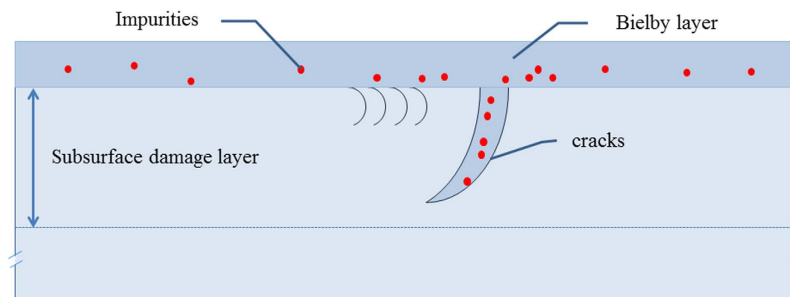
**Figure 1. Schematic illustration of known precursors on fused silica surfaces and subsurface.** The precursors are impurities in the Beilby polishing layer or cracks, the intrinsic silica defects on fracture surfaces (i.e., cracks) and redeposit of silica.

The surface and subsurface region can be described as two distinct layers:<sup>10</sup> Beilby layer and subsurface damage (SSD) layer, which overlapped successively in bulk material, as schematically shown in Fig. 1. The Beilby layer consists of heavily hydrated material resulted from conventionally polish. As is well known, there are many highly absorptive photoactive impurities in the beilby layer (e.g., Ce, etc). The scratches and cracks often distribute in SSD layer under the beilby layer. As a result, the foreign matters (e.g., impurities and heavily hydrated material) often embed in the subsurface cracks. The depth of SSD layer of fused silica prepared by conventional polish technology is often more than 20  $\mu\text{m}$ <sup>8</sup>. In a recent study, the highly absorptive photoactive impurities and the scratches was regarded as low fluence laser damage precursors. On the other hand, HF aqueous solution was used to etch SSD layer to improve laser damage resistance. The solubility of reaction product ( $\text{SiF}_6^{2-}$ ) reduces because of the impurities; and that would results in redeposition on the surface of fused silica. In the case, laser damage resistance would be affected by redeposition especially for etching deeply<sup>22</sup>.

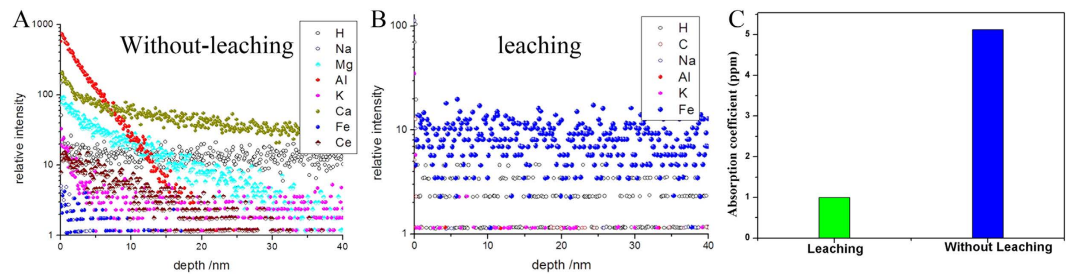
**Figure 2.** Depth profiles of impurity elements detected in fused silica surface by TOF-SMIS: (A) Without leaching; (B) Leaching; (C) thermal absorption of fused silica with and without leaching.

The highly absorptive photoactive impurities can be globally processed by chemical leaching contaminants from optical surfaces. Figure 2 shows the depth profiles of impurities element detected by TOF-SIMS. Figure 2(A,B) are samples without and with chemical leaching process conditions, respectively. All of the data had been normalized with silicon particle number (counts 10,000) as a standard. Comparing Fig. 2(B) with Fig. 2 (A), it is seen that Ce element disappears absolutely and other impurities decrease at the subsurface layer of fused silica after leached in strong acid solution. The analysis of impurities defects shown in Fig. 2 suggests that metal impurities at the subsurface of fused silica nearly disappear completely after leaching in strong acid solution. On the other hand, the Fe element concentration was found to slight increase after chemical leaching. The removal mechanism of leaching in strong acid is that chemical impurities are eliminated through solubilization-diffusion. The impurity ions diffuse and solubilize because of oxidation reaction in strong acid solution. There is a balance between adsorption and desorption on the surface of substrate in the solution. Fe was one of trace elements in chemical solution. The increase of Fe element is because of the adsorption of Iron in aqueous solution of mineral acids. Even so, as reported in previous work, Fe element has a very weak influence on laser damage property in current laser damage threshold level. Cerium element is closely related to the laser damage property<sup>23</sup>.

In order to understand the change of thermal absorption after chemical leaching process, the thermal absorption of fused silica sample with and without leaching in strong acid solution was measured by photo-thermal common-path interferometer. As shown in Fig. 2(c), the thermal absorption of fused silica wafer was decreased from 6 ppm to 1 ppm after leaching in strong acid solution.

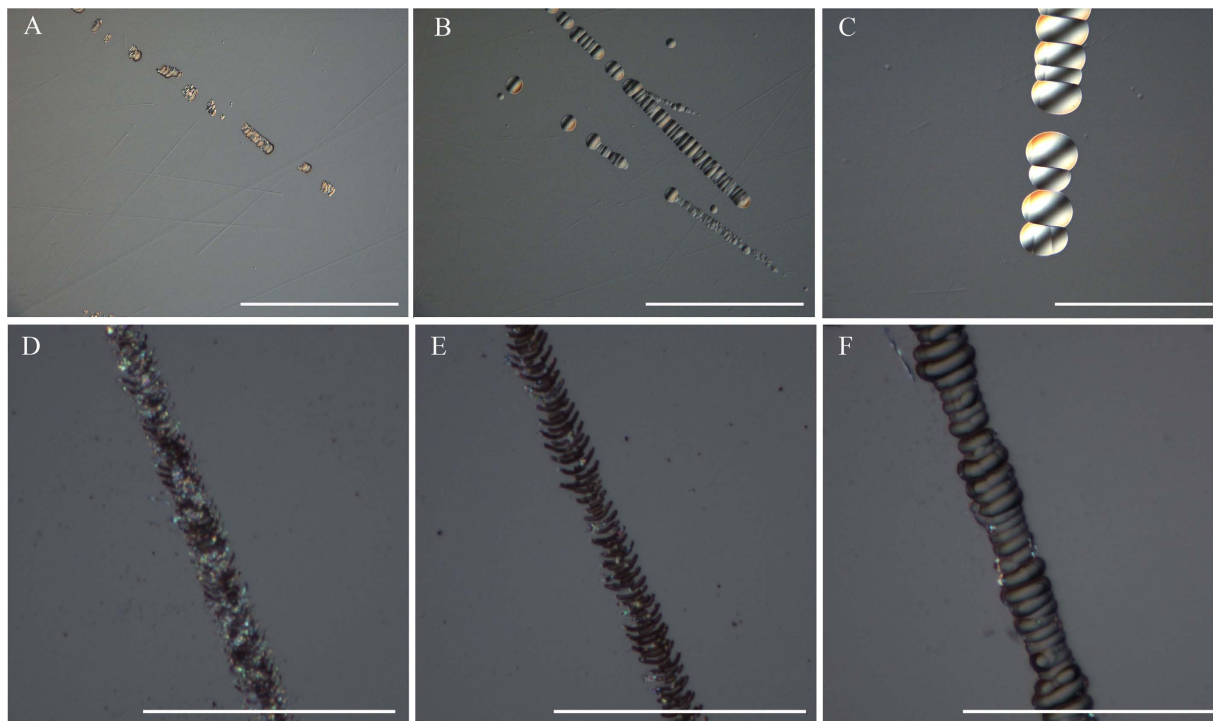
**Figure 4.** Optical micrographs of cracks generated on fused silica after HF etching with the addition of agitation (A, 5 min etching; B, 50 min etching, and C, 100 min etching) and static HF etching (D, 5 min etching; E, 50 min etching, and F, 100 min etching). The scale bar is 100  $\mu\text{m}$ .

Figure 4 shows optical micrographs of scratches in the SSD layer to illustrate the change in morphology of the scratches during the HF etching process. These samples were processed by static etching and high frequency

ultrasonic agitation etching, respectively. The scratches become more visible after HF etching process, as shown in Fig. 4(A–C). The scratches were also etched isotropically during the process of HF wet etching. The size of the scratches can be controlled by varying the etching duration during high frequency ultrasonic agitation etching. As presented in Fig. 4(A), the average size of the scratches is about 3  $\mu\text{m}$  after 5 min HF-etching. Upon extending the etching duration to 50 min, the average size of the scratch increases to 20  $\mu\text{m}$  (Fig. 4B). After increasing etching duration further to 100 min, the scratches shown in Fig. 4(C) are about 40  $\mu\text{m}$  in size. As shown in these Figures, the cracks and scratches were blunted sufficiently after 100 min etching, also leading to increased laser damage threshold. These will be discussed later.

The Fig. 4(D–F) show the optical micrographs of cracks from the samples etched statically. As shown in Fig. 4D, there still are many foreign matters in the cracks after 5 min HF static etching. The foreign matters in the cracks were removed obviously after 50 min and 100 min HF etching process (Fig. 4E,F). However, there are still some foreign matters which haven't been removed in the cracks. From the comparison of Fig. 4(A–F), we can see that the foreign matters are dramatically reduced with the addition of agitation.

Because of isotropic HF-based wet etching, the average of the cracks increases with the increase of etching depth. As shown in Fig. 4C, the average size of cracks are several tens micrometers. And the surface roughness increases with the etching depth during HF based wet etching process. And this optics cannot be used in reality applications. Here in our case, the optimized mitigation process is acid leaching and  $\sim 20\ \mu\text{m}$  SSD layer removed during HF etching.

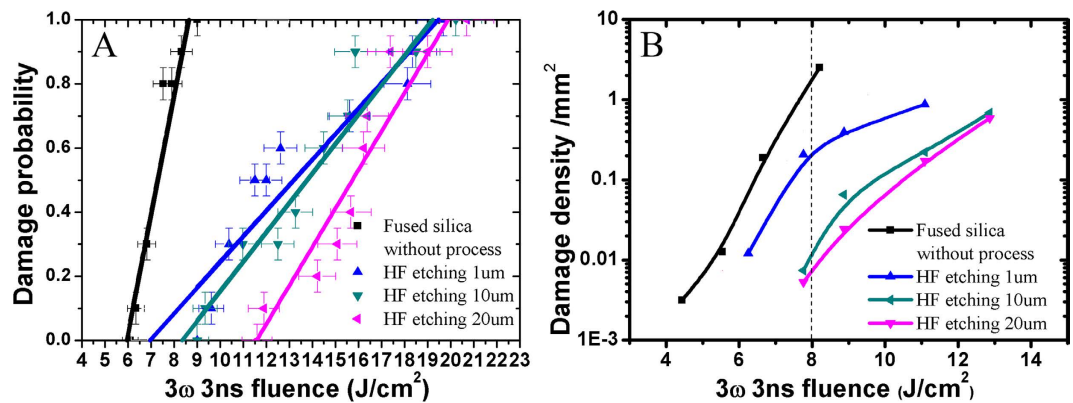
**Figure 5.** Damage probability (A) and Damage density (B) of fused silica etched different times.

In order to understand the HF etching effects on laser induced damage, we investigated laser induced damage threshold of fused silica etched different depth by HF based acid solutions. Here the damage densities tested with Raster scan are shown in Fig. 5(A), and the damage thresholds tested with 1 on 1 are shown in Fig. 5(B).

Using HF etching technology, the laser induced damage threshold can be improved with different etching time. Subsurface damage layer was removed different depths by changing the etching time. Figure 5B shows the laser damage initiation density of fused silica etched by HF-based solutions per square micrometer at the different laser fluence. After the optimized HF acid etch process, the laser damage initiation density decreased from 2.5/mm<sup>2</sup> to 0.005/mm<sup>2</sup> at 8 J/cm<sup>2</sup> fluence. (see magenta line in Fig. 5B) The laser damage probability of these samples etched for different durations also was devoted in this work. After 5 min HF etching, the subsurface damage layer was removed 1  $\mu\text{m}$ . The 0% laser induced damage threshold was 7 J/cm<sup>2</sup> and 100% laser induced damage threshold was 19.3 J/cm<sup>2</sup> (the blue line in Fig. 5A). The dark cyan line in Fig. 5A shows the laser damage probability of fused silica after 50 min etching. The 0% and 100% laser induced damage threshold increased to 8.4 J/cm<sup>2</sup> and 19.0 J/cm<sup>2</sup>, respectively. In this case, the subsurface was etched 10  $\mu\text{m}$ . After 100 min HF etching, the fused silica was removed 20  $\mu\text{m}$ , and from the magenta line in Fig. 5A, we can see the 0% laser damage threshold of the sample is 11.6 J/cm<sup>2</sup>;

the 100% laser damage threshold increased to 19.7 J/cm<sup>2</sup>. The laser induce damage resistance of fused silica much depend on HF-etching process. From the Fig. 5A, it is seen that the 0% laser induce damage threshold increased with the increase of etching time. This suggests that the subsurface damage layer was removed gradually as the etching time increases. There is also other evidences that can be used to explain this issue. Figure 6 is morphology of damage site from different etching time sample. As shown in Fig. 6B, there are still scratches in the subsurface after 5 min etching. Therefore, the morphology of the damage site has similar profile with the scratches. As presented in Fig. 6C,D, after increasing etching duration further to 50 min or 100 min, all of the scratches in the subsurface damage layer appeared. The scratches cracks were blunted enough during the etching process. From them, it is seen that the damage sites always appeared on the non-scratches area. It means that the low fluence precursors e.g. scratches and cracks were mitigated enough by HF etching. To the best our knowledge, this phenomenon has not been reported in the previous work. Though, the 100% laser induce damage threshold are similar to case with different etching time. This suggests that there are high fluence precursors which cannot be mitigated by HF etching in the subsurface. These high fluence precursors would be Non-bridging Oxygen Hole Center (NBOHC) and Oxygen Deficient Center (ODC). HF etching technology was often applied to improve laser damage resistance of fused silica in previous studies. Laser damage resistance could be increased different level after different HF process<sup>24,25</sup>. Though, more than 20  $\mu\text{m}$  should be etched by HF acid solution for removing all the SSD layer<sup>8</sup>. In that case, laser damage resistance has decreased unpredictably often especially after etching deeply. That is because the reaction product deposited on surface of fused silica as discussed above. Though, multi-frequency ultrasonic and chemical leaching are used to avoid redeposition of reaction produce; and to make the increase of laser damage threshold stably in our work.

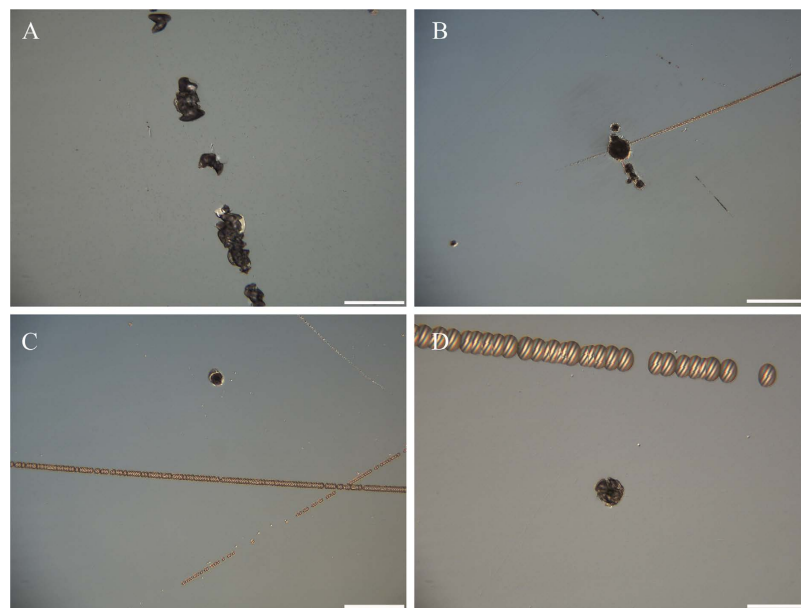
**Figure 6.** The morphology of damage site of different samples: (A) without process, (B) leaching and HF etching 5 min, (C) leaching and HF etching 50 min, (D) leaching and HF etching 100 min. The scale bar is 100  $\mu\text{m}$ .
