## Role of tool marks inside spherical mitigation pit fabricated by micro-milling on repairing quality of damaged $\text{KH}_2\text{PO}_4$ crystal

Repairing initial slight damage site into stable structures by engineering techniques is the leading strategy to mitigate the damage growth on large-size components used in laser-driven fusion facilities. For  $\text{KH}_2\text{PO}_4$  crystals, serving as frequency converter and optoelectronic switch-Pockels cell, micro-milling has been proven the most promising method to fabricate these stable structures. However, tool marks inside repairing pit would be unavoidably introduced due to the wearing of milling cutter in actual repairing process. Here we quantitatively investigate the effect of tool marks on repairing quality of damaged crystal components by simulating its induced light intensification and testing the laser-induced damage threshold. We found that due to the formation of focusing hot spots and interference ripples, the light intensity is strongly enhanced with the presence of tool marks, especially for those on rear surfaces. Besides, the negative effect of tool marks is mark density dependent and multiple tool marks would

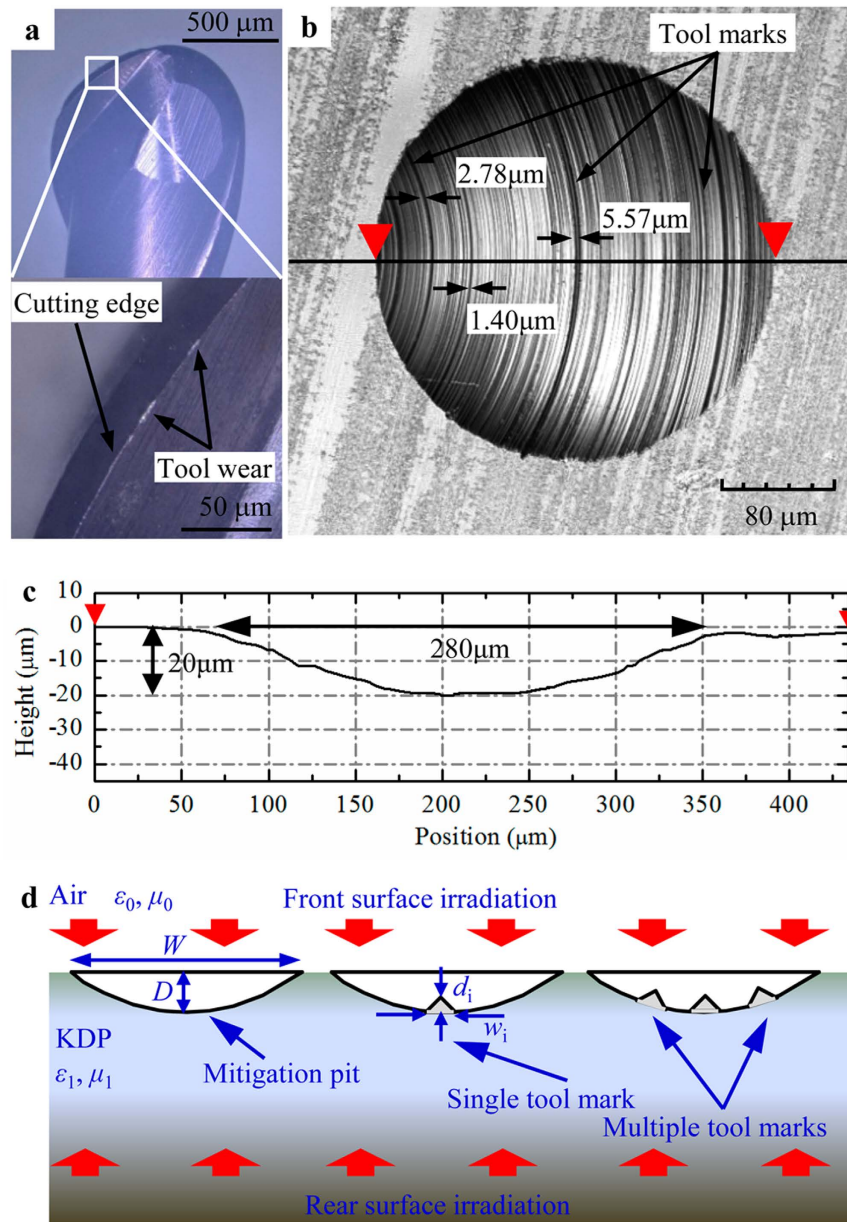
**Figure 2. Characterization of worn milling tool edges, tool mark inside spherical mitigation pit and the FDTD simulation models.** (a) The micro-milling tool with flaws at the cutting edge caused by wearing. (b) The tool marks inside repaired pit introduced by the flaws at the cutting edges. (c) The cross-section profile of the repaired pit with tool marks. The mitigation pit is roughly  $280\ \mu\text{m}$  wide and  $20\ \mu\text{m}$  deep, achieved using a  $500\ \mu\text{m}$ -radius milling tool. (d) Schematic of the FDTD models for ideal mitigation pit and mitigation pits with single and multiple tool marks.

**Characterization of tool marks and FDTD algorithm.** In the actual repairing process with cemented carbide micro-milling tools, a series of isolated flaws can be generated at the cutting edges by means of wear and friction at the tool-chip interface<sup>28</sup>. As shown in Fig. 2, the cutting edges of milling tool are discontinuously chipped at some localized areas after a certain cutting period. The flaws appear to be in forms of dents or pits distributed along the edges. When the flawed tools are adopted to repair the crystal surfaces, the tool marks would be correspondingly reproduced inside the spherical mitigation pit. The reproduced internal tool marks should be like raised arc strips, which are essentially the uncut crystal material missed by the flaws at the cutting edges. The spherical mitigation pit with discontinuous tool marks are shown in Fig. 2b,c. One can see that the dimensions of the tool marks are almost several micrometers wide and sub-micrometers deep, which are both highly dependent on the wear level of the milling tool. In all the following simulations, the geometries of modeled tool marks are chosen based on the tested information above.

The modulation to incident laser light by surface features can potentially produce light intensification inside optical components, which is closely associated with the localized energy deposition and increased nonlinear absorption of intense light<sup>23–25,29</sup>. These negative effects introduced by tool marks would largely lower the laser damage resistance of repaired crystal surfaces. At this point, the light intensification caused by tool marks is modeled to quantitatively evaluate its bad influence on repairing quality of damaged KDP crystals. In this work, the Maxwell's equations are numerically solved by employing FDTD algorithm to model the scenarios of light propagation through structured surfaces<sup>30–32</sup>. The FDTD models for repaired crystal surfaces with and without tool marks are presented in Fig. 2d based on the tested profiles and geometry of the practically repaired mitigation structures. For the reason that multiple tool marks can actually coexist inside the mitigation pit as shown in Fig. 2b, the effect of tool mark density is also taken into account to describe the interactions between neighboring tool marks. It has been widely known that the modulation property to incident light by rear-surface features always differs from that by front-surface structures<sup>13,25–27</sup>, hence, the effects of tool marks on front- and rear-surface mitigation pits are both simulated in this work. As shown in Fig. 2d, the front- and rear-surface features are realized by reversing the propagation direction in the simulations. For the sake of simplicity, the plane incident wave with TE-mode polarization and 355 nm-wavelength is adopted as the initial input source in our simulations. The electric field intensity of the initial plane wave is normalized to  $E_0 = 1 \text{ V/m}$ . The simulation domain is rectangular and uniformly gridded with mesh size of 25 nm, which is less than  $\lambda/12$  to weaken the effect of numerical dispersion caused by differencing the Maxwell's equations with FDTD algorithm<sup>30</sup>. Among all the simulations, the perfectly matched layers (PML) are employed in the vertical directions, while the periodic boundary conditions (PBCs) are applied in the horizontal directions as shown in Fig. 2d<sup>33,34</sup>. The optical parameters applied to KDP crystal and air can be found in Ref. 23.

**Light intensification modulated by mitigation pit with single tool mark.** The single tool mark inside spherical mitigation pit is generally introduced by single flaw at the cutting edges of micro-milling tool. As depicted in Fig. 2d, the tool marks are raised uncut crystal material, which is reproduced inside the repaired mitigation pit by the chipped cutting edges. Figure 4c,d present the distributions of light intensification caused by the spherical mitigation pit with single tool mark on both front and rear surfaces. The single tool mark is set to be 2.0 μm wide and 0.5 μm deep, according to the tested geometrical

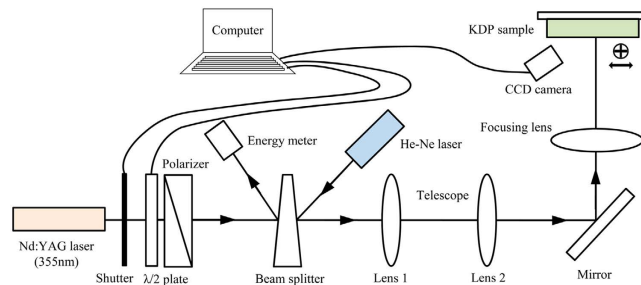
**Figure 3. Schematic of laser damage setup for determining the LIDTs of KDP crystals.**

The experimental set up for testing the LIDTs of KDP samples with various surface features is depicted in Fig. 3. The adopted Nd:YAG SAGA laser, operating at  $355\ \text{nm}$  wavelength,  $10\ \text{Hz}$  repetition rate and  $6.4\ \text{ns}$  pulse duration, is capable to output laser pulses with single longitudinal mode and approximate Gaussian spatial distribution. The  $355\ \text{nm}$ -wavelength is chosen to be consistent with that used in the simulation and actual laser fusion facilities. The switching action of laser pulses is controlled by a mechanical shutter. The combination of a wave plate and polarizer is installed following the shutter to adjust the variable laser fluence. Besides, depending on a wedged splitter, a fraction of pulse energy is detected by energy meter and a He-Ne laser is employed to calibrate the incident light. A CCD camera is placed against the KDP sample to monitor *in situ* the changes of surface morphology after each laser pulse. The LIDTs of various KDP surfaces are measured based on R-on-1 testing strategy<sup>21</sup>, and the detailed implementation for determining the LIDTs are described in Supplementary Fig. S1 online. It is worth noting that the laser damage experiments in this work are just designed for testing the repaired

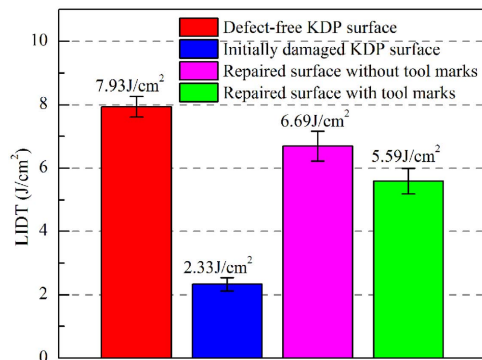
**Figure 7. Comparison of the experimentally tested LIDTs for KDP crystals with damage-free surfaces, initially damaged surfaces, and repaired surfaces with and without tool marks.** The LIDT is determined by testing 10 spots and the error bar is the standard deviation of the tested data.

The tested LIDTs of KDP crystal with different surface features are exhibited in Fig. 7. It is shown that the LIDT of diamond turned defect-free surface is  $7.93 \text{ J/cm}^2$ . However, the growth threshold of initial damaged surface is only  $2.33 \text{ J/cm}^2$ , which implies that once the damage occurs, the damaged surface is susceptible to suffer damage growth under the irradiation of subsequent laser pulse even with very low fluence. The LIDT of ideally repaired mitigation pit with no tool mark comes out to be  $6.69 \text{ J/cm}^2$ . It means that replacing the initial damage site with a spherical mitigation pit by micro-milling can successfully retrieve the damage resistance of previously damaged crystal surfaces. However, with the presence of tool marks inside mitigation pit, the LIDT of repaired KDP surface decreases to  $5.59 \text{ J/cm}^2$ , which is only 83.6% of that for ideally repaired spherical mitigation pit. The electromagnetic energy density is related to electric field  $\mathbf{E}$ ,  $1/2 \epsilon_0 \eta^2 |\mathbf{E}|^2$ , through the refractive index  $\eta$  and vacuum permittivity  $\epsilon_0$ <sup>37</sup>. As known, the light intensity is linearly proportional to  $|\mathbf{E}|^2$ . So, for a given pulse width, the laser fluence threshold LIDT is solely dependent on the light intensity. Based on this, since the tested LIDT for repaired KDP surface with tool marks decreases to 83.6% of that for ideally repaired surface, it is

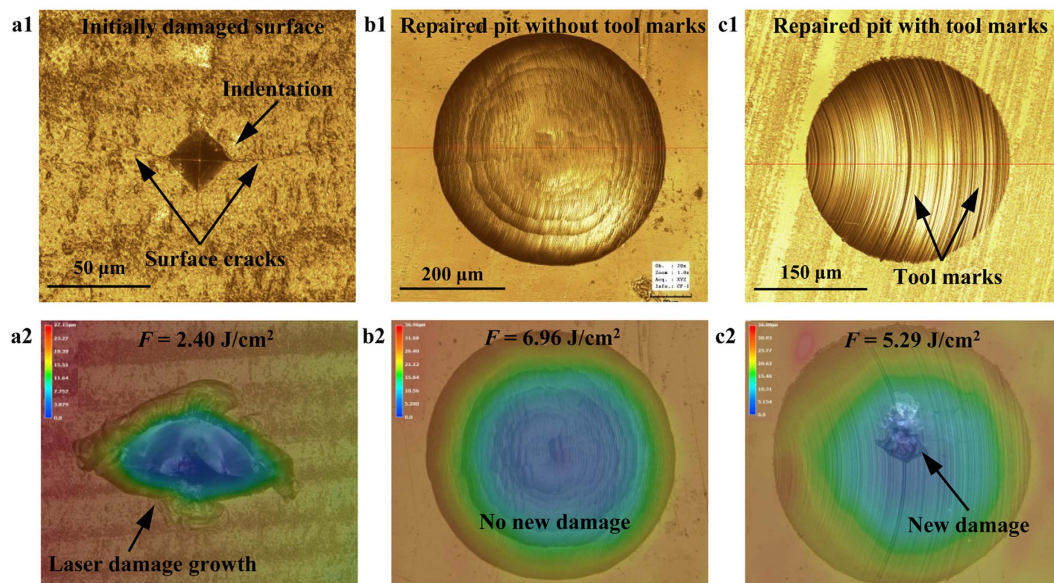
**Figure 8.** Morphologies of the various KDP surfaces before (a–c) and after (d–f) 355 nm-laser pulse irradiation: initially damaged surfaces (a,d), ideally repaired surfaces without tool marks (b,e) and repaired surface with tool marks (c,f). The applied fluences are  $2.40\text{ J/cm}^2$ ,  $6.96\text{ J/cm}^2$  and  $5.29\text{ J/cm}^2$ , respectively for initial damaged surfaces, repaired surfaces without and with tool marks.

Figure 8 presents the further experimental evidence to verify the improvement of laser damage resistance of initial damaged KDP surfaces by micro-milling repairing and the negative effect of tool marks on repairing quality. The initial damaged crystal surface with micro-indentation shows aggravated damage after the laser irradiation with  $2.40\text{ J/cm}^2$  fluence as shown in Fig. 8a1,a2, while for the repaired surface without tool mark in Fig. 8b1,b2, even irradiated by laser pulse with much higher fluence ( $6.96\text{ J/cm}^2$ ), no new damage appears on the repaired KDP surfaces. However, when the repaired surface with tool marks is irradiated with  $5.29\text{ J/cm}^2$  laser pulse, new laser damage comes out right at the tool marks inside the mitigation pit, which is shown in Fig. 8c1,c2. By comparing with the simulation results in Fig. 6a, it can be found that the front-surface tool marks can greatly modulate the incident light, and consequently generate a series of hot spots among the tool marks region. When incident laser comes, even with low fluence, the energy can be concentrated and multiplied in this confined hot-spot region, and hence initiate laser damage at the tool marks inside the repaired pit, which is well consistent with the actual damage scenario shown in Fig. 8c2. This implies that the tool marks are the potential weak points, lowering the laser damage resistance of repaired KDP crystals. The above experiments testify that repairing the initial damage site with a spherical pit can positively hold the damage growth for KDP optical components, while the tool marks reproduced by the flaws at the cutting edges would indeed lower the repairing quality to a certain extent.
